Technical Service Bulletin

Topic	Clicking noise from the front wheels when conducting a static lock to lock steering manoeuvre
Market area	Bentley: worldwide (2WBE),China 723 Volkswagen (Anhui) Automotive CO (6723),China 796 VW Import Comp. Ltd (Vico), Beijing (6796)
Brand	Bentley
Transaction No.	2060446/9
Level	EH
Status	Released for publishing
Release date	Jan 27, 2026

New Continental GT/GTC and New Flying Spur

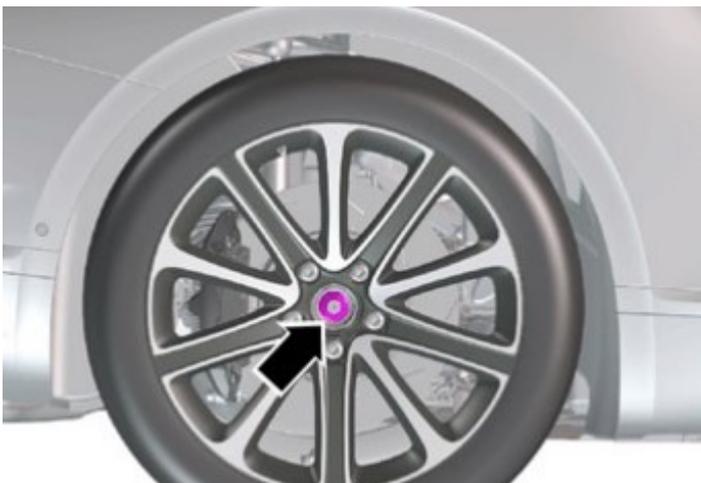
Clicking noise from the front wheels whilst performing a static lock to lock steering manoeuvre

4) Referring to Figure 1 - Remove and discard the left and right front hub retaining nuts - Refer to Rep.Gr 40 Front wheel bearing housing - To remove and fit

5) Install new the left and right front hub retaining nuts - Refer to Rep.Gr 40 Front wheel bearing housing - To remove and fit
