Technical Service Bulletin

Topic	Sunroof blind not retracting Bentleyga Series 17-26MY
Market area	Bentley: worldwide (2WBE),China 796 VW Import Comp. Ltd (Vico), Beijing (6796)
Brand	Bentley
Transaction No.	2078373/2
Level	EH
Status	Released for publishing
Release date	Jan 27, 2026

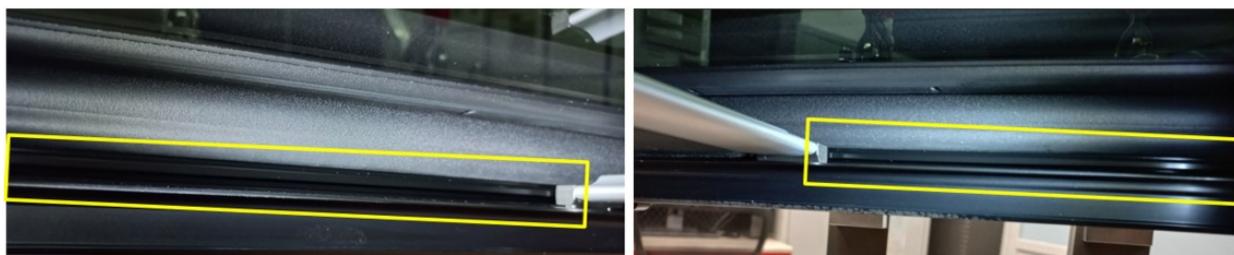
Figure 2 Contamination of roof / guides for sunblind slide shoes

1. Inspect the sunroof blind frame for contamination of the guides (located under rear glass).

2. While the sunroof is stationary, visually inspect the rear section of the guide channels from underneath the rear glass. Check for small materials such as:

- Small stones
- Excessive dirt or dust
- Organic matter (e.g., pine needles, leaves).

NOTICE
The guides must be completely clean and free from all contamination to ensure smooth operation.

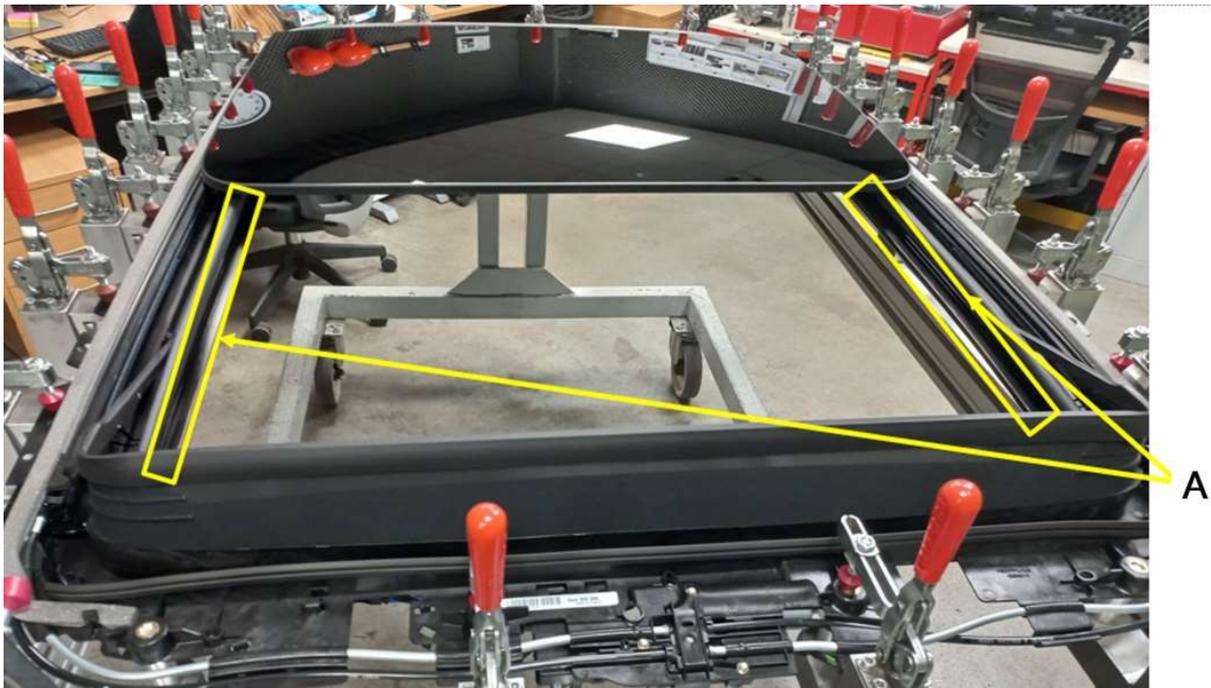
Figure 3 Contamination of roof check

3. Inspect areas 'A' labelled in figure 3 of the frame for contamination.

The yellow markings highlight the area most likely to become contaminated when the roof is opened.

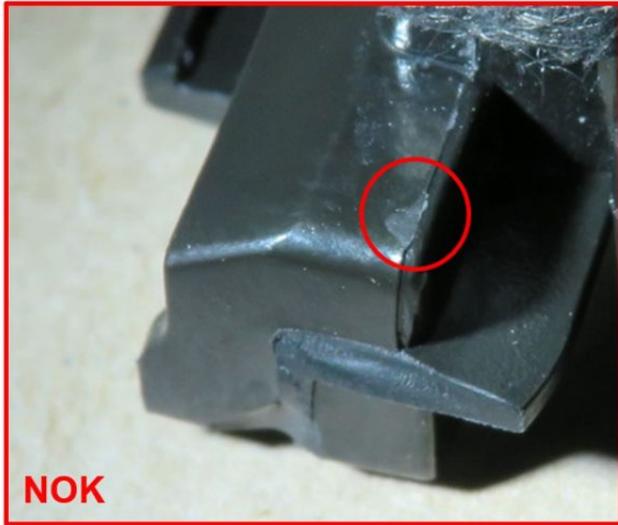
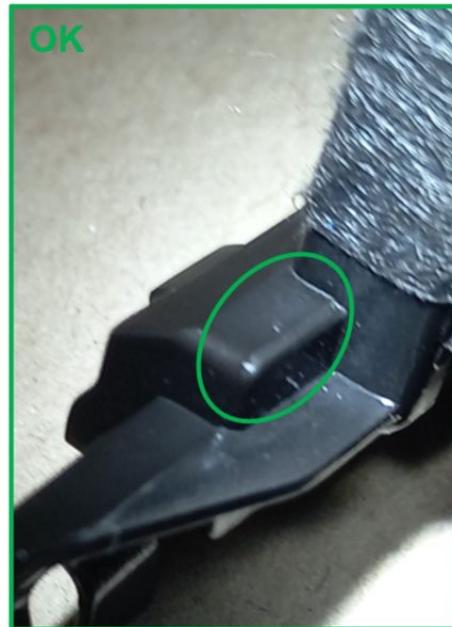
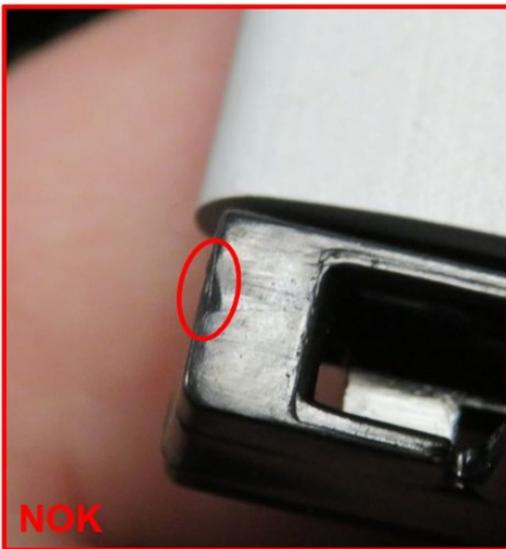
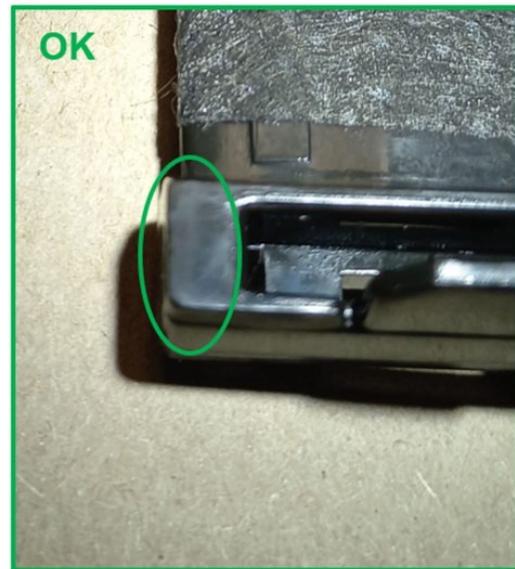
Figure 4 Damage of the sunroof blind slide shoes due to contamination check

4. Inspect the sunroof blind slide shoes for:

- Cracks
- Wear
- Missing plastic components
- Distortion from misalignment.

All slide shoes must be intact and free of visible damage.

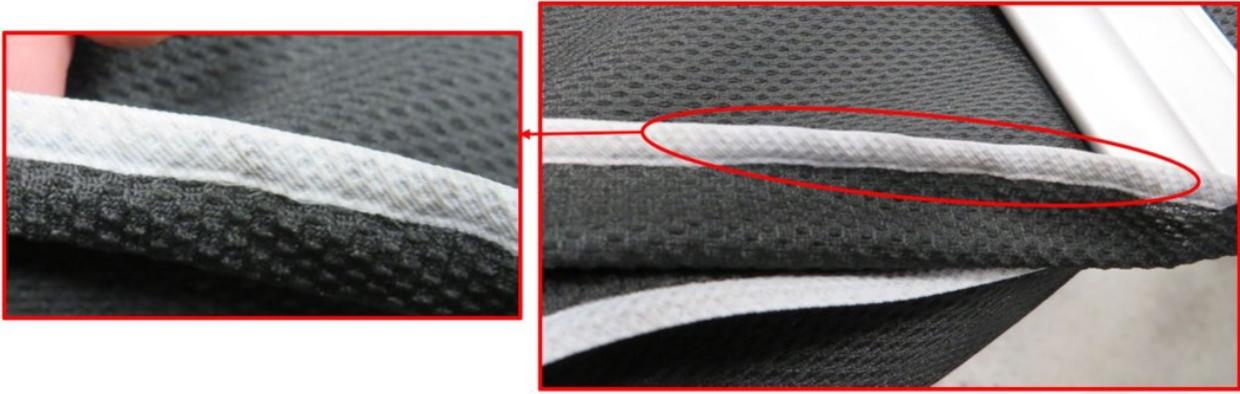
Figure 5 Contamination of roof / PDF strip check

5. Inspect the PDF strip of the blind material, check for contamination on areas corresponding to the slide shoe path. If the guide is contaminated it is likely that the PDF strip is also contaminated or damaged.

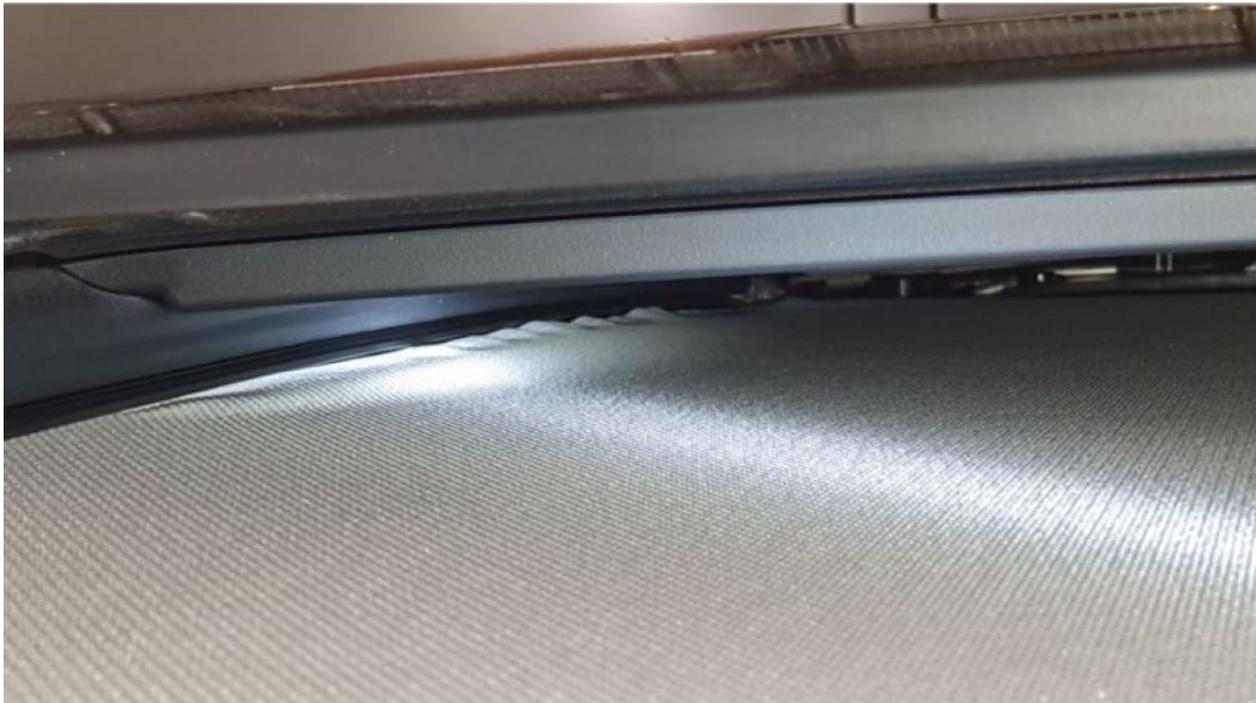
Figure 6 PDF strip derailment check

6. Inspect the blind guides if they are coming off the runners and check the PDF strip for any derailing issue or NOK welding of the PDF strip.

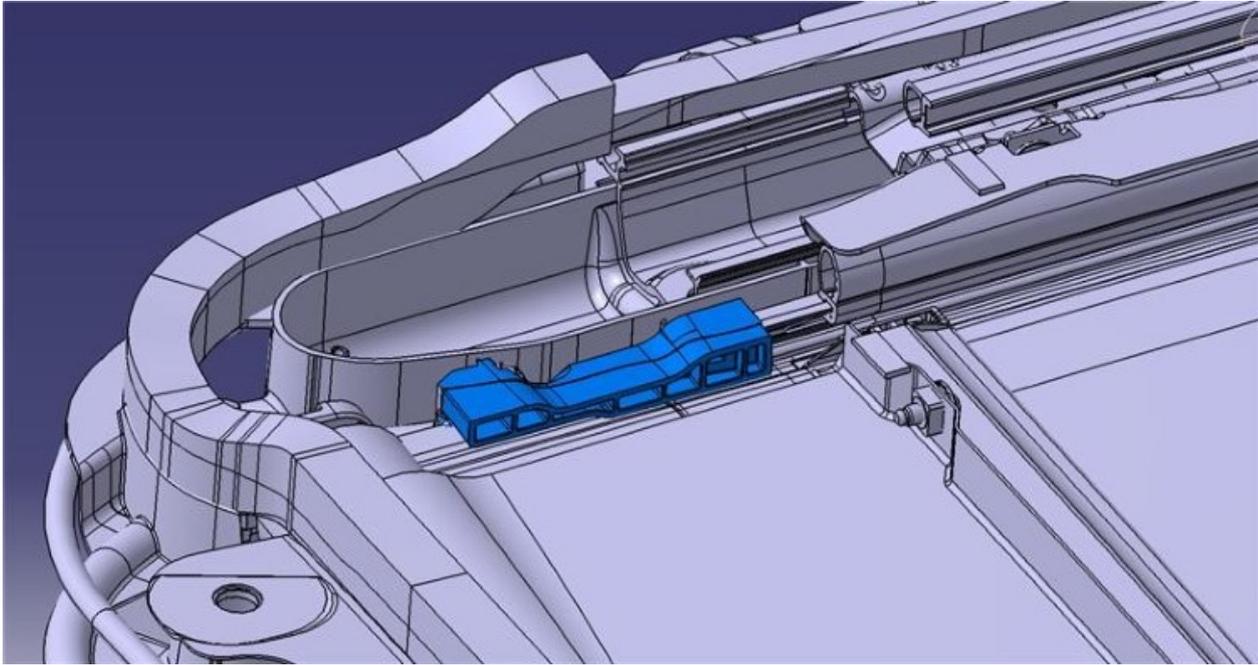
Figure 7 *Guide part location*

Inspect the guide part by removing headliner (refer to ElsaPro Repair Group 70 'Headlining – To remove and fit').

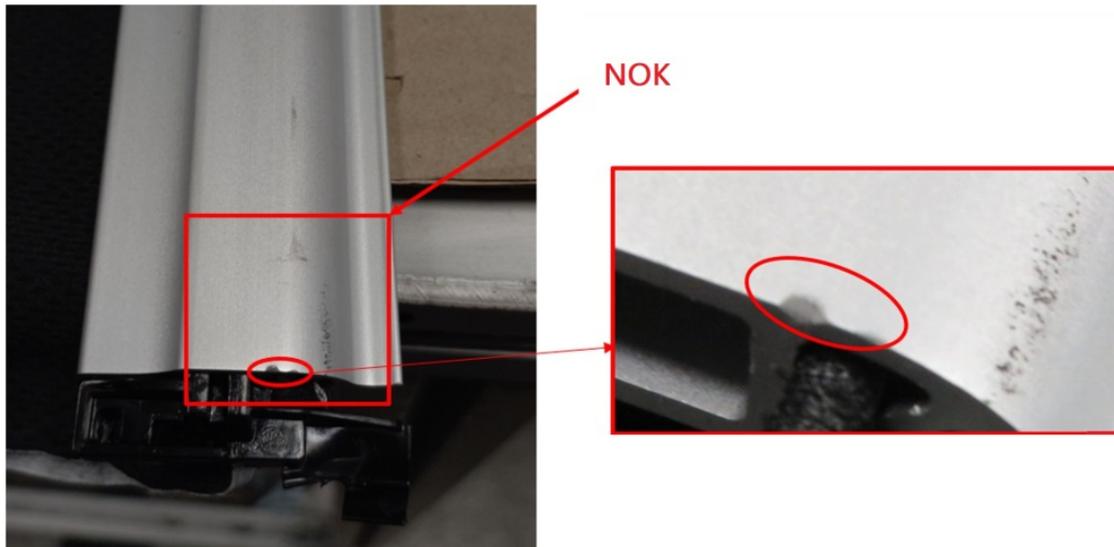
Figure 12 Sunblind beam check

7. Inspect the sunblind beam for scratches or damage. Damage would indicate presence of external contamination.

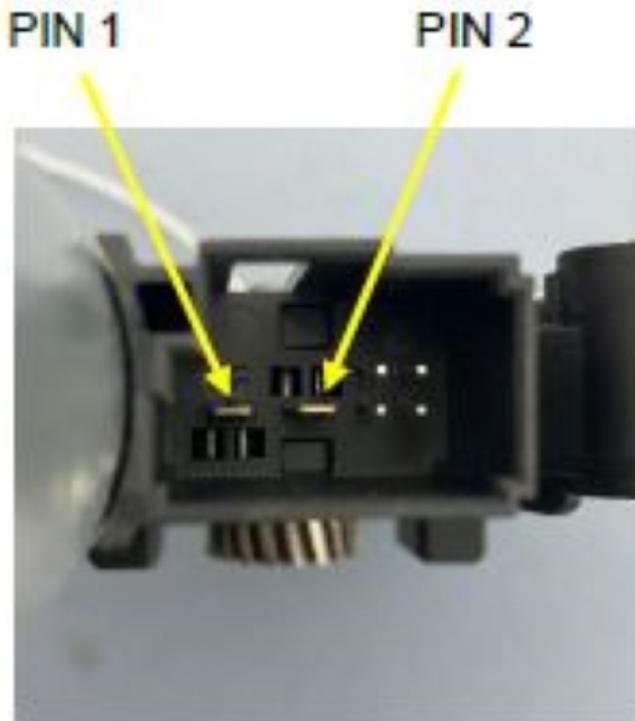
Figure 14 Location of pins on motor

9. Measure and record resistance across Pins 1 and 2 and include reading in DISS ticket.

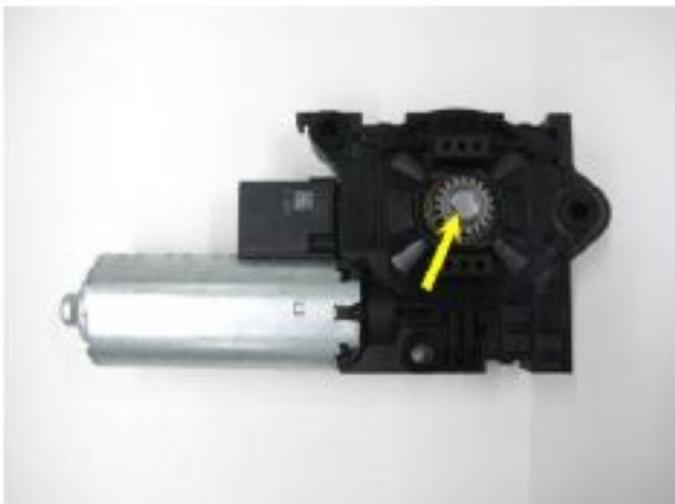
Figure 15 Position of motor shaft

10. While the motor is disengaged from the drive cables, rotate the motor shaft using a soft jaw wrench and verify that it operates correctly in isolation.

If operation does not resume, replace sliding motor 4M0 959 591/A (refer to ElsaPro Repair group 60 'Sunroof motor – To remove and fit').
