Technical Service Bulletin

Topic	Turbo Charger Under-boost - DTC P029900 is evident in 0001 V8 Kovomo All Models
Market area	Bentley: worldwide (2WBE),China 796 VW Import Comp. Ltd (Vico), Beijing (6796)
Brand	Bentley
Transaction No.	2079115/1
Level	EH
Status	Released for publishing
Release date	Jan 27, 2026

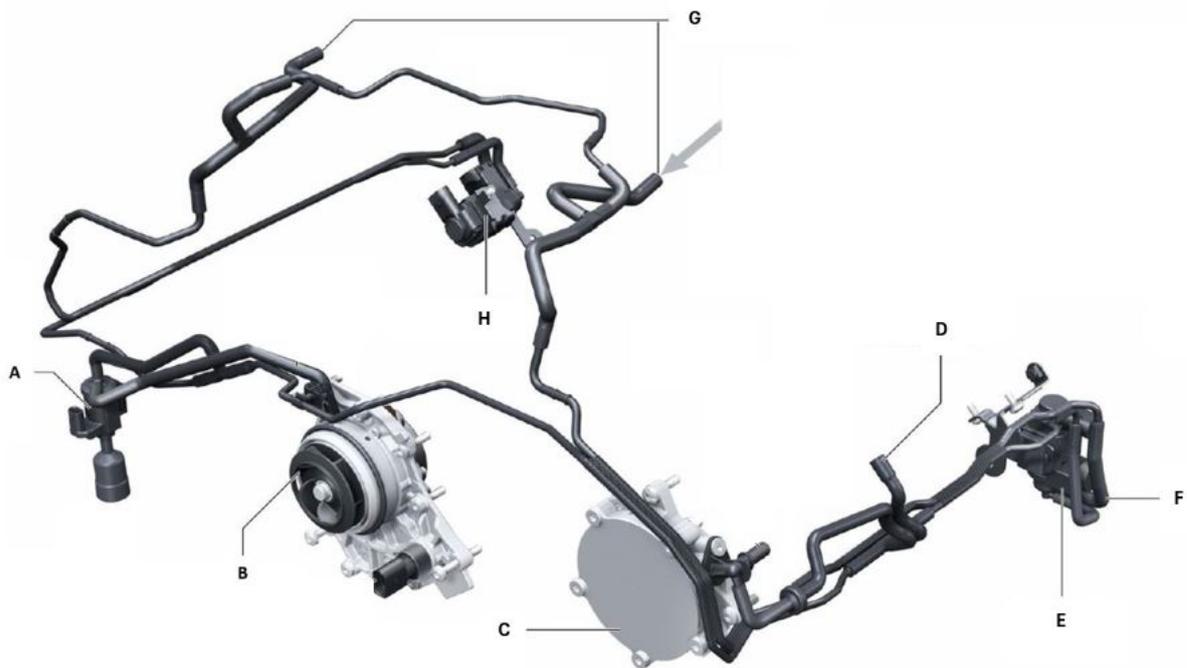
Vacuum System Layout – Use for Illustration purposes only

The wastegate actuator relies on vacuum pressure to regulate turbocharger boost. If vacuum is not maintained, the wastegate may remain open, preventing the turbocharger from generating full boost. This can trigger engine protection mode, limiting performance and displaying warnings in the DIP. Refer to the measure section for guided fault-finding steps.

A) Switch valve for mechanical coolant pump	B) Coolant Pump	C) Vacuum pump	D) Connection for vacuum reservoir
E) Boost pressure control solenoid 1	F) Outlet (Vacuum pressure input)	G) Connection for Vacuum unit/turbo charger	H) Boost pressure control solenoid 2
