E326: EPA 17-21 MX-13 Fuel Injector Connector Upgrade

E326

3/11/2025

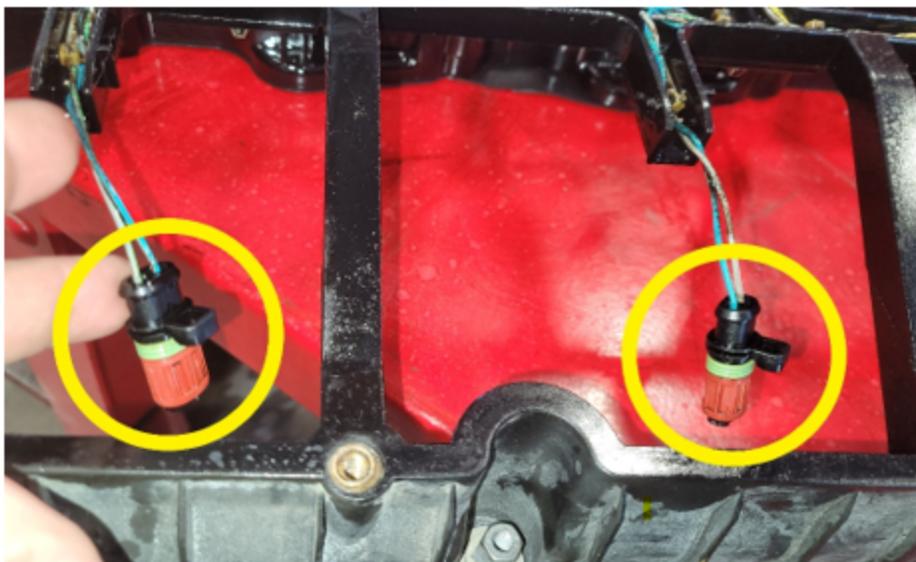
During repairs which involve disconnecting the injectors or removing the valve train casing, the injector connector shells (1439888PE) locking tabs may be broken. Since the injector connector shells were not previously available, the entire valve train casing assembly had to be replaced to fix the issue.

Broken Injector Connectors in Valve Train Casing Assembly

Injector connector shell locking tabs may break when disconnected, resulting in valve train casing assembly replacement.

To prevent downtime, dealers should stock the injector connector shells (1439888PE). Replacement of

broken connector shells should occur rather than replacement of the valve train casing assembly.

Injector connector shell replacement procedures can be found in RMI by searching “valve train casing”, then select Parts > Valve train casing > Jobs > replace 1 (one) connector 2-pin (Basic assembly).

When connector shells are replaced according to RMI, a pin extraction tool is required to complete the repair. This tool is part number 539972-1, available through PACCAR Parts.
