# FS015: PACCAR TX-12 MTM Loose Rail Cap Screws

FS015

Transmission - 26

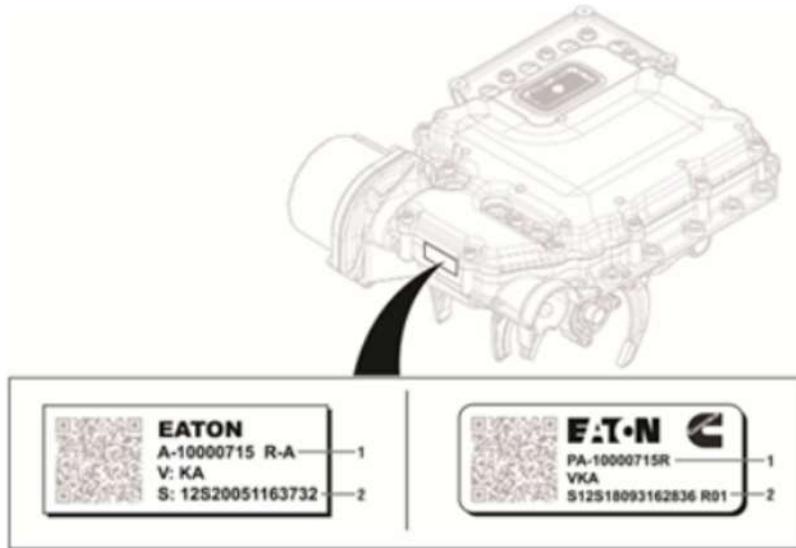
MTM Label Location

1. Inspect the Mechatronic Transmission Module (MTM) label for type and serial number:

- If it is an Eaton/Cummins Joint Venture label (pictured below) or the five bolded digits of the MTM serial number are 22342 or sequentially higher (12S**22342**145012), then no repairs are required. File a claim for inspecting the MTM label.

- If it is an Eaton label (pictured below) and the five bolded digits of the MTM serial number are sequentially lower than 22342 (12S**22342**145012), then proceed to step 2.
