# FS016: Eaton Endurant MTM Loose Rail Cap Screws

Eaton Endurant MTM Loose Rail Cap Screws

Transmission - 26

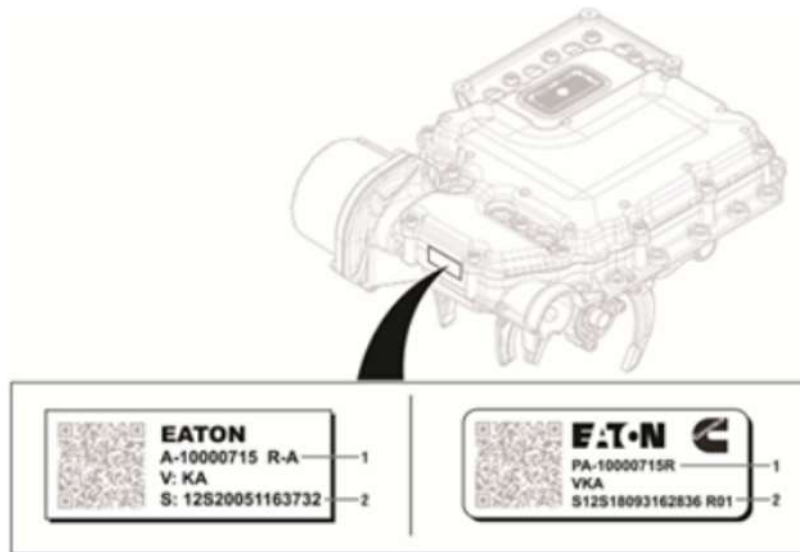
*MTM Label Location*

1. Inspect the Mechatronic Transmission Module (MTM) label for type and serial number:

- If it is an Eaton/Cummins Joint Venture label (pictured below) or the five bolded digits of the MTM serial number are 22342 or sequentially higher (12S**22342**145012), then no repairs are required. File a claim for inspecting the MTM label.

- If it is an Eaton label (pictured below) and the five bolded digits of the MTM serial number are sequentially lower than 22342 (12S**22342**145012), then proceed to step 2.
