Technical Service Bulletin

26-BE-001H

JANUARY 2026

**INOPERATIVE HORN ASSEMBLY REPLACEMENT
(WARRANTY EXTENSION Z09)**

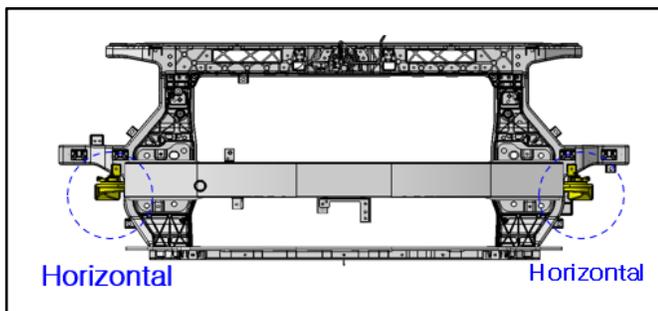
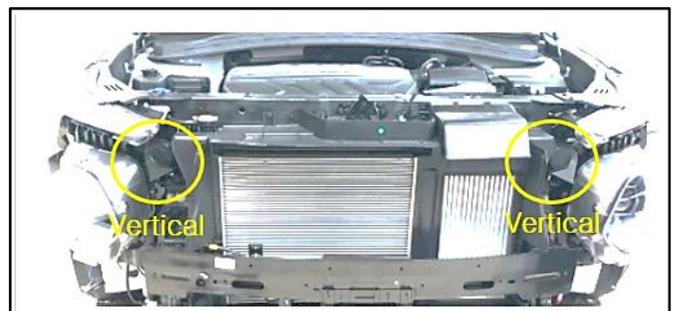
Description: Certain Santa Fe Hybrid (TM HEV) and Santa Fe Plug-In Hybrid (TM PHEV) vehicles may have an inoperable horn that may be caused by foreign substances causing internal parts to oxidize.

If a horn needs to be replaced, follow the instructions within this TSB to install the latest design.
