Technical Service Bulletin

GROUP HVAC	NUMBER 26-HA-001H
DATE JANUARY 2026	MODEL(S) SEE BELOW

SUBJECT: A/C VENT MODE CHANGE ISSUES/NOISES –
VENTILATOR LEVER INSPECTION & REPLACEMENT

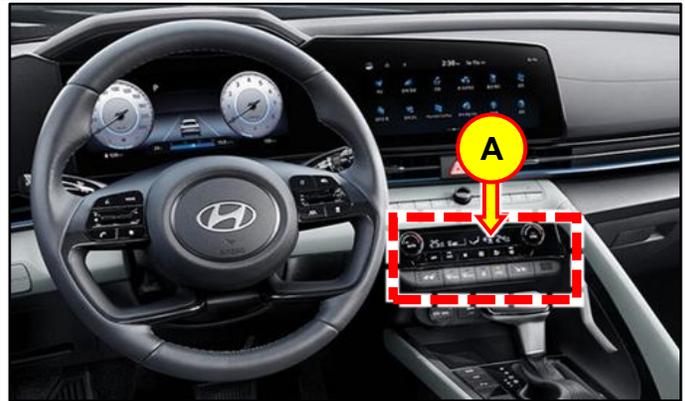
1. Turn **ON** the A/C or heater.
2. Set the airflow to **floor mode (A)** only.

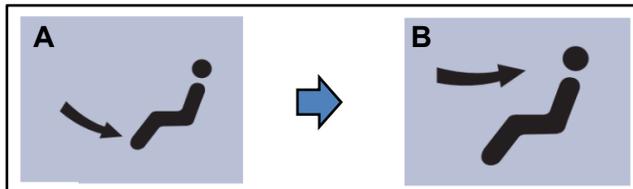
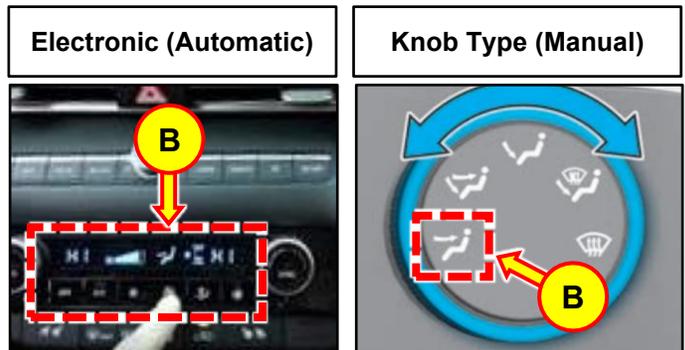
3. Change the mode actuator to the **forward-facing vent mode (B)** and verify if airflow is coming from the center vents.

- If there is airflow out of the center vents, but other concerns are present, this TSB does **NOT** apply. Follow normal diagnostic procedures.
- If **NO** airflow is present from the forward-facing center vents, or a popping/snap noise is heard when switching modes, replace the ventilator lever and cam mode guide.

Proceed to **Ventilator Lever and Cam Mode Guide Replacement** procedure.

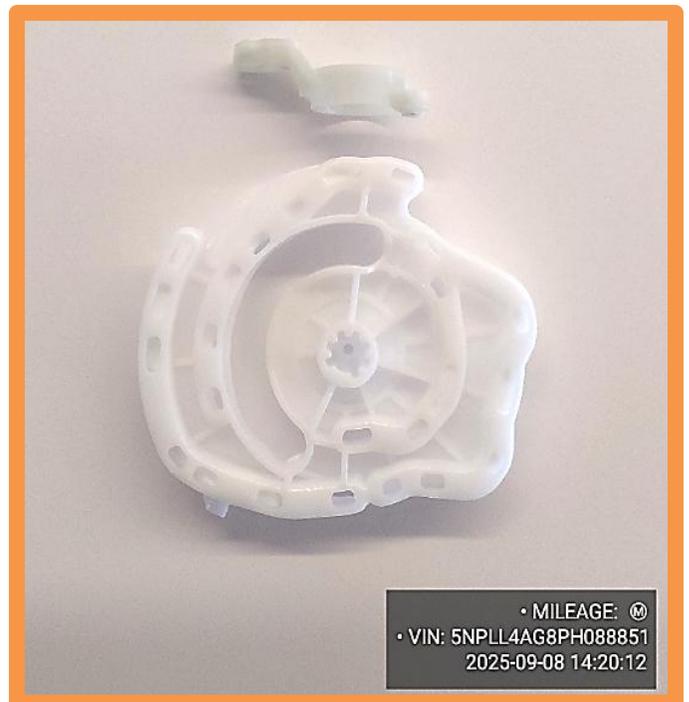
Using the STUI camera function, take a photo of the original ventilator lever arm and cam mode guide.

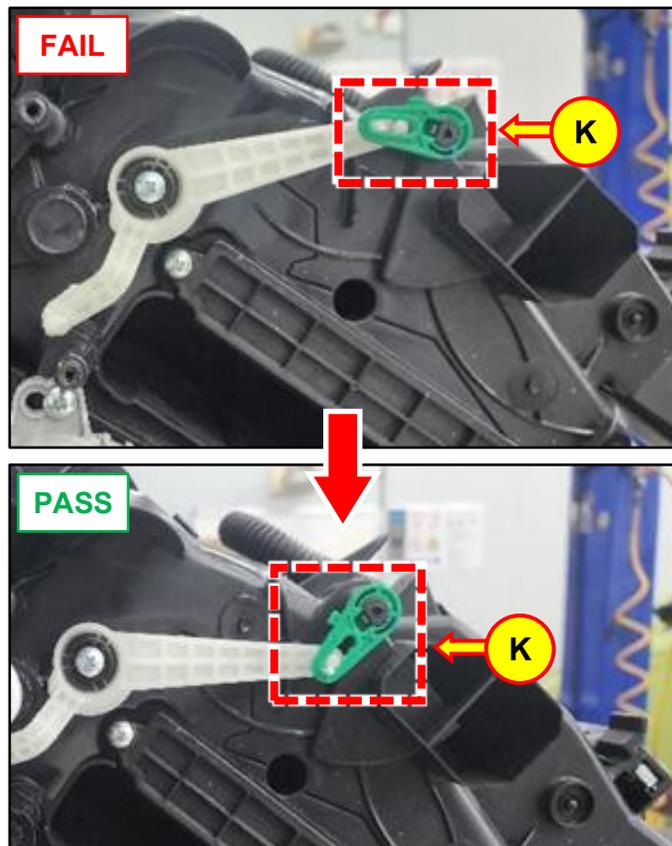
9. Before reinstalling the mode actuator and replacing the cam mode guide, inspect the position of the floor door lever (K).
- If the floor door lever is horizontal as shown (**FAIL**), then correct the position by pushing the lever downward as shown in the second photo (**PASS**).

10. Replace the cam mode guide with the newly supplied part and re-install the actuator in the reverse order of removal.
11. Reinstall the main crash pad in the reverse order of removal process.

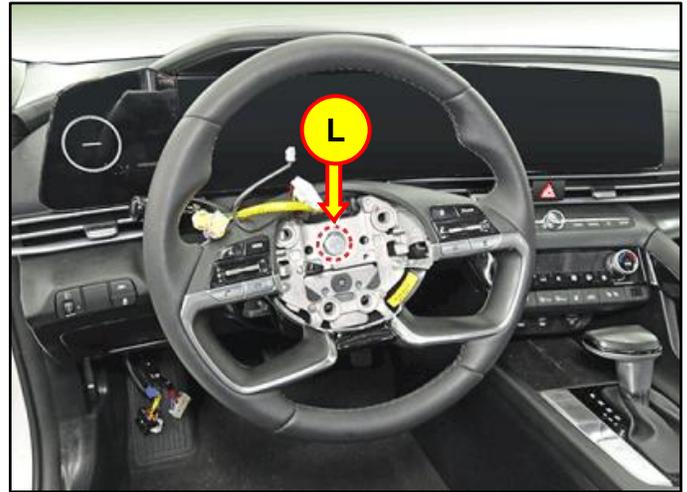
When reinstalling the steering wheel, be sure to replace the steering wheel lock bolt (L) with a new one (P/N: **56115-B1000**).
