Countries: CANADA, MEXICO Document ID: IK1300197  
 Availability: Revision: 0  
 Major System: TRANSMISSION Created: 1/15/2026  
 Current Language: English Last Modified: 1/16/2026  
 Other Languages: NONE Author: Frank Amstadt  
 Viewed: 40

Title: T14 Upper Transmission Harness Updates

Applies To: LT, RH, HV, HX, S13, T14

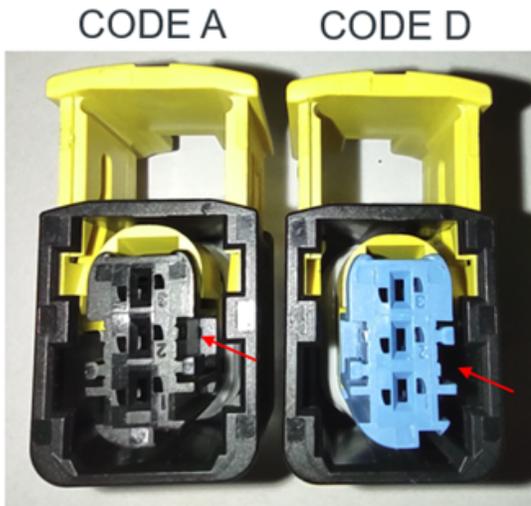
The Rear Gearbox Harness (Upper Transmission Harness) has been updated for better fitment. One key change is a new harness side connector design for the TOSS (Transmission Output Shaft Sensor) to match the updated TOSS. The new harness and new TOSS use different keying than the older versions, which has caused confusion when updated harnesses does not fit the original TOSS.

- **If diagnostics indicate replacing the transmission harness (112221N91):**  
Check that the new harness fits the TOSS currently installed.
  - If it does **not** fit, the TOSS must also be replaced with the updated version (115139N1).
- **If diagnostics indicate replacing the TOSS:**  
Check that the new TOSS (115139N1) fits the existing harness.
  - If the connector does **not** fit, the existing harness is the original version and must be replaced with the updated harness (112221N91).
