L634-
A.01.26

To: After Sales Official Network
Subject: Rework routing RH VVT cable
Date: 16/01/2026
Pages: 6

Campaign name:
Rework routing RH VVT cable

Model:
Temerario

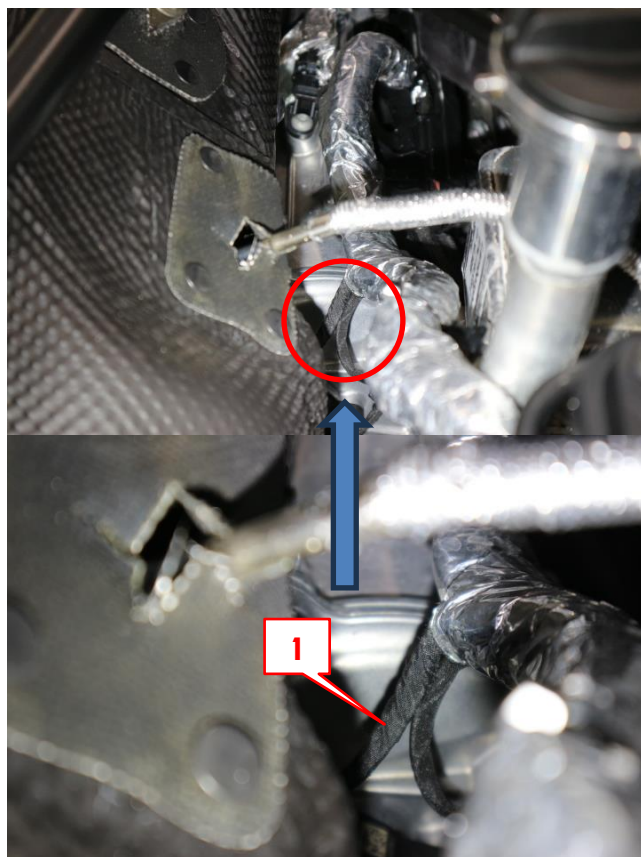
1. Open the right kidney.
2. Locate the wiring (1) (right side of the motor).

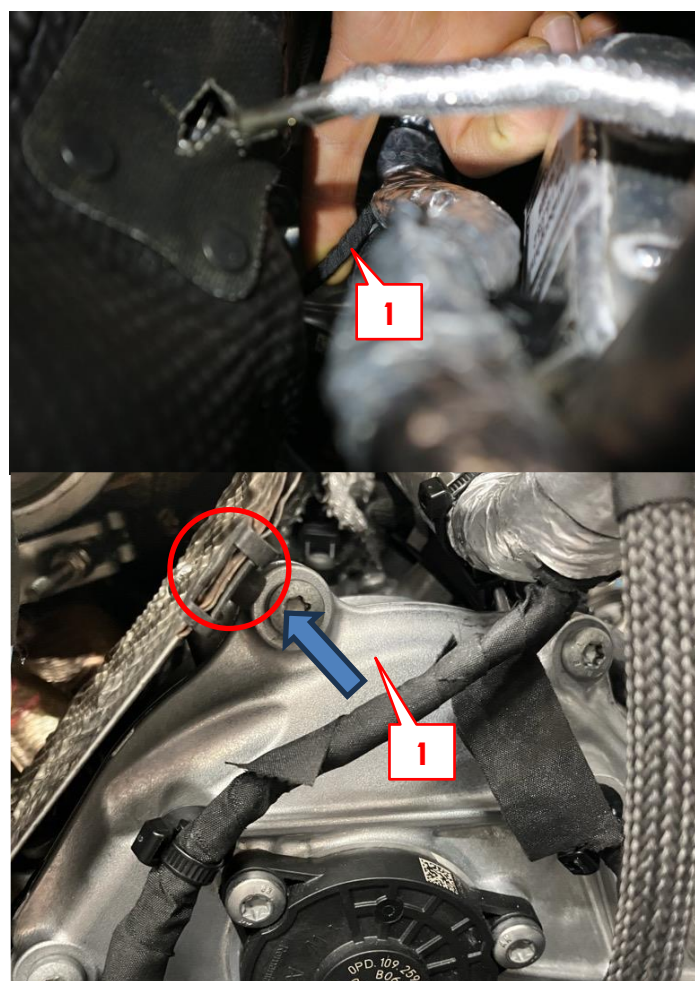
3. Push the wiring (1) upwards from the bottom towards the screw/clip (circled) on the heat shield and check whether the wiring (1) comes into contact with the screw/clip.
4. If the wiring (1) does not make contact, push the wiring (1) down again, moving it as far away as possible from the screw/clip. The check can then be considered complete.
5. Close the right kidney.
6. If the wiring (1) makes contact, perform **operation D**.

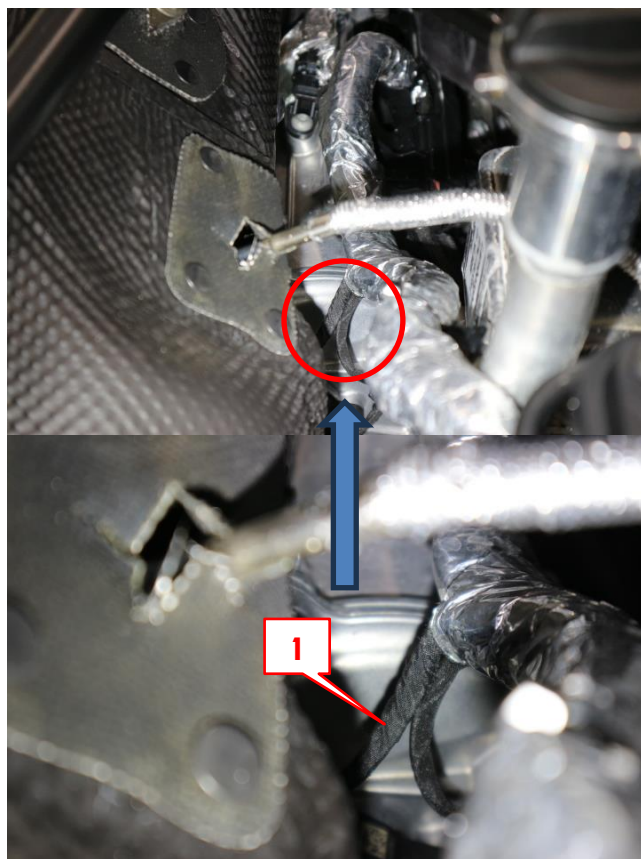
8. Locate the wiring (1) (right side of the motor)

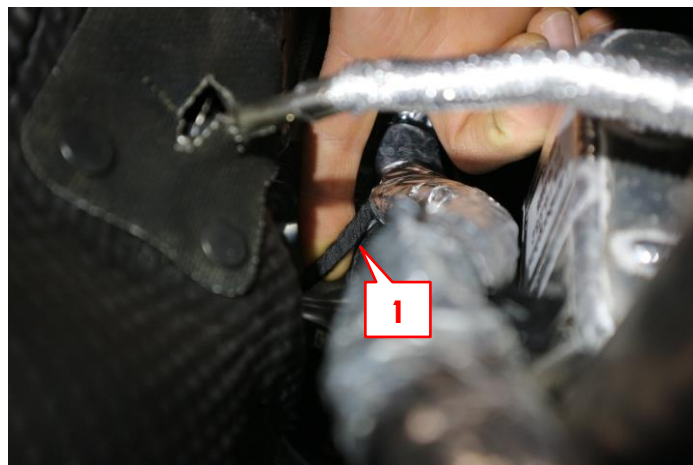
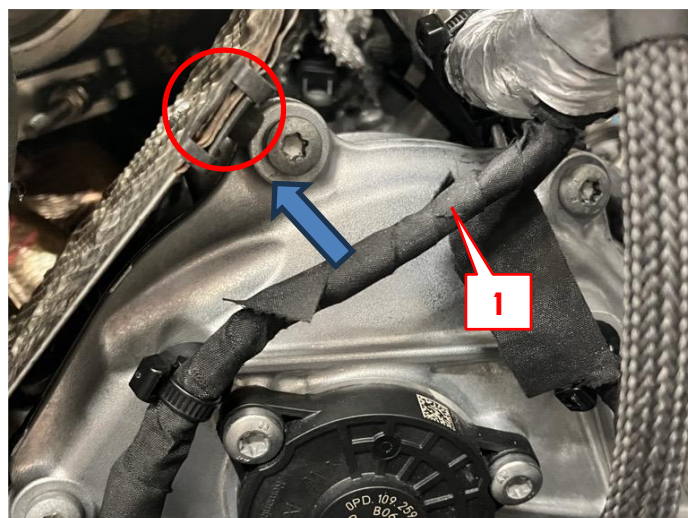
9. Push the wiring (1) upwards from the bottom towards the screw/clip (circled) on the heat shield and check whether the wiring (1) comes into contact with the screw/clip.

10. If the wiring (1) does not make contact, push the wiring (1) down again, moving it as far away as possible from the screw/clip. The check can then be considered complete, follow the instructions given in the Workshop Manual at the following path:

11. If the wiring (1) makes contact, perform **operation E**.

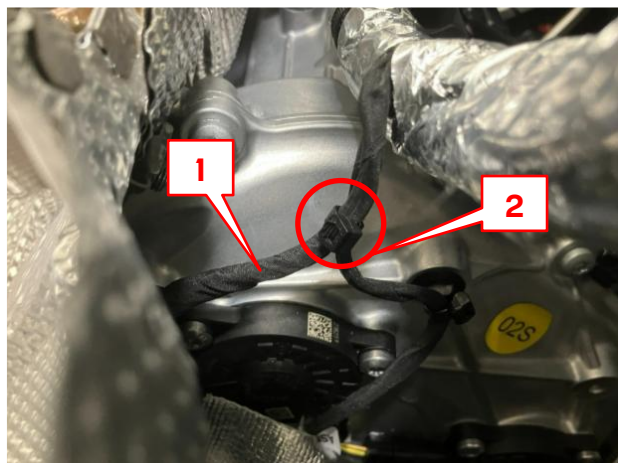
12. Check that the wiring (1) is not damaged due to contact with the screw/clip on the heat shield.
13. If the wiring (1) is intact and undamaged, add the cable tie (N90937701) by attaching it to the second wiring (2) of the GDI pump. After applying the cable tie, check that the wiring (1) does not touch the screw/clip.

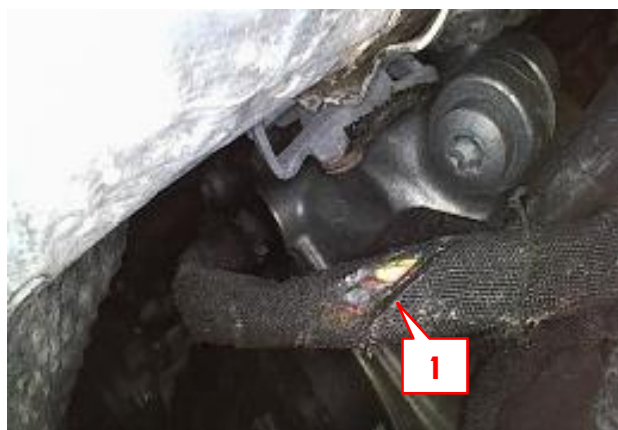
14. If the wiring (1) has suffered any kind of damage, open a claim on the Liass portal.

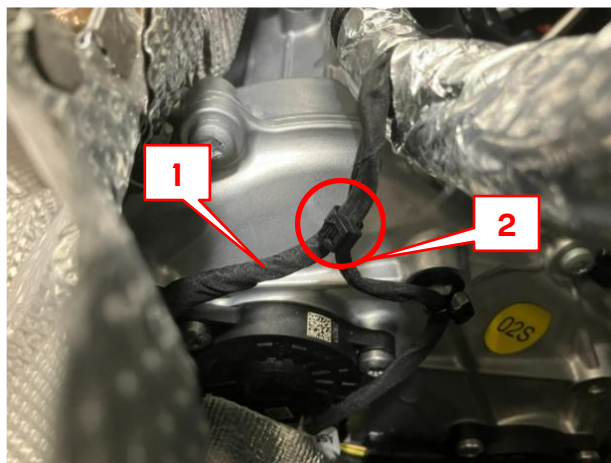
15. Check that the wiring (1) is not damaged due to contact with the screw/clip on the heat shield.
16. If the wiring (1) is intact and undamaged, add the cable tie (N90937701) by attaching it to the second wiring (2) of the GDI pump. After applying the cable tie, check that the wiring (1) does not touch the screw/clip.

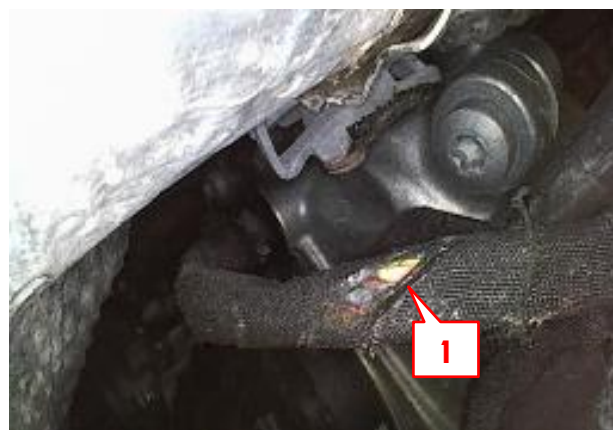
17. If the wiring (1) has suffered any kind of damage, open a claim on the Liass portal.
