01-25-09 - Service information, ID. Software (ID.S) Baseline Update ID.S 5.4.3
KD

Applicable Vehicles						
Model(s)	Year	Eng. Code	Trans. Code	VIN Range From	VIN Range To	PR Code
ID.4	2024 – 2025	All	All	All	All	V7B, V7C, V7G

Revision Table			
Instance Number	Published Date	Version Number	Reason For Update
2080124/3	1/5/2025	01-25-09	Update incorrect sequence (version) number
2080124/1	12/18/2025	01-25-07	Original publication.

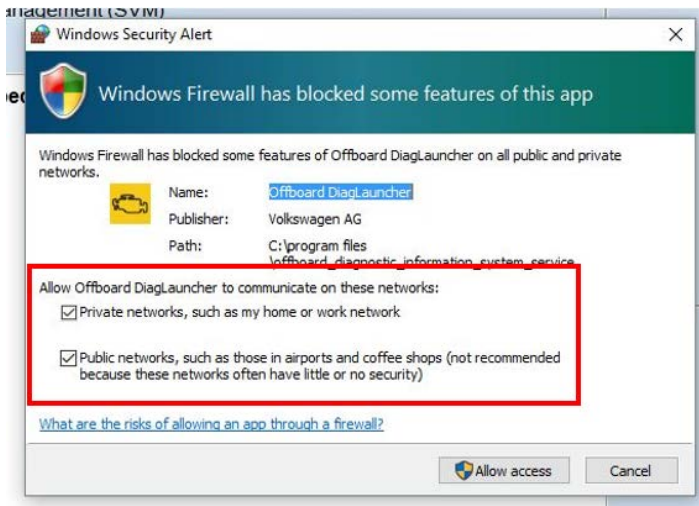
Figure 14. Windows Firewall notification (error)

Do not continue if a Windows Firewall notification appears (see figure 14). Attempting to proceed without resolving incorrect firewall settings can cause the update to fail.

- All network options must be checked. See service references noted under "2. Review prerequisites and perform preliminary work"

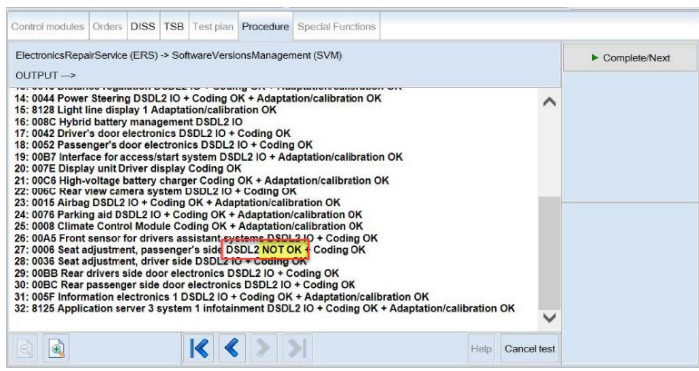
Figure 15: Example “NOT OK” response

- If there is an “NOT OK” note for one or several control units (see figure 15), the update must be attempted again (go back to step 7).

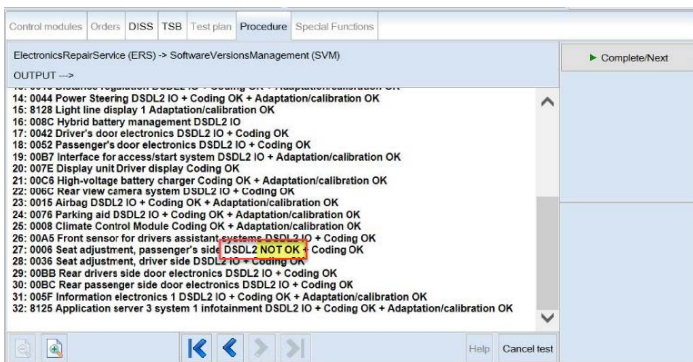
Figure 17: Example “NOT OK” response

- If there is an “NOT OK” note for one or several control units (see figure 17), the update must be attempted again (go back to step 7).

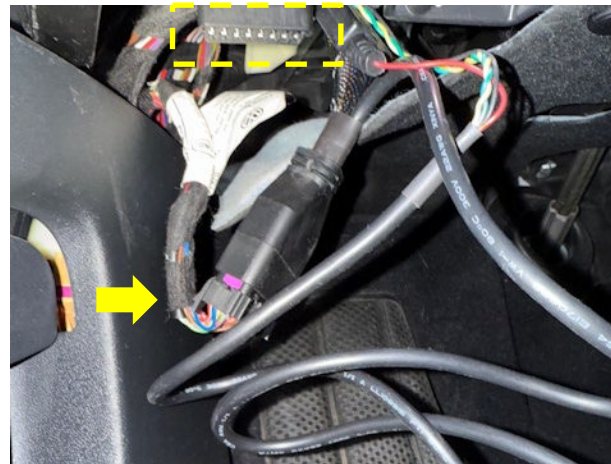
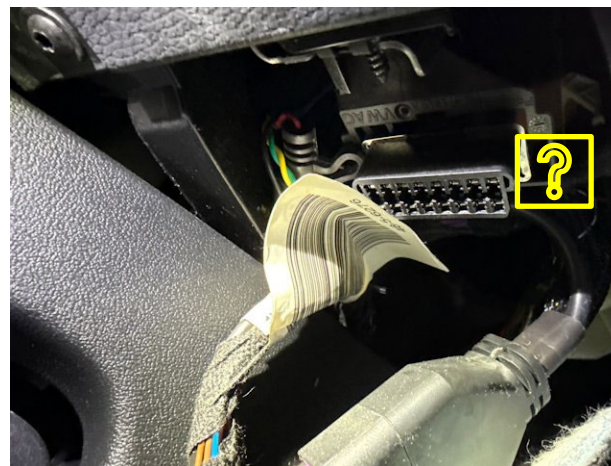
Checking for aftermarket equipment at the diagnostic connection (U31)

- Check for a non-original diagnostic connection (U31) or any aftermarket equipment or wiring connected to the vehicle's original diagnostic connection (U31).
- The diagnostic interface VAS 6154A or VAS 6154B must be connected to the original diagnostic connection (U31) for a stable connection and proper CAN/ DoIP switching.

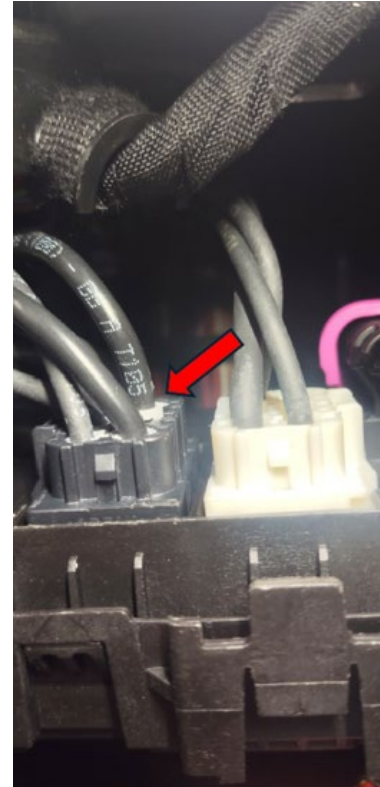
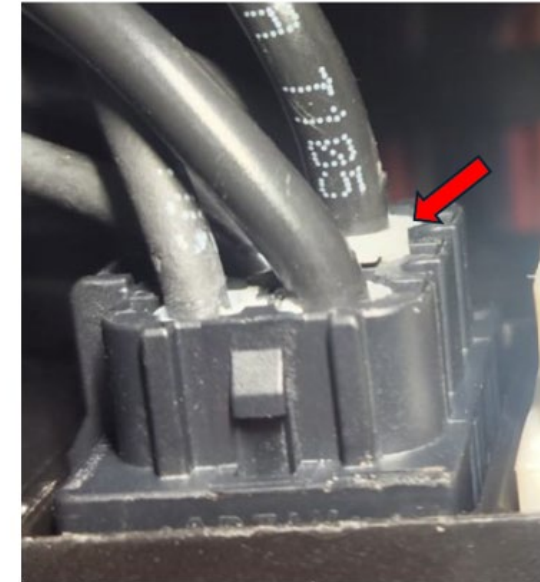
Checking the Ethernet lines

- Check the Ethernet wires at the gateway connector for correct installation.
- If any are not fully seated (red arrow) seat the connector fully, if necessary, repair.
