Condition

Applicable Vehicles					
Model(s)	Year	Eng. Code	Trans. Code	VIN Range From	VIN Range To
Atlas	2024 - 2026	2.0T DRKB	All	All	All
Atlas Cross Sport	2024 - 2026	2.0T DRKB	All	All	All

The MIL is flashing or illuminated.

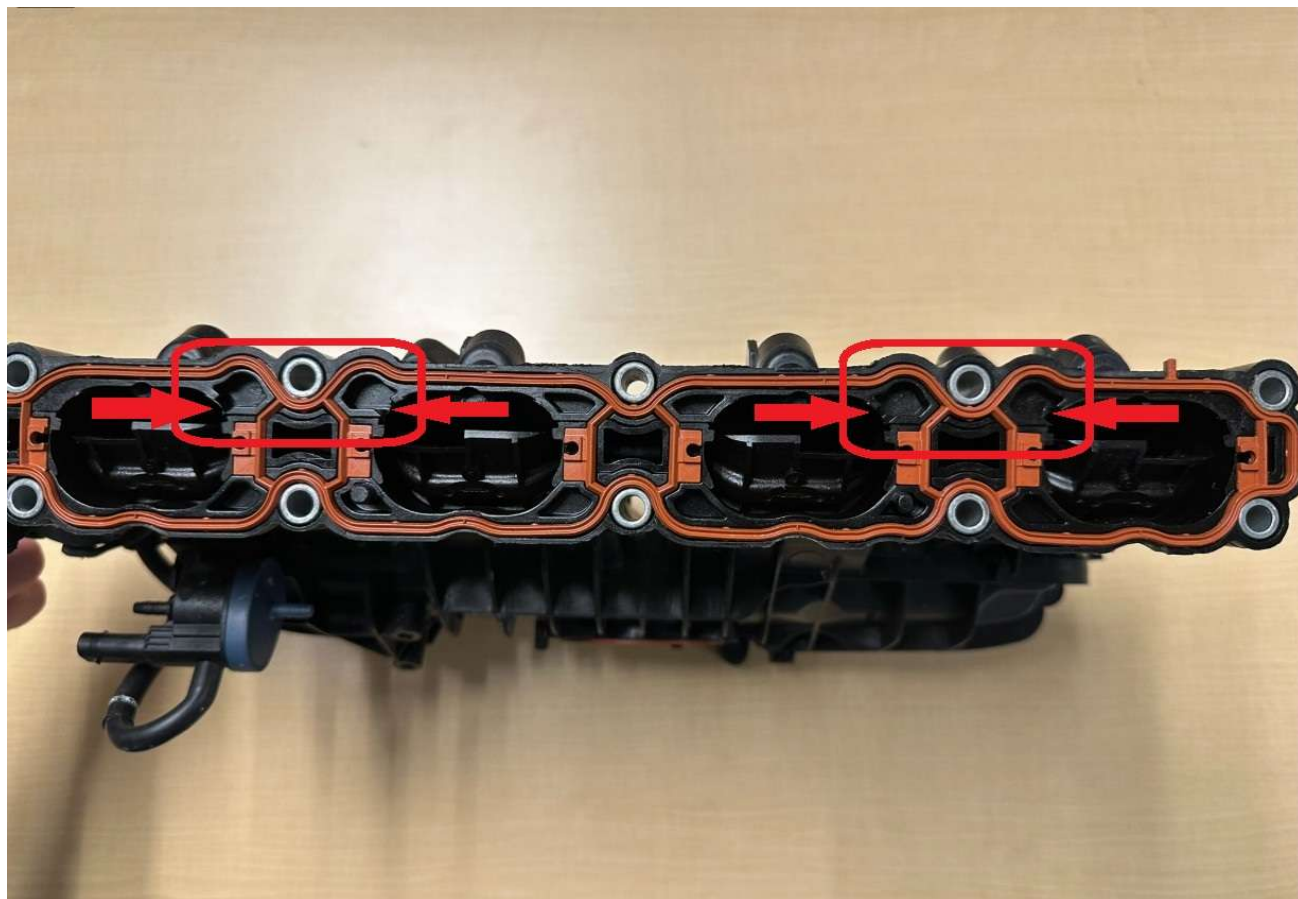
Figure 1:

1. Remove the intake manifold per the steps outlined in the repair manual.
2. Inspect the 4 intake ports for excess flashing in the areas circled in red below in figure 1.

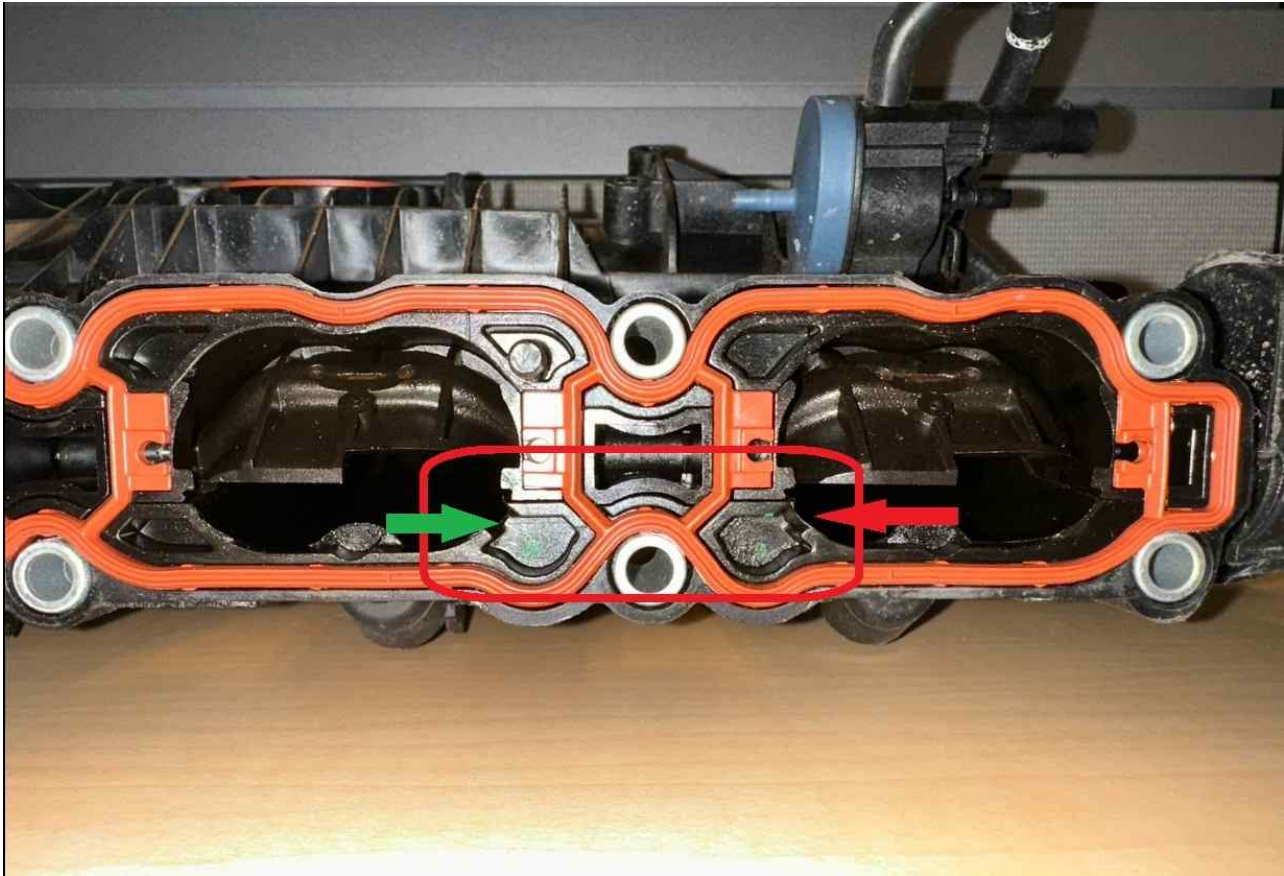
Figure 2:

In figure 2 below, the green arrow shows an intake port without excess flashing, and the red arrow shows an intake port with excess flashing.

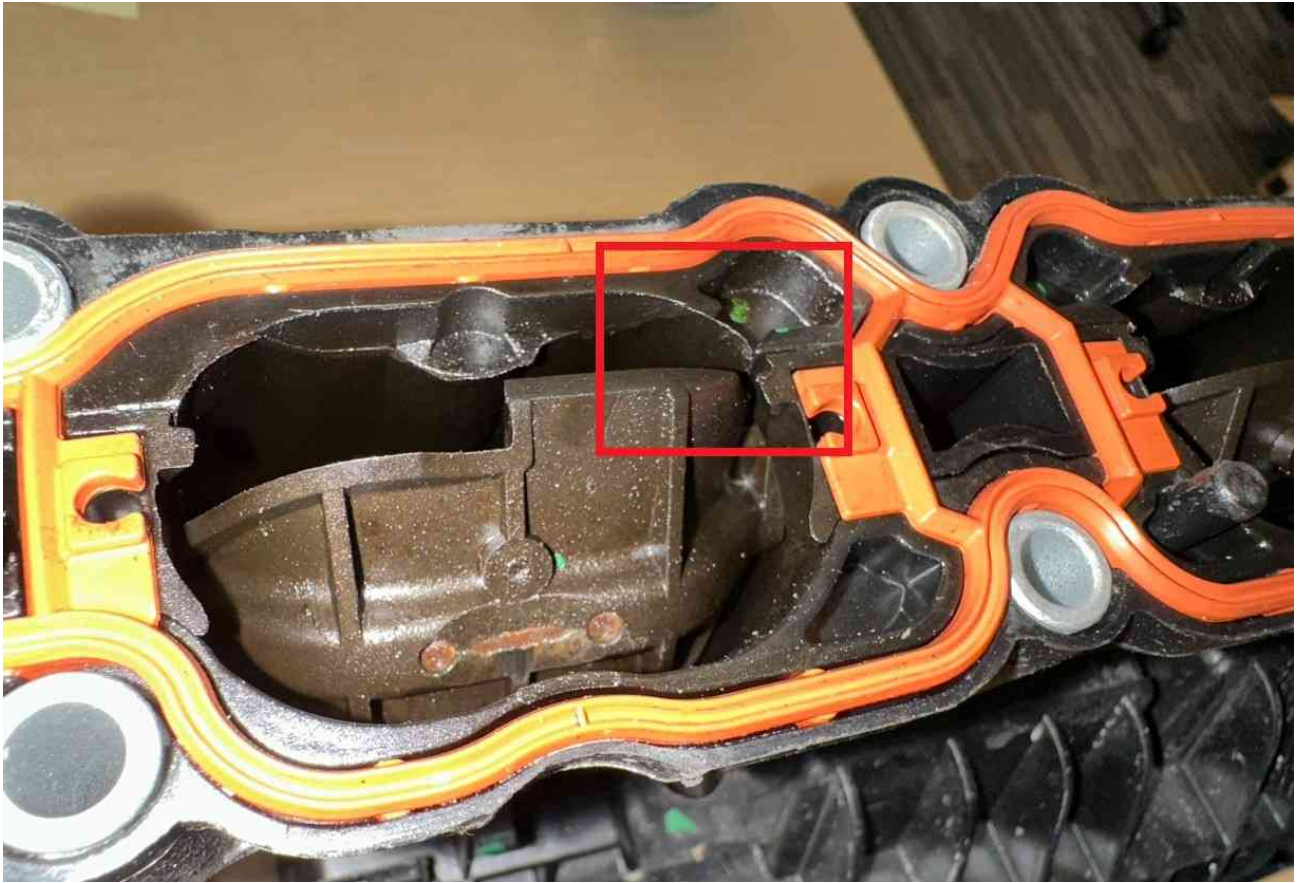
Figure 3:

3. If excess flashing is found blocking the intake manifold port, rework of the intake manifold will be required. See figure 3 below for another example.

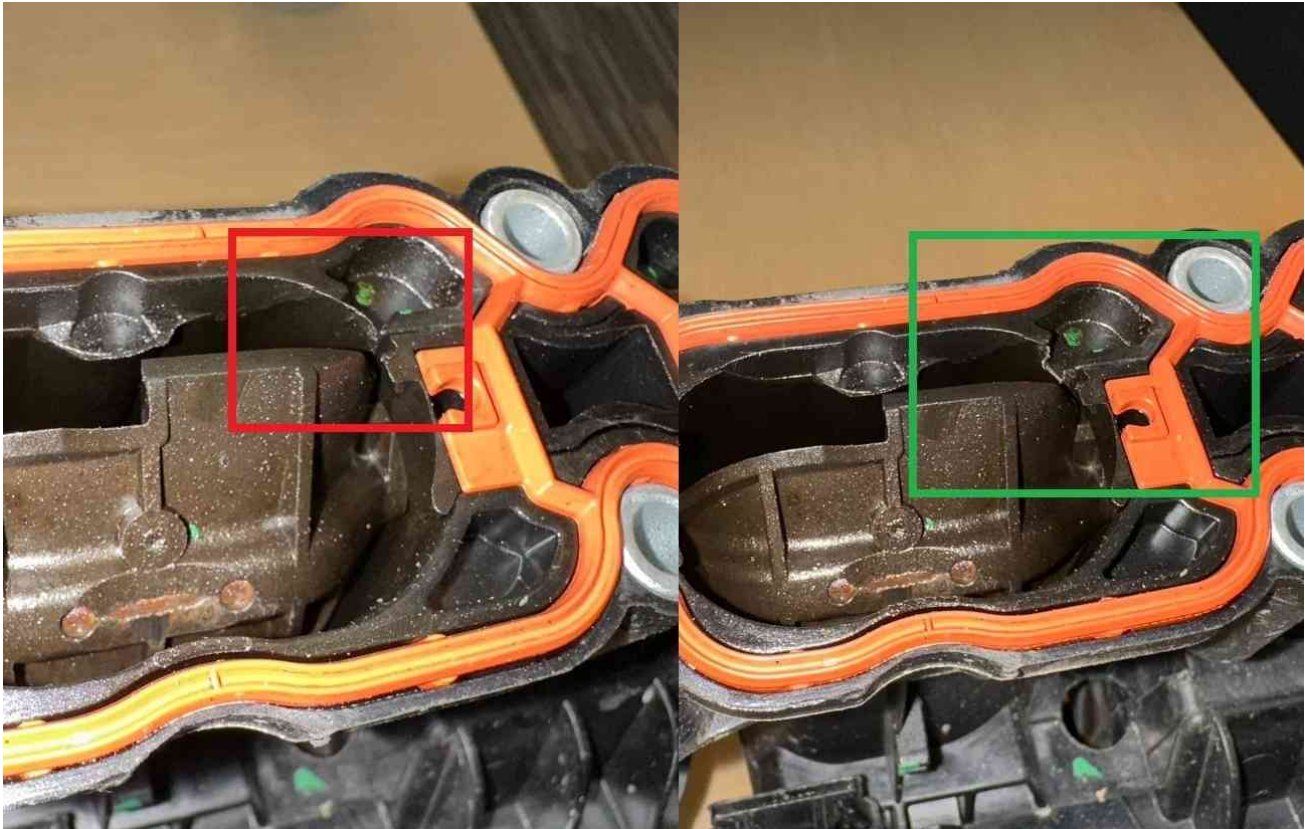
Figure 7:

Figure 7 below shows an example of the intake port before and after the rework procedure.
