Squeaking Noise Symptom When Retracting and/or Extending the Rear-view Mirror: Greasing Mirror Base Seal (SY 108/25)

Model Line: **Macan (XAB)**

Model Year: **As of 2024**

Concerns: **Rearview mirror**

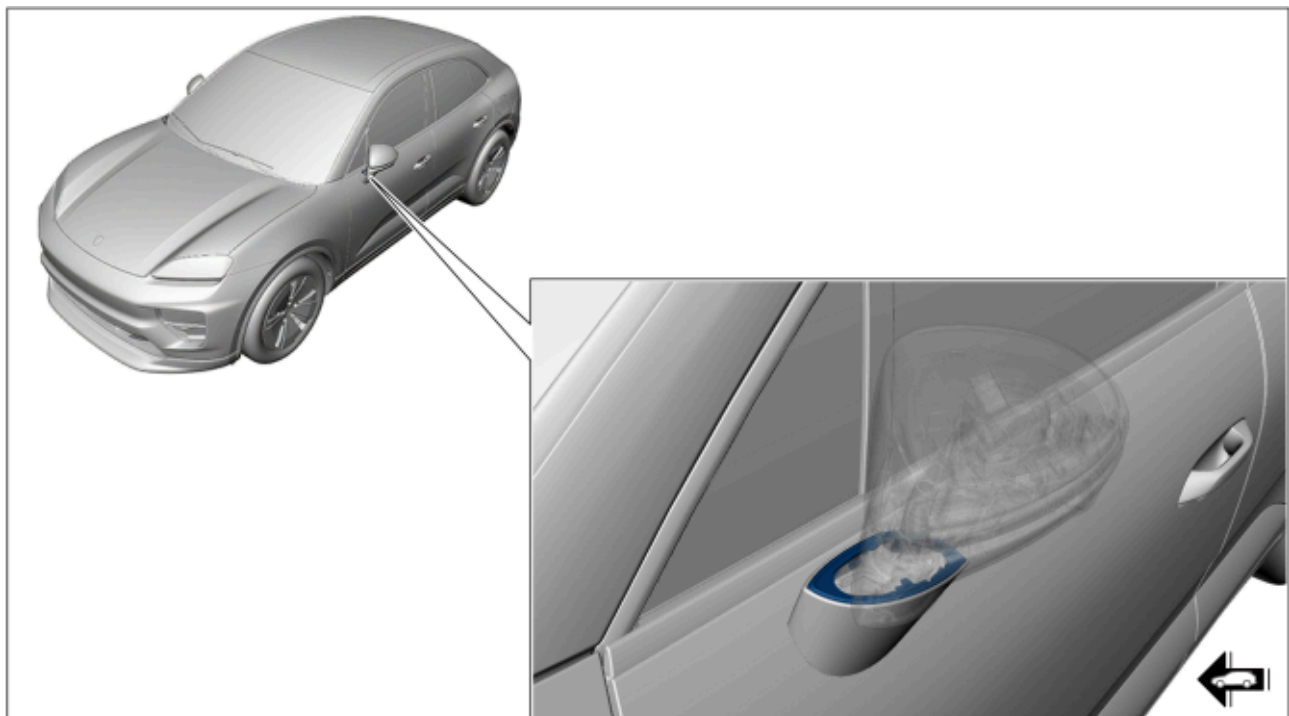
Installation position of mirror base seal

Symptom: Squeaking noises can be heard when retracting and/or extending the rear-view mirrors.

Cause: The noises can be caused by a lack of lubricating film on the mirror base gasket.

Remedial Action: In the event of a complaint, check the mirror base seal and grease or replace it, depending on the result of the check.

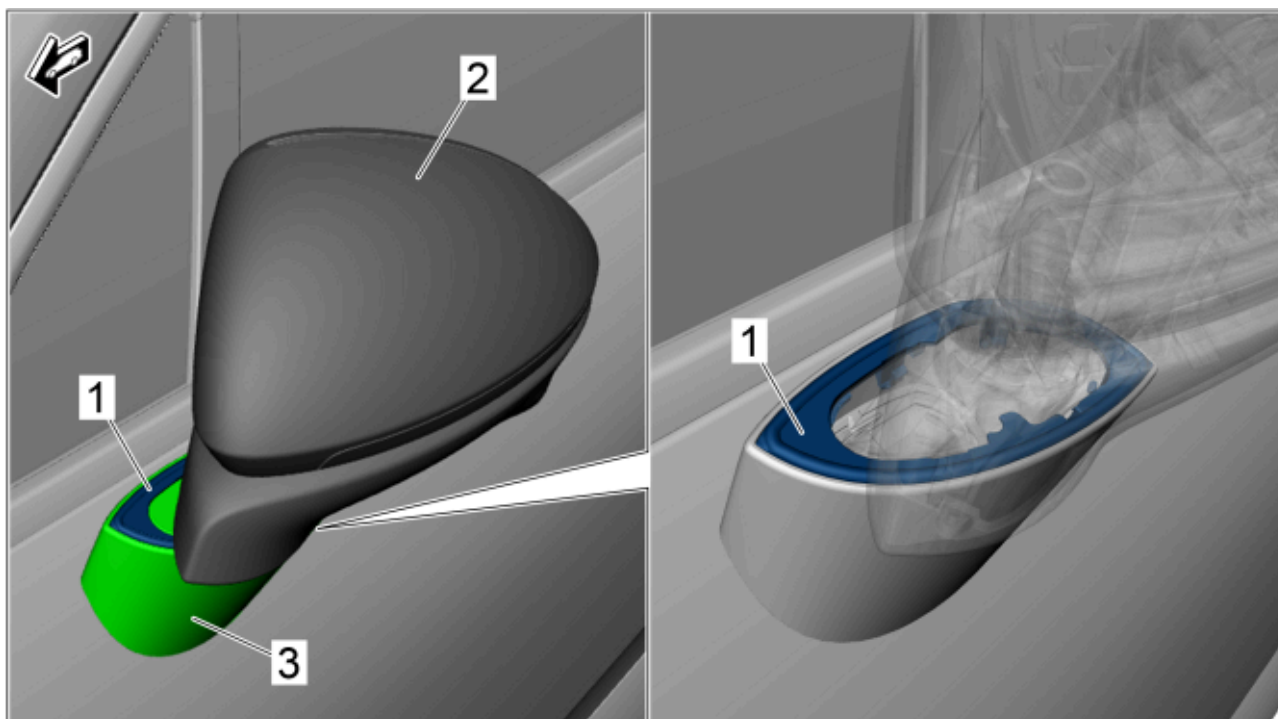
Mirror base seal

- 1.1 Guide rearview mirror ⇒ *Mirror base seal -2-* in and out at the left and right and check for squeaking noises.
- 1.2 Retract ⇒ *Mirror base seal -2-* rearview mirror at the left and right and check the mirror base seal ⇒ *Mirror base seal -1-* in the mirror support ⇒ *Mirror base seal -3-* for damage.

Assessment		Action
(✓)	The mirror base seal is not damaged .	⇒ <i>Mirror base seal -1-</i> Clean mirror base seal and grease with Krytox lubricant.
(x)	The mirror base seal is damaged .	Replace mirror base seal and grease with Krytox lubricant. For work procedure, see: ⇒ <i>Technical Information '667919 Removing and installing rear-view mirror housing (lower part)'</i>

If the mirror base seal must be replaced, grease it before assembling the rear-view mirror.
