PARK System Red Ring Around Vehicle During Front or Rear Camera Flap Actuation

Topic number	LI54.71-P-080236
Version	1
Function group	54.71 - Camera and radar-assisted assistance systems
Date	2/2/26
Validity	213 Facelift (Starting model year 2019)
	223
	238
	257
	290
	297
Reason for change

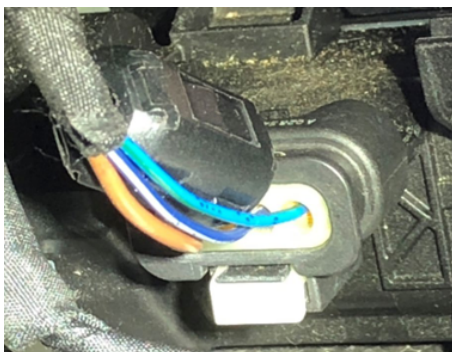
Red ring displayed around vehicle when front or rear camera door actuates.

EMF interference.

- 223, 297 > Install clip on ferrite magnet on M35/1, pin 3.
