ASA2 - Replace Front Seat Cushion (Passenger Side) (Recall Campaign)

Model Line: **Taycan (Y1A/Y1B/Y1C)**

Model Year: **As of 2022 up to 2023**

Concerns: **Front seat (passenger side)**

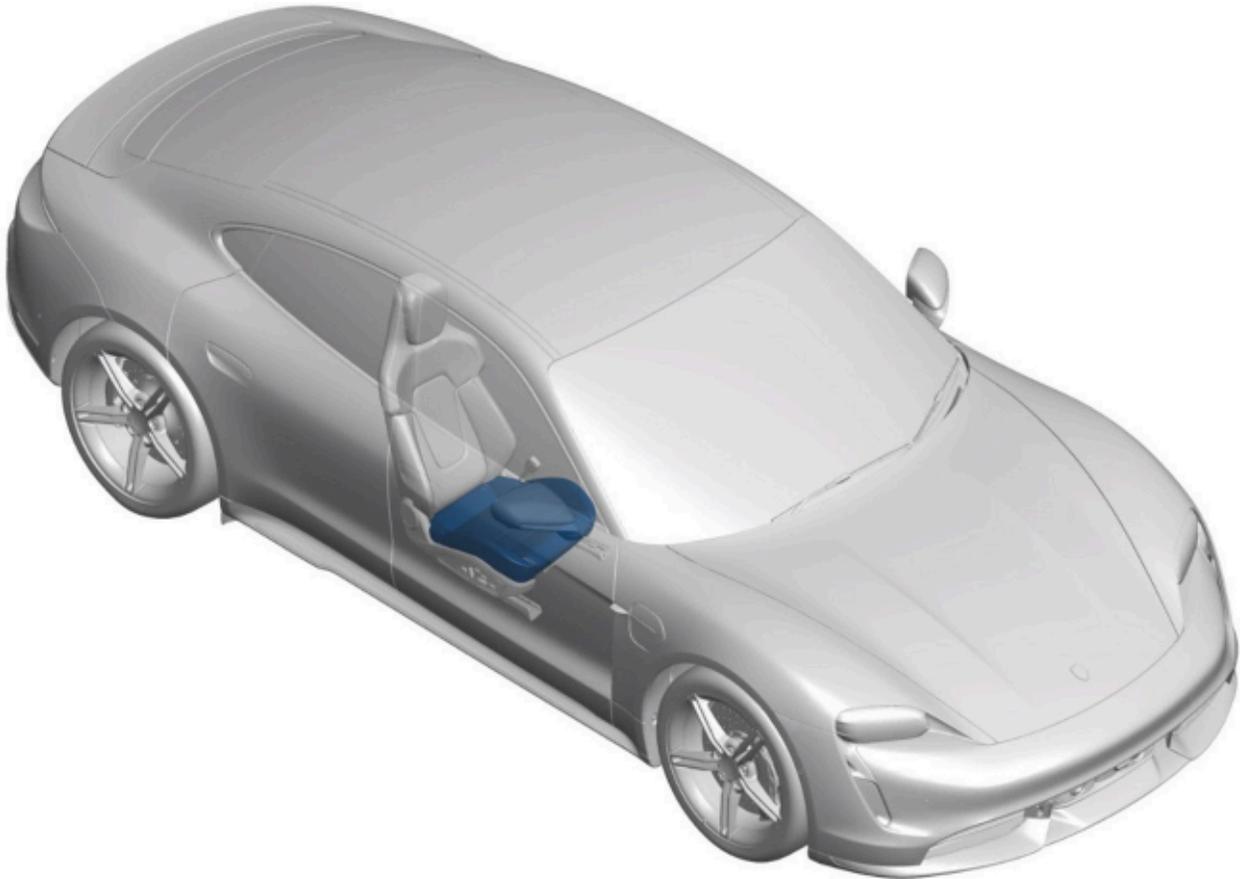
Installation  
Position:

Cause: **Due to a faulty crimping connection of the seat cushion heating, the seat occupancy detection for the passenger side can activate a failsafe mode that deactivates the airbag on the passenger seat. If the activated airbag warning signal or the warning message "passenger airbag OFF" is ignored by the passenger and the passenger does not move to another seat position or leaves the vehicle, the protection of the front airbag system is not fully available to the passenger in the event of an accident. This increases the risk of injury to the passenger on the passenger seat.**

*Installation position of seat cushion with integrated seat occupancy detection*

Action: Replaced the seat cushion with the integrated seat occupancy detection (passenger side).
