**Little or No Cooling Power from the Air-Conditioning System: Checking Refrigerant Lines on Air-Conditioning Compressor (174/23)**

Model Line: **Panamera (971 / YAA / YAB)**  
**Cayenne (9YA / 9YB)**

Model Year: **As of 2019**

Concerns: **Air-conditioning compressor**

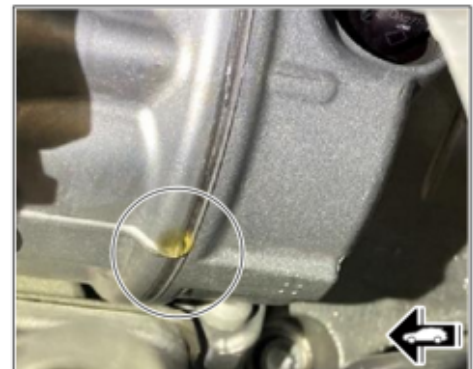
Information: **Customers complain that the air-conditioning system cooling performance is too low. Drop formation of refrigerant compressor oil is detected at the low point of the air-conditioning compressor housing. ⇒ Drop formation on air-conditioning compressor**

*Drop formation on air-conditioning compressor*

Action: If there is a complaint, check the respective O-ring of the affected refrigerant line and replace it if necessary.

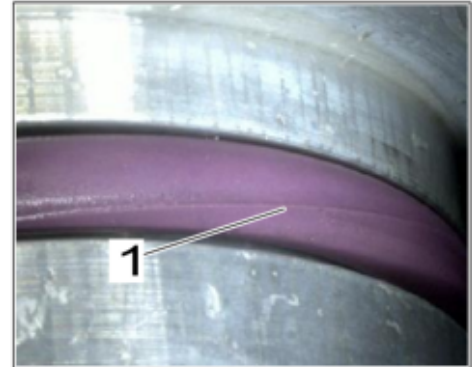
Cause: Insufficient sealing of the refrigerant lines on the air-conditioning compressor can lead to a leak in the air-conditioning system.

This leak can be caused by a twisted O-ring  $\Rightarrow$  *Twisted O-ring* installed in conjunction with the design-related burr on the O-ring  $\Rightarrow$  *Twisted O-ring -1-* or by a damaged O-ring on the refrigerant line.

*Twisted O-ring*

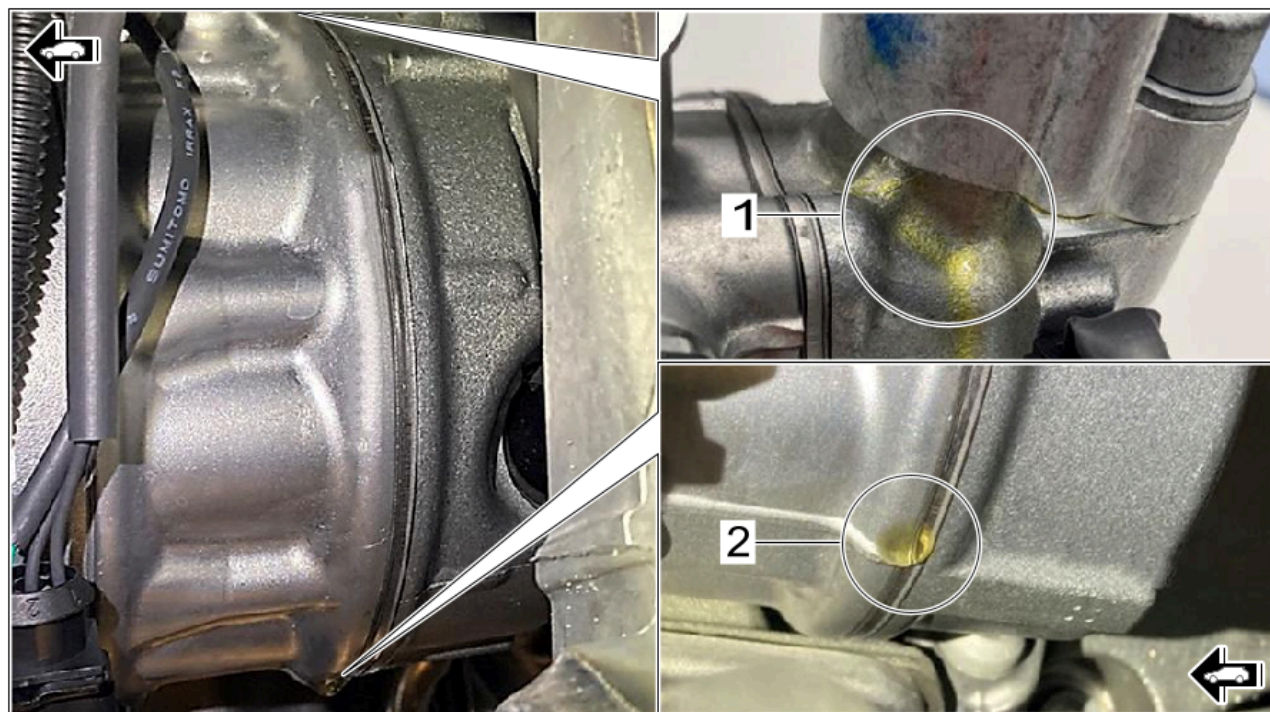
Oil loss on air-conditioning compressor

Assessment	Action
(✓)	No refrigerant compressor oil loss can be detected on flange ⇒ Oil loss on air-conditioning compressor -1- or air-conditioning compressor ⇒ Oil loss on air-conditioning compressor -2-.	Locate the complaint elsewhere. End of test. Continue with: ⇒ Technical Information '505619 Follow-up actions'
(✗)	Refrigerant compressor oil loss can be detected on flange ⇒ Oil loss on air-conditioning compressor -1- or air-conditioning compressor ⇒ Oil loss on air-conditioning compressor -2-. ⇒ Flange refrigerant line leak	Replace the O-ring of the affected refrigerant line. Continue with: ⇒ Technical Information '505619 Replacing O-ring refrigerant line on air-conditioning

- Work Procedure: 1 Replace the O-ring of the affected refrigerant line on the air-conditioning compressor.  
For procedure, see:  
⇒ Workshop Manual '874319 Removing and installing refrigerant line between compressor and condenser'  
⇒ Workshop Manual '874519 Removing and installing compressor/evaporator line (section from air-conditioning compressor to internal heat exchanger)'
