992 2WD – DME Fault P310B00 – ‘Fuel Low Pressure – Implausible’

Vehicles Affected

Customer complains of a check-engine light resulting from fault “**P310B00- Fuel low pressure – implausible**” in the DME control unit.

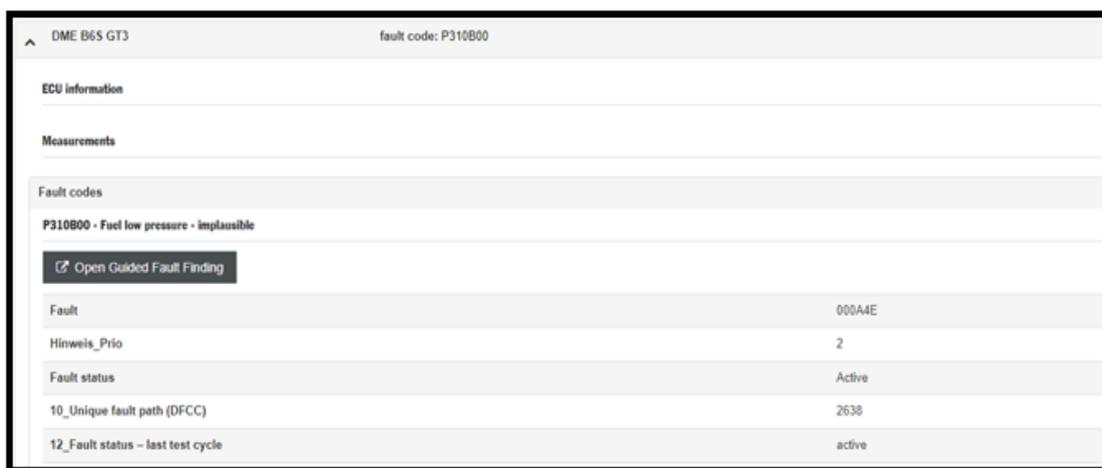
Figure 1

The diagnostic responsible for this fault monitors supply deviation within a finite time between the demanded or target low-pressure requested of the low-pressure fuel pump and that of the actual supplied quantity to meet the request, as correlated to pressure. In some instances, manufacturing tolerances for the low-pressure pump result in the actual supplied fuel quantity exceeding the DME's requested quantity, in other words, the pump's operation is 'too effective.' By consulting the Vehicle Analysis Log (VAL) containing the fault it is possible to see if the supplied fuel quantity exceeded the requested quantity in the low-pressure system to cause the fault.

If the fault data is consistent with the condition exemplified in Figure 1, please replace the fuel pump, **NOT** the fuel pressure sensor.
