Troubleshooting AC Charging

Vehicles Affected

Models	Model Year	Model Type	VIN Range	Vehicle-Specific Equipment
Taycan (J1-I)	As of 2020	Y1A, Y1B, Y1C	N/A	N/A
Panamera (G2-I)	As of 2021	971	N/A	E-Hybrid Variants
Cayenne (E3-I)	As of 2020	9YA, 9YB	N/A	E-Hybrid Variants
Macan (H2)	As of 2024	XAB	N/A	N/A

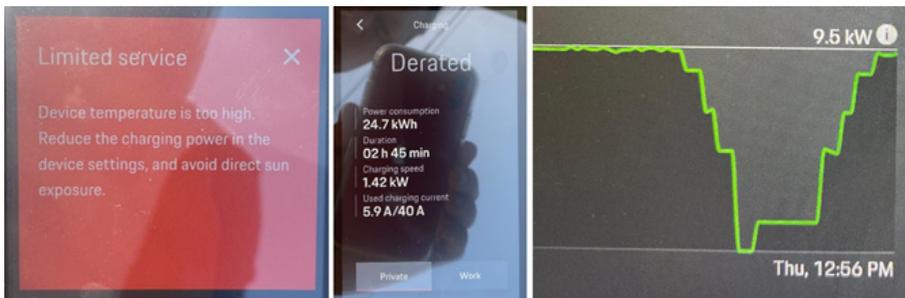
The PMCC was left in direct sunlight while charging at 40A / 9.6 kW. The device automatically derated to 0.0 kW charge rate and displayed the red "Limited service" message shown here. 1 minute later, the device automatically increased charge rate to 6A / ca. 1.42 kW and presented as indicated in the "Derated" screen shown here. The device was then moved from direct sun to shade and proceeded to automatically increase charge rate until it returned to 40A / 9.6 kW. The total time period for the entire derating session was 13 minutes and is indicated by the graph in Figure 8 from the PMCC Web App.
