**Refrigerant Loss – Possible Misdiagnosis due to Fluorescent Corrosion Protection at the Electric Air-Conditioning Compressor (SY 115/25)**

Model Line: **Panamera (971/YAA/YAB)  
Cayenne (9YA/9YB)**

Concerns: **Electric air-conditioning compressor**

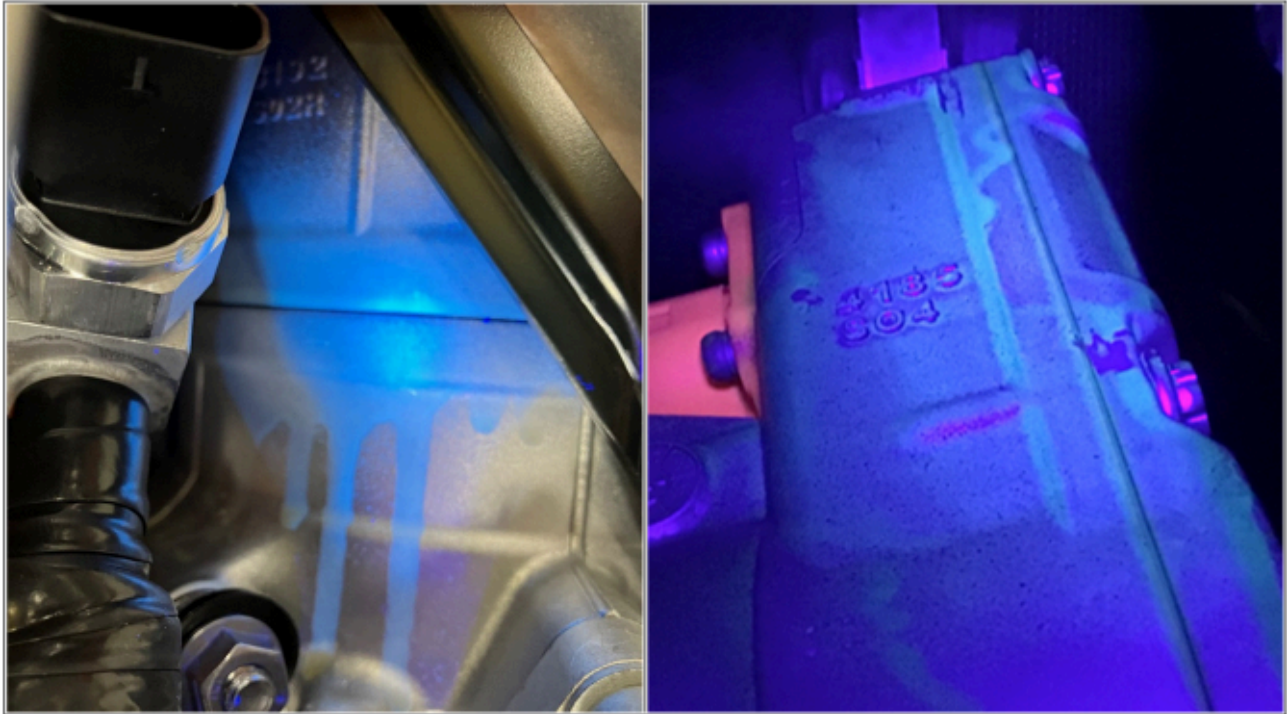
Cause: The electric air-conditioning compressor is coated with a corrosion preventive compound to protect against corrosion in the area of the separating joints. This corrosion preventive compound is **fluorescent** and can be misinterpreted as a loss of refrigerant.

These marks do not indicate a leak in the electric air-conditioning compressor. ⇒ *Traces of fluorescent corrosion preventive compound (example shown)*

*Traces of fluorescent corrosion preventive compound (example shown)*

Always check the air-conditioning system using the Workshop Manual to clearly identify possible leaks on the air-conditioning system.

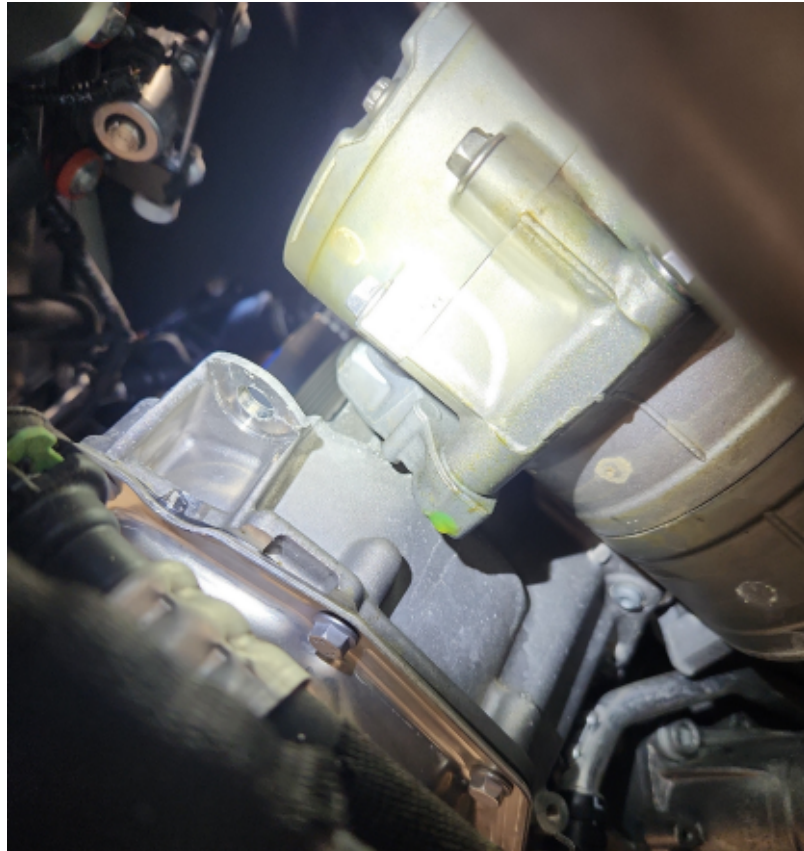
*Leaking Compressor*

In the absence of UV light, the corrosion preventative compound will appear as a dry yellow/brown stain. This is clearly differentiated from an active leak, where drops of dye can be seen underneath the compressor.
