<b>Title:</b>	<b>T07 and T17 TCU Module Software Patch</b>

<b>Number:</b>	<b>SB_498</b>	<b>Release Date:</b>	<b>03/01/2021</b>	
<b>Revision Number:</b>	<b>6</b>	<b>Revision Date:</b>	<b>01/20/2026</b>	
<b>Chassis Type:</b>	<b>All Command Zone III Chassis with a TCU</b>			
<b>Component Description:</b>	<b>MODULE, TCU,4G LTE WIFI, CELL, GPS, ETHERNET, HED</b>			
<b>Warranty:</b>	<b>1 Year Limited Base Warranty or 5 Year Command Zone Warranty</b>			
<b>Parts:</b>	<b>Qty 1 of 3630705 (If Needed)</b>			
<b>Tools:</b>	<b>Laptop with WIFI, Tools for removal of TCU</b>

## SERVICE BULLETIN #498.6

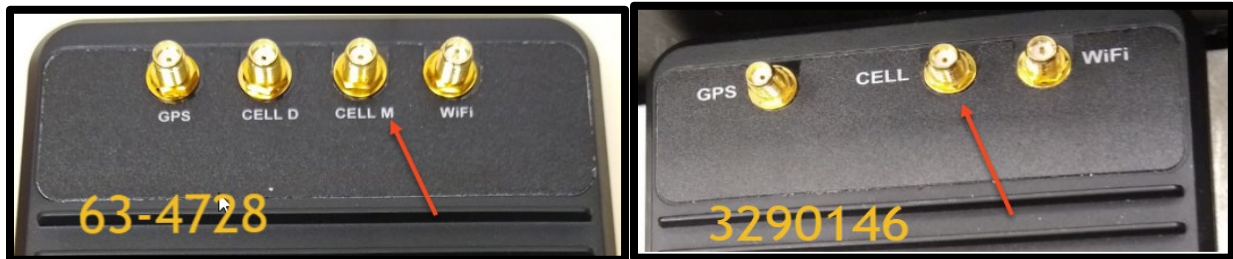
if the cell antenna going to the Cell connection on the original TCU will connect to the Cell M connection and the Cell D port will be left open on the replacement TCU.

2. Ordering Replacement TCU to resolve HTTP 500 Error:
  - Place Order for PN 3630705
    - Provide Job Number and Unit Number on Order.
    - If you have a 63-4728 TCU with 4 antenna connections and you receive a 3630705 with 3 antenna connections, we need to connect the Cell M antenna to the Cell connection of the replacement TCU. The left-over cell antenna can be tied up out of the way.
    - In the opposite situation if you have the original 3290146 TCU with 3 antenna connections and you receive a 3630705 replacement TCU with 4 antenna connections on
