# HYUNDAI

## Technical Service Bulletin

GROUP	NUMBER
ENGINE MECHANICAL	26-EM-003H
DATE	MODEL(S)
FEBRUARY 2026	SONATA (DN8/DN8A)

**SUBJECT:** INTEGRATED THERMAL MANAGEMENT (ITM) REPLACEMENT & ECM/TCU SOFTWARE UPDATE – DTCS P218100, P2181F0, P2181F1

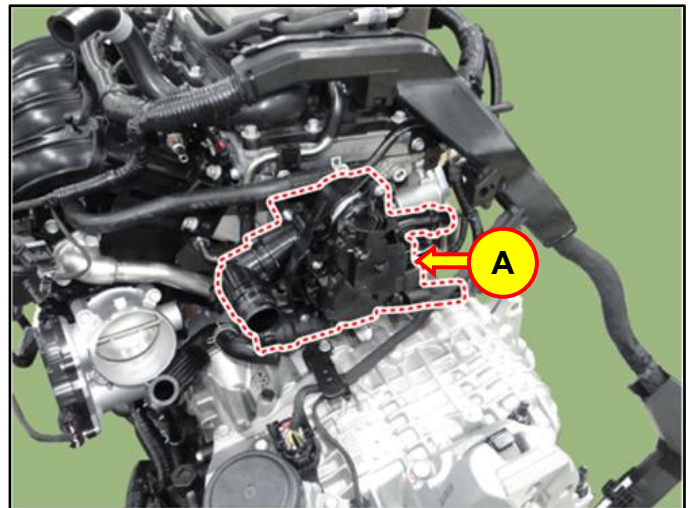
**Description:** Some Sonata (DN8, DN8A) vehicles may have DTCs P218100, P2181F0, and/or P2181F1 (Cooling System Performance) set in the Engine Control Module, resulting in an illuminated Check Engine warning lamp. Follow the procedure in this TSB to replace the Integrated Thermal Management (ITM) module and update both the Engine Control Module (ECM) and Transmission Control Module (TCM) if applicable. Follow the flowchart in this TSB to update the appropriate modules.

2. Replace the ITM (A) by referring to the shop manual.
  - **Engine Mechanical System > Cooling System > Integrated Thermal Management Module (ITM) > Repair procedures**

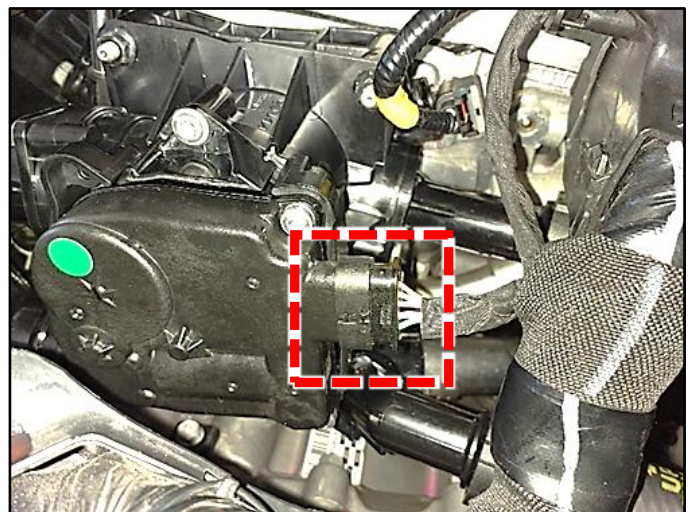
The ITM design inverts the connector's orientation.

3. Reinstall parts in the reverse order of the removal process.
