HYUNDAI

Technical Service Bulletin

GROUP ENGINE MECHANICAL	NUMBER 26-EM-004H
DATE FEBRUARY 2026	MODEL(S) TUCSON (NX4, NX4A)

SUBJECT: INTEGRATED THERMAL MANAGEMENT (ITM) REPLACEMENT & ECM/TCU SOFTWARE UPDATE – DTC P218100, P2181F0, P2181F1

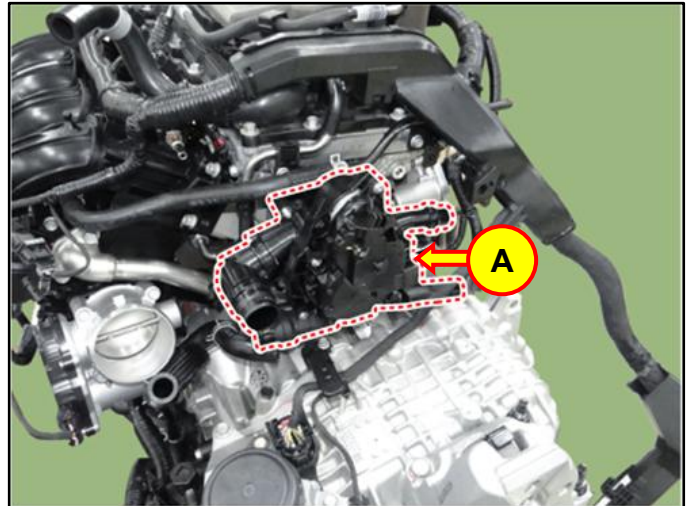
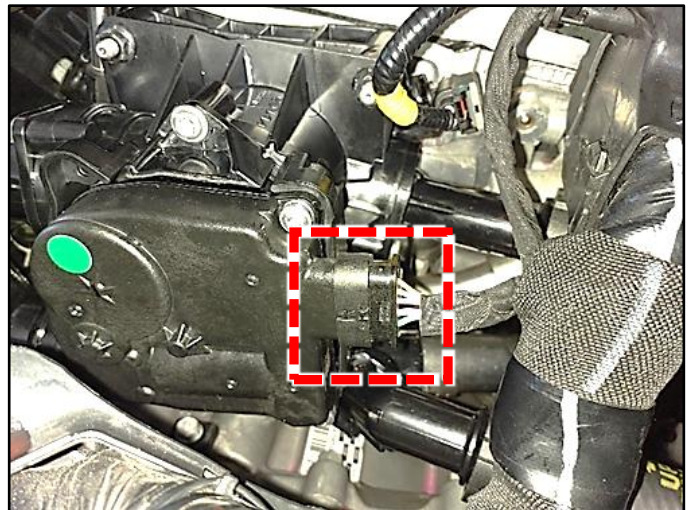
Description: Some Tucson (NX4, NX4A) vehicles may have DTC P218100, P2181F0, and/or P2181F1 (Cooling System Performance) set in the Electronic Control Unit (ECU), resulting in an illuminated Check Engine warning lamp. This TSB provides instructions to replace the Integrated Thermal Management (ITM) module and update both the Engine Control Module (ECM) and Transmission Control Module (TCM), if applicable. Follow the flowchart in this bulletin to update the appropriate modules.

The ITM design inverts the connector's orientation.

1. Replace the ITM (A) by referring to the shop manual.
 - **Engine Mechanical System > Cooling System > Integrated Thermal Management Module (ITM) > Repair procedures**
2. Reinstall all parts in the reverse order of the removal process.
