HYUNDAI

Technical Service Bulletin

GROUP	NUMBER
ENGINE MECHANICAL	26-EM-005H
DATE	MODEL(S)
FEBRUARY 2026	SANTA FE (TMA)

SUBJECT: INTEGRATED THERMAL MANAGEMENT (ITM) REPLACEMENT & ECM/TCU SOFTWARE UPDATE – DTCS P218100, P2181F0, P2181F1

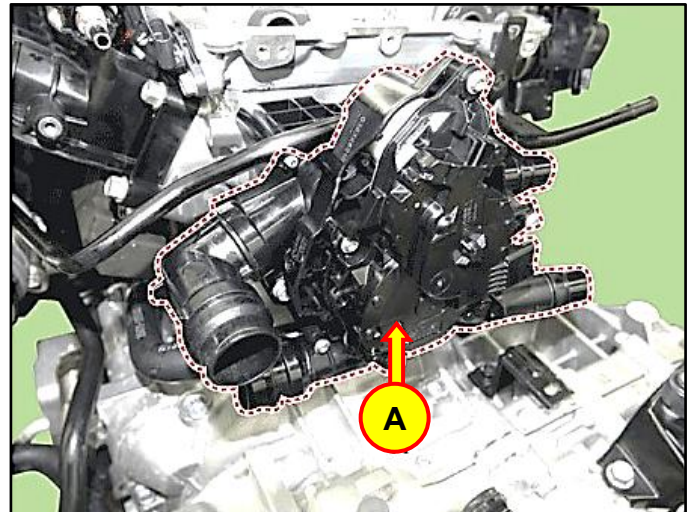
Description: Some Santa Fe (TMA) vehicles may have DTCs P218100, P2181F0, and/or P2181F1 (Cooling System Performance) set in the Electronic Control Unit (ECU), resulting in an illuminated Check Engine warning lamp. Follow the procedure in this TSB to replace the Integrated Thermal Management (ITM) module and update both the the Engine Control Module (ECM) and Transmission Control Module (TCM) if applicable. Follow the flowchart in this TSB to update the appropriate modules.

2. Replace the ITM (A) by referring to the shop manual.
 - **Engine Mechanical System > Cooling System > Integrated Thermal Management Module (ITM) > Repair procedures**

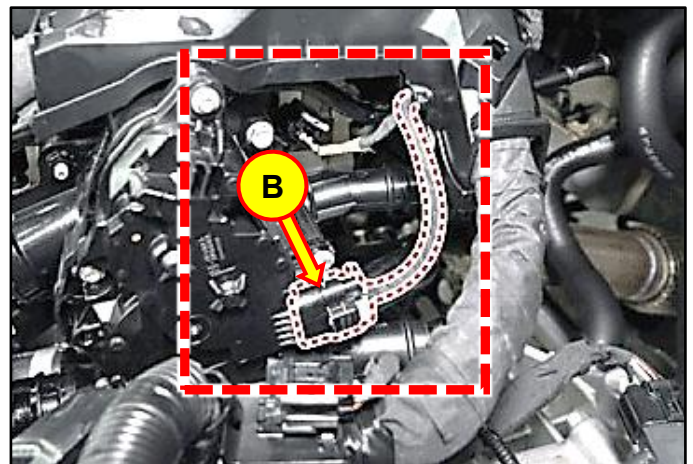
The ITM design inverts the connector's (B) orientation.

3. Reinstall parts in the reverse order of the removal process.
