# TECHNICAL SERVICE BULLETIN

BT25-013

ITB26-001

## METAL TICKING NOISE AT B-PILLAR

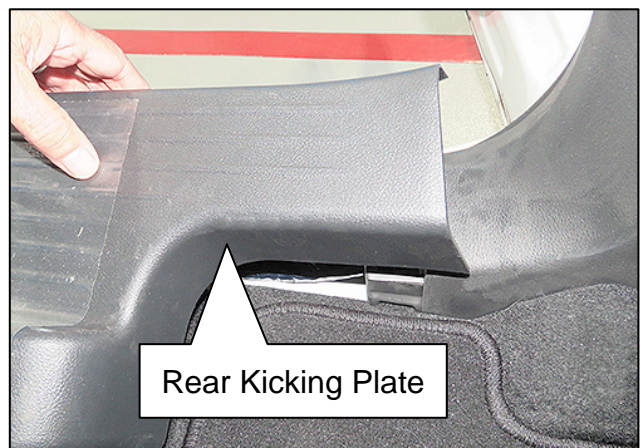
Figure 2

Rear Kicking Plate

**HINT:** The Rear Kicking Plate can be partially removed to allow Center Pillar Lower Finisher removal.
