TECHNICAL SERVICE BULLETIN

| Classification: BT25-012 | Reference: NTB26-004 | Date: January 22, 2026 |

METAL TICKING NOISE AT B-PILLAR

APPLIED VEHICLES: 2025-2026 Pathfinder (R53)

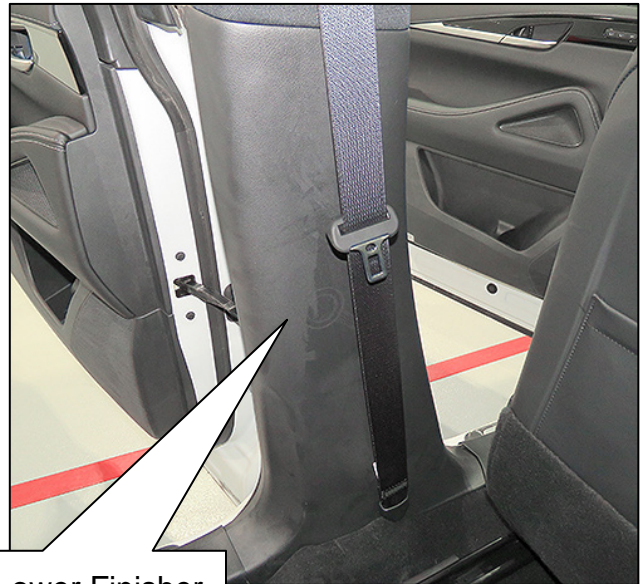
Figure 1

Center Pillar Lower Finisher

2. Remove the Center Pillar Lower Finisher of the affected B-Pillar.
 - Refer to the ESM: **BODY INTERIOR > INTERIOR > REMOVAL AND INSTALLATION > BODY SIDE TRIM > CENTER PILLAR LOWER FINISHER**

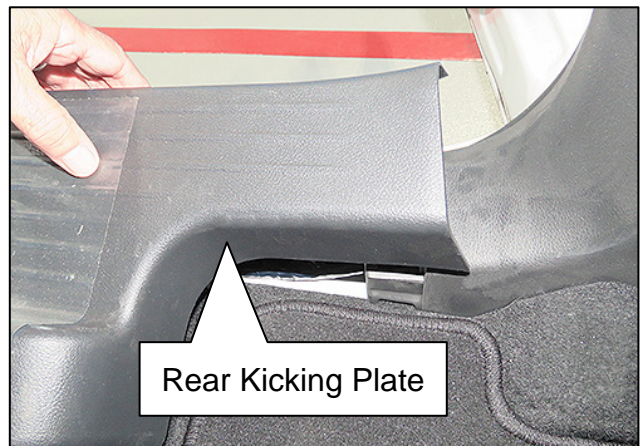
Figure 2

Rear Kicking Plate

HINT: The Rear Kicking Plate can be partially removed to allow Center Pillar Lower Finisher removal.

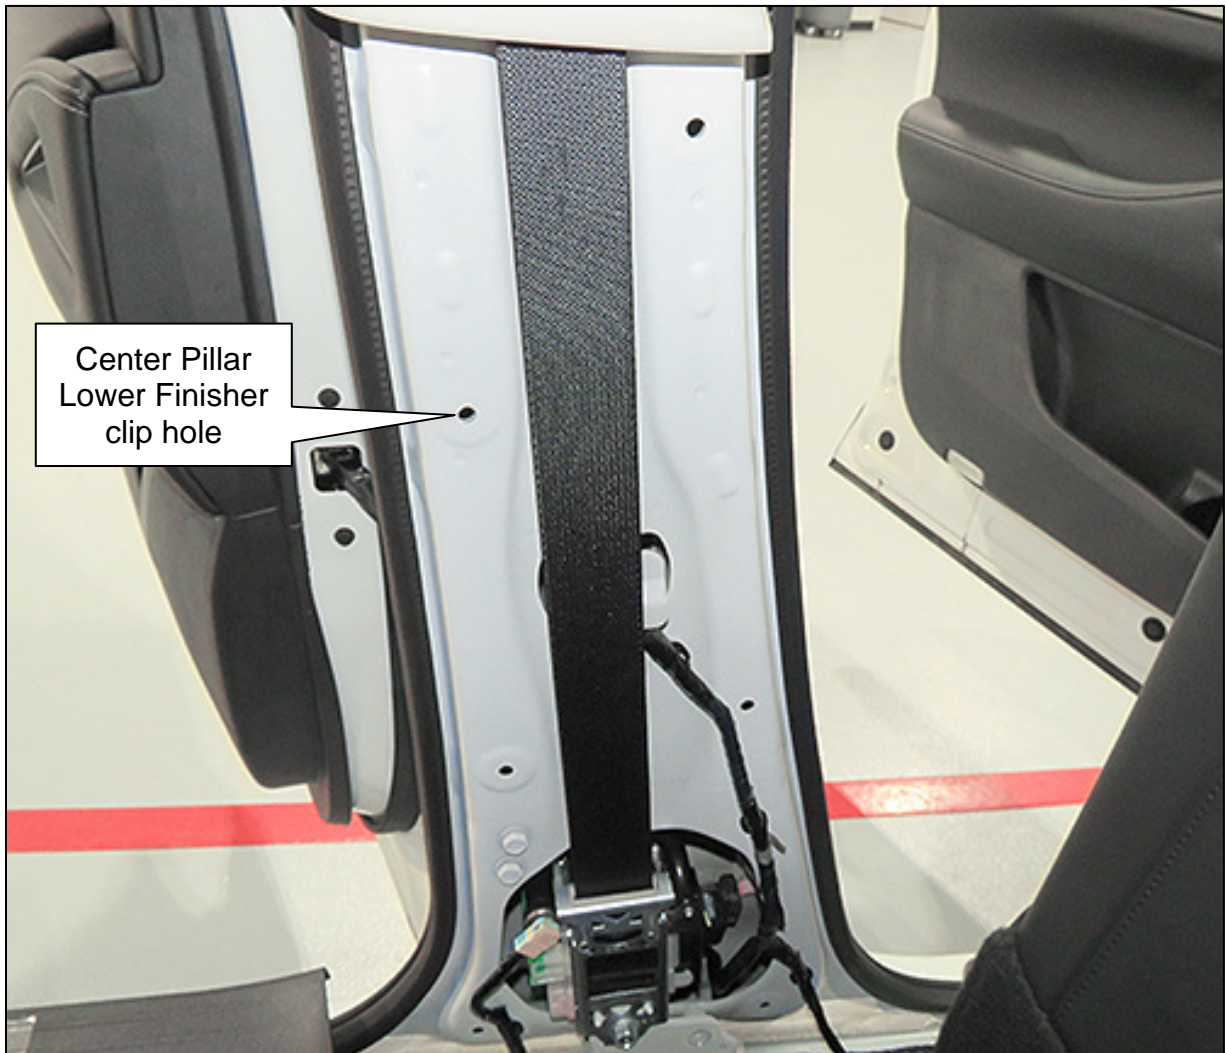
Figure 3

HINT: Driver (LH) side shown in Figure 3.

4. Locate the Center Pillar Lower Finisher clip hole on the B-Pillar that is shown in Figure 3.
 - This will be the center clip hole on the left when facing the driver (LH) side, or the center clip hole on the right when facing the passenger (RH) side inside B-Pillar.

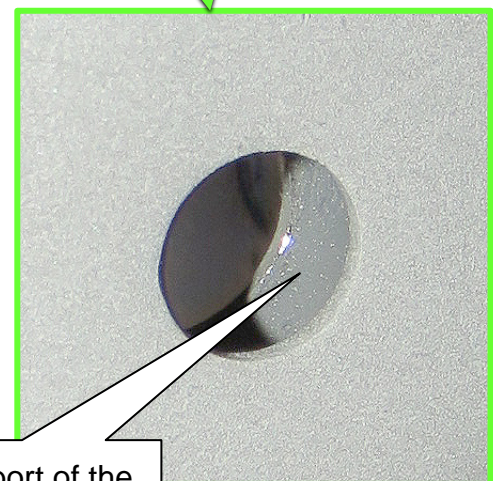
Figure 5

- Close-up of the B-Pillar clip hole with inner support of the B-Pillar.

5. Insert a 1/4-inch or 3/16-inch flat faced punch into the center clip hole that was located in step 4 on page 3.
6. Turn the punch toward the rear of the vehicle (Figure 4) until the flat-faced tip rests on the inner support of the B-Pillar shown in Figure 5.
