Service Bulletin

Bulletin No.: PIT6483

Subject: IPC Gauges Drop Out / Flicker / Sweep / Several Warning Messages / Low Speed Lan DTC U0078 U0140

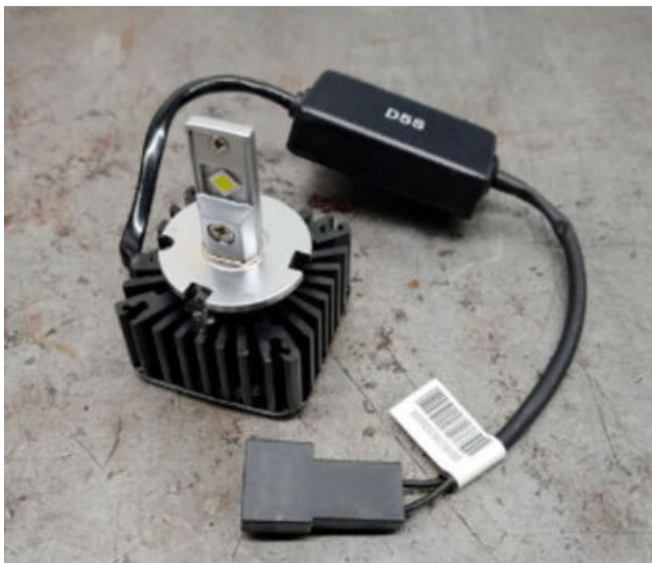
7074045

<ul style="list-style-type: none"> - Service Restraint System • IPC PRNDL display intermittently turning on and off • Headlamps, exterior lighting, and/or interior backlighting cycling on and off • Backup/Reverse camera image appears fuzzy <p>These symptoms typically occur within the first minute after starting the vehicle. In some cases, there may or may not be a correlation with the headlamps being turned on or off.</p> <p>In all cases, multiple modules will set DTC U0140 (Loss of Communication with BCM). Additional DTCs that may or may not be present include: U0078, B2575, B2699, B3135, B3883, U0151, U0155, U0170, B3130, or other low-speed LAN communication-related DTCs.</p>
<p>Cause</p>	<p>These conditions may be caused by the installation of aftermarket LED headlamps. Due to the wide variety of aftermarket LED headlamp designs, the example shown below is provided for reference only.</p>

Disconnect the aftermarket headlamps and retest the vehicle. If normal operation is restored, install the original factory light bulbs.
