Service Bulletin

Bulletin No.: PIP6095A

Subject: 6T40 Harsh Garage Shift into Drive or Reverse

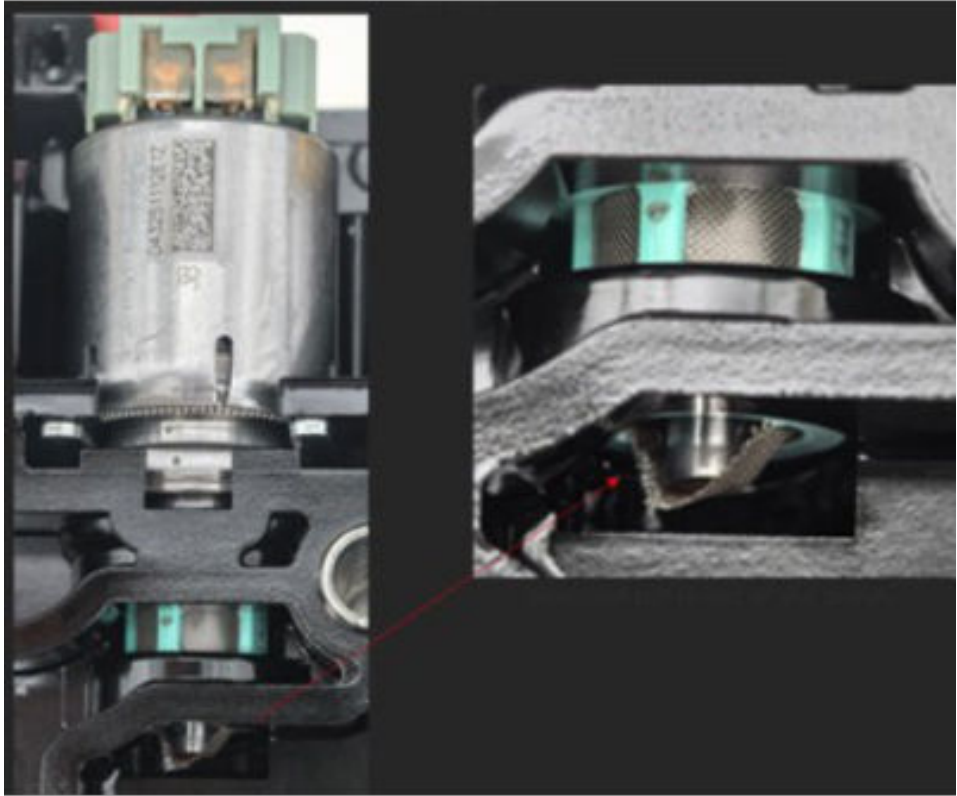
7046070

Involved Region or Country	GMNA, South Korea, China, Japan
Condition	Some customers may complain of harsh garage shifts into reverse or drive.
Cause	<p>There may be an issue with the normally high solenoids in the control solenoid valve and transmission control module assembly (TEHCM) having a valve over travel and contact or rupture the solenoid screen as shown below.</p>

6. If the solenoid valve is found to be touching or pushing through the screen, replace the control solenoid valve and transmission control module assembly (TEHCM) and the control valve body per SI instructions.
