GENERAL MOTORS
DCS7429
URGENT - DISTRIBUTE IMMEDIATELY

Date: February 11, 2026
Subject: N252528650 - Service Update
Body Seal Water Leak
Models: 2024-2025 Chevrolet Equinox EV

N252528650 Body Seal Water Leak

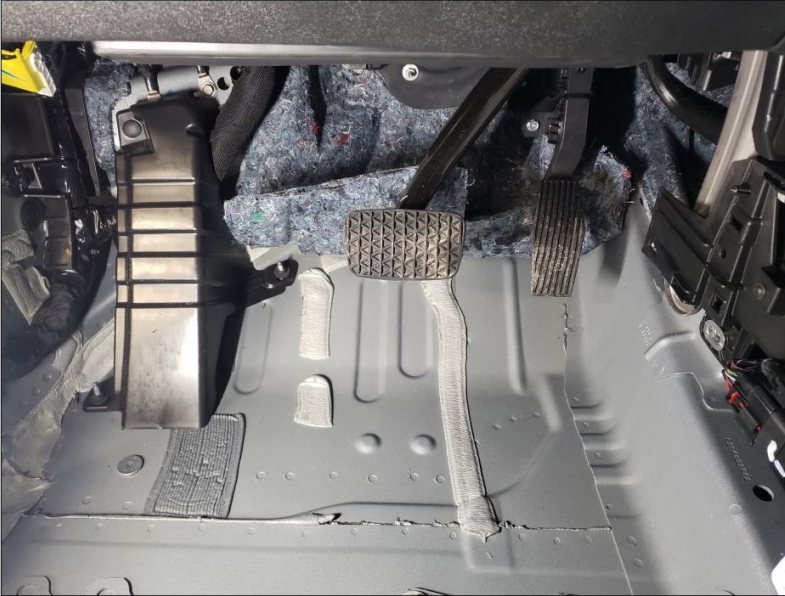
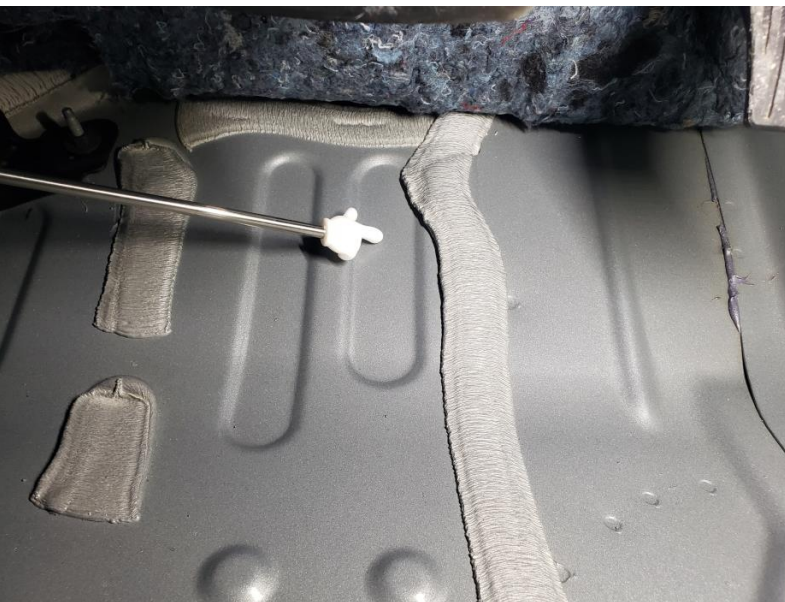
7. Inspect the seam sealer in the driver side footwell for any signs of water intrusion. If **ANY** sign of water intrusion or moisture damage is found, contact GM Technical Assistance Center to provide information on location of water found. If directed, refer to *Seam Sealer Repair* below.
- TAC U.S. can be reached at 877-446-8227 for assistance.
 - TAC Canada (English) can be reached at 800-263-7740
 - TAC Canada (French) can be reached at 800-263-7960
8. Reassemble the driver's side carpet and trim.
9. Repeat steps 3-6 to roll back the passenger side carpet.

6. Remove the push retainer (1) and roll back the driver's side carpet.

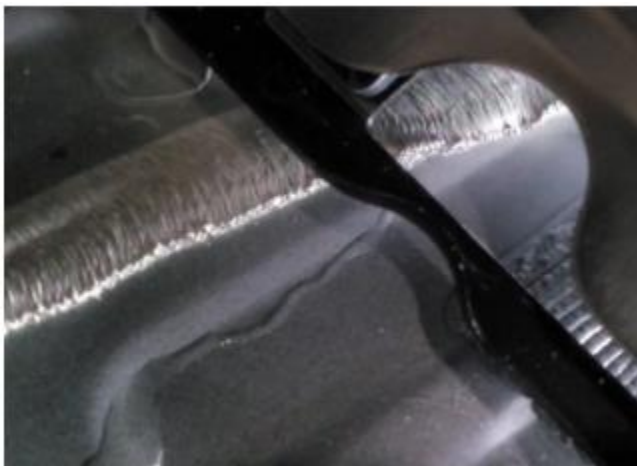
7002662

13. Inspect the seam sealer in the passenger side footwell for any gaps or signs of water intrusion. If **ANY** gap or sign of water intrusion is found, refer to *Seam Sealer Repair* below.
14. If signs of water intrusion are not present: reassemble the passenger side carpet and trim, no further action is required.

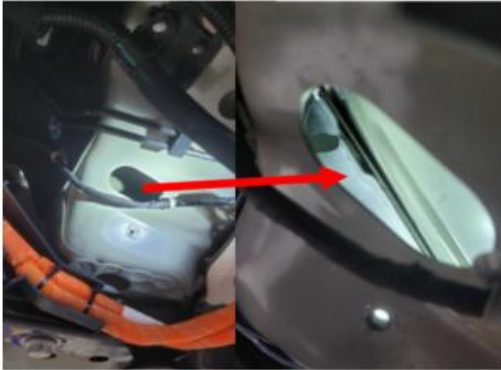
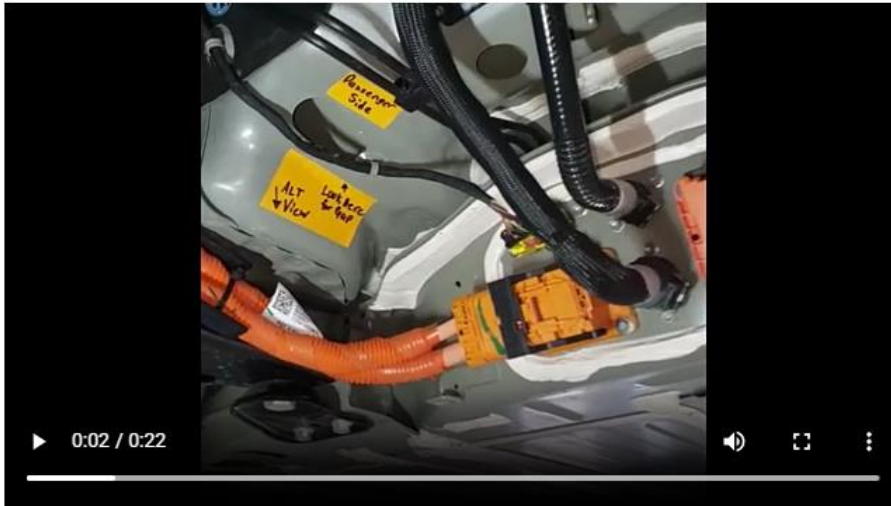
Note: Passenger side shown above, Driver's side has the same access.

3. Confirm the leak by applying water to the seam shown above on the appropriate driver or passenger side. After spraying, lower the vehicle and check for water inside the appropriate footwell.
4. After confirming, raise the vehicle again and use compressed air to blow all the water out of the affected area. It must be DRY before applying seam sealer.
