**Technical Service Bulletin (TSB)**  
**Power Top Switch Collapsed Into The Overhead Console**

<b>REFERENCE:</b>	<b>TSB:</b> 23-002-26 <b>GROUP:</b> 23 - Body	<b>Date:</b>	February 7, 2026	<b>REVISION:</b>	—
<b>VEHICLES AFFECTED:</b>	<b>2025 (JL) Jeep Wrangler</b> This bulletin applies to vehicles built on or after June 01, 2025 (MDH 0601XX) equipped with Sky One-Touch Power Top (Sales Code STJ).	<b>MARKET APPLICABILITY:</b>		<input checked="" type="checkbox"/> NA <input type="checkbox"/> MEA <input type="checkbox"/> SA <input type="checkbox"/> IAP <input type="checkbox"/> EE <input type="checkbox"/> CH <b>NOTE:</b> This bulletin applies to the North American market.	
<b>CUSTOMER SYMPTOM:</b>	<b>Customers may experience the following:</b> <ul style="list-style-type: none"> <li>The power top switch collapsed and has been pushed inside the overhead console <a href="#">Fig. 1</a>.</li> </ul> <b>NOTE:</b> The switch will still operate the top after being pushed in.				
<b>CAUSE:</b>	Manufacturing issue

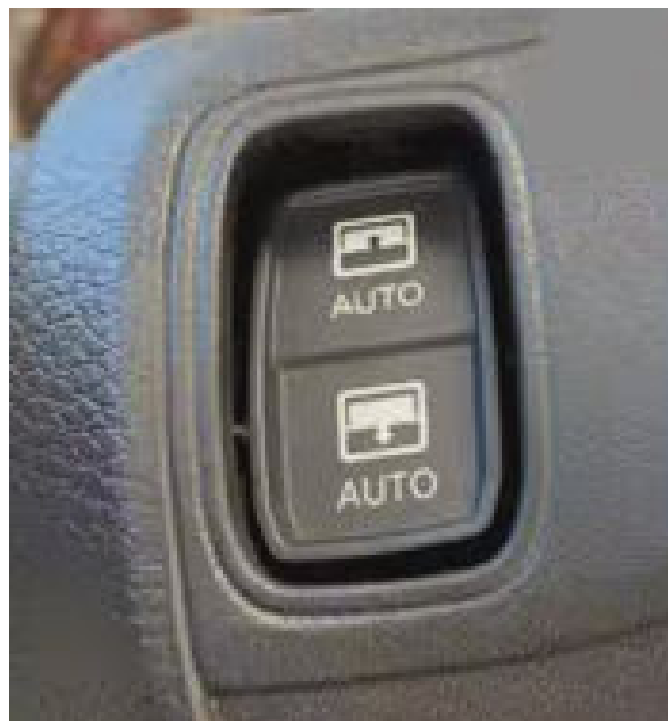
**Fig. 1**  
Collapsed Switch Power Top Switch

This bulletin involves inspecting the power top switch and possibly replacing the overhead console bezel.

1. Inspect the switch by cycling the power top switch three times.
2. Did the power top switch collapse or press into, the overhead console [Fig. 1](#)?
  - YES >>> Proceed to [Step 3](#).
  - NO >>> Use Inspect LOP (23-14-02-9C) to close the active RSU.
3. **For PHEV vehicles:** Disconnect the 12 volt battery. Refer to the detailed service procedures available in DealerCONNECT > Service Library under: Service Info>08 - Electrical / 8F - Engine Systems / Battery System / Standard Procedure>12-volt Battery Disconnect - PHEV.
4. Remove the front header panel. Refer to the detailed service procedures available in DealerCONNECT/ Service Library under: 23 - Body / Interior / Panels / Removal.
5. Disconnect all wire harness connectors.
6. Remove the four fasteners [Fig. 2](#) and the overhead console from the front header panel.
