TECHNICAL SERVICE BULLETIN

"Steering Assist Fault Service Required" Message In The IPC And Reduced Steering Assist With DTCs U3008:1B And/Or U3009:1B Stored In The PSCM

26-2035
04 February 2026

Ford 2025-2026 Explorer
2025-2026 Police Interceptor Utility
Lincoln 2025-2026 Aviator

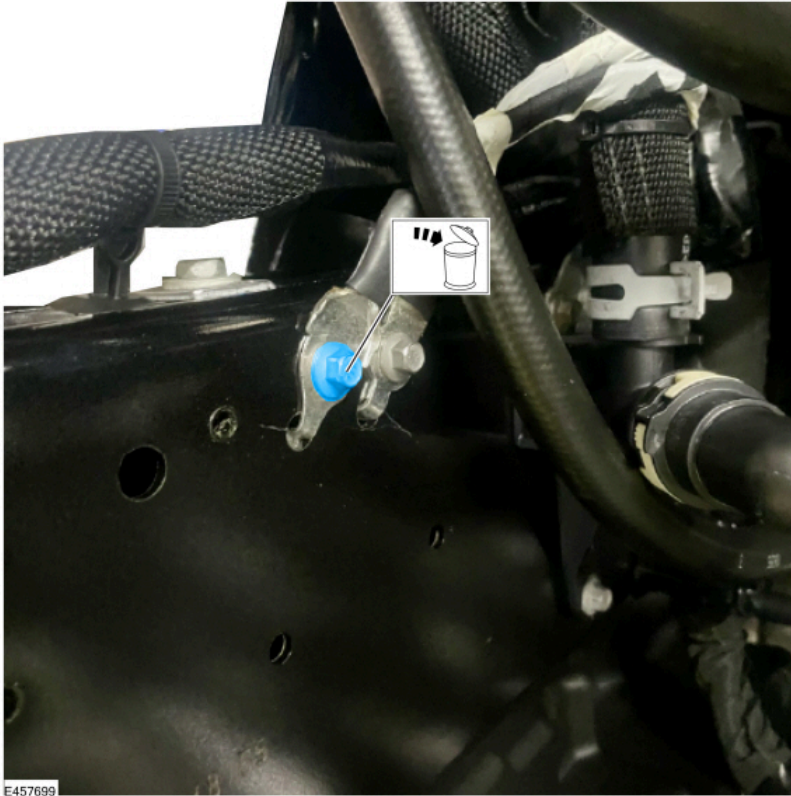
Figure 1

6. Remove and discard the M6 fastener from ground G104 (Explorer/Police Interceptor Utility) or G116 (Aviator) on the passenger side frame rail. Refer to Wiring Diagram Cell 151 for connection locations. (Figure 1)

NOTE: Do not remove any paint from the body as the ground path conduction is through the bolt threads.

7. Carefully enlarge the existing holes in the frame rail sheet metal and the harness eyelet by drilling with a 7 mm (9/32 in.) drill bit.

8. Reinstall ground G104 (Explorer/Police Interceptor Utility) or G116 (Aviator) using the new self-tapping M8 fastener. Make sure the ground eyelet locating tab is properly aligned with the alignment hole in the frame. Tighten to 71 lb.in (8.0 Nm).

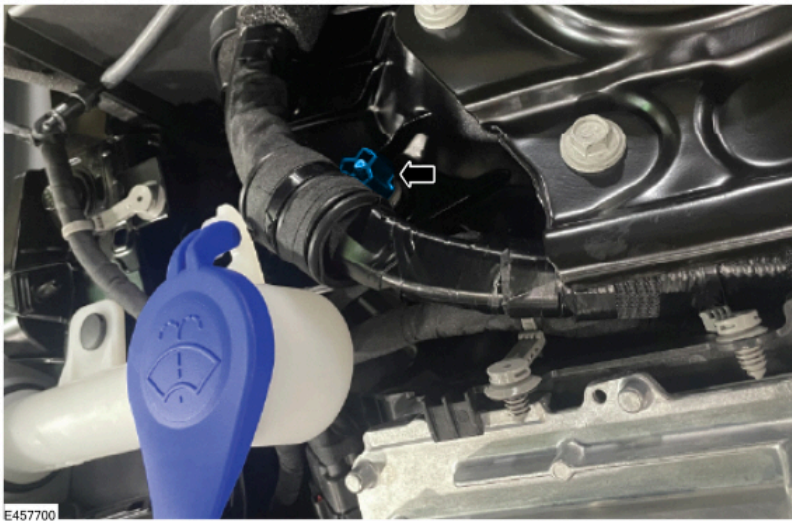
Figure 2

12. On Aviator vehicles, remove the wiring harness retainer from the ground G119 stud bolt in order to hold the bolt while tightening the nut in Step 14. (Figure 2)

16. On Aviator vehicles, install the wiring harness retainer on the ground G119 stud bolt.

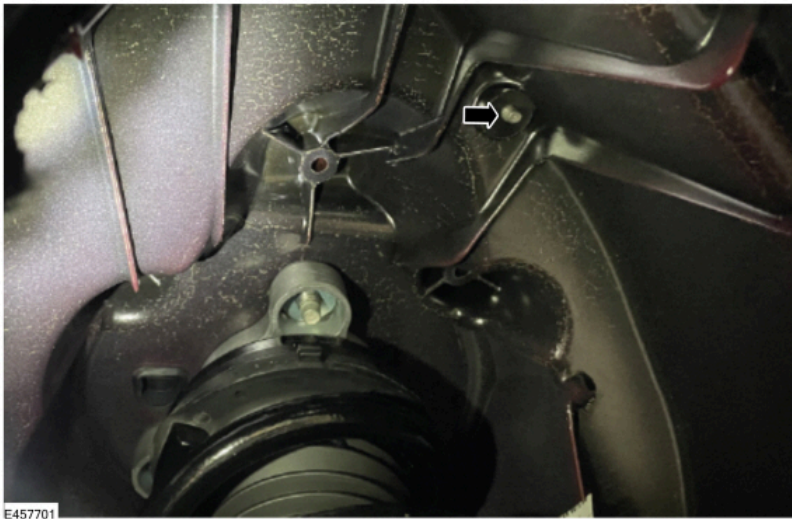
Figure 3

NOTE: Do not remove any paint from the body as the ground path conduction is through the bolt threads.

14. Install the new M6 nut on the existing fastener on ground G103 (Explorer/Police Interceptor Utility) or G119 (Aviator) on the passenger side shock tower. Tighten to 106 lb.in (12.0 Nm). (Figure 3)
