# TECHNICAL SERVICE BULLETIN

## Floor Console Armrest Latch Broken

**26-2001**  
12 January 2026

Lincoln 2018-2024 Navigator
--------------------------------

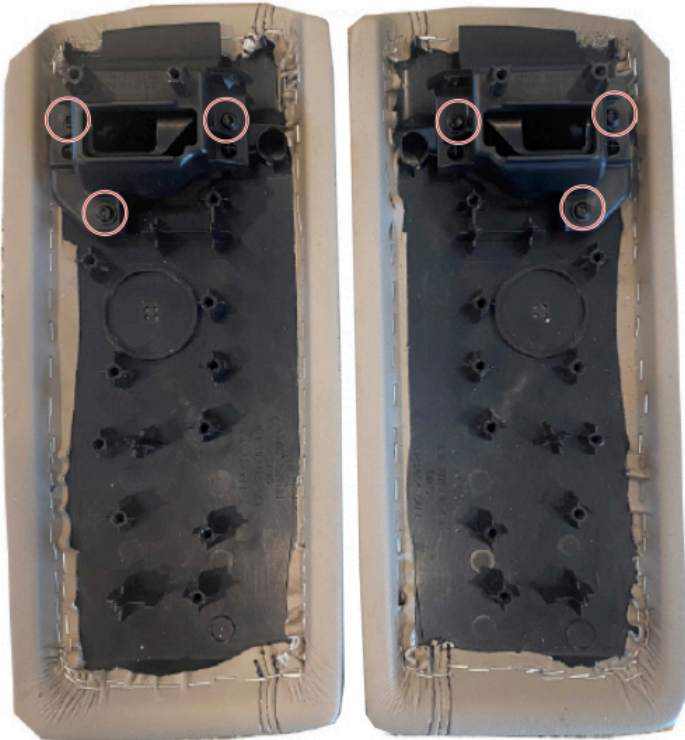
**Issue:** Some of the vehicles listed in the Model statement above may exhibit a broken floor console armrest latch.

13. Remove the 6 screws on both armrests and replace the 2 latch assemblies. (Figure 10)  
Figure 10
