## Vehicle cannot disengage “P” (Park), red warning message in instrument cluster

Topic number	LI27.60-P-080167
Version	1
Function group	27.60 - Gearshift, control
Date	2/12/26
Validity	167 (pre-facelift), 205, 213, 253 with M264 and 725.0 (NAG3 Classic)
	with transmission software version 19A/B
Reason for change	awareness of software release

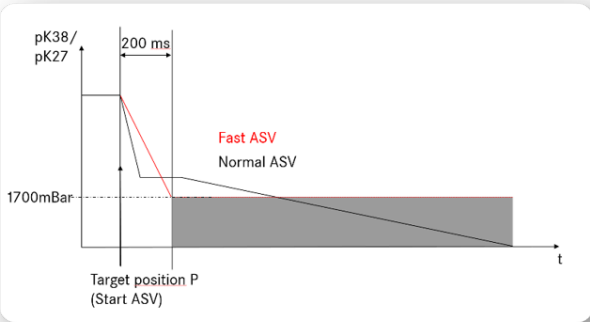
Attachments	
File	Description
<a href="#">Parksperr_M264 (1).png</a>	Pressure diagram

Excessive pressure in the disengaging clutch during monitoring of the parking lock (see attachments for diagram).

Various parking lock monitoring errors and R/D monitoring errors occur, only with engine M264 and software versions 19A and 19B.

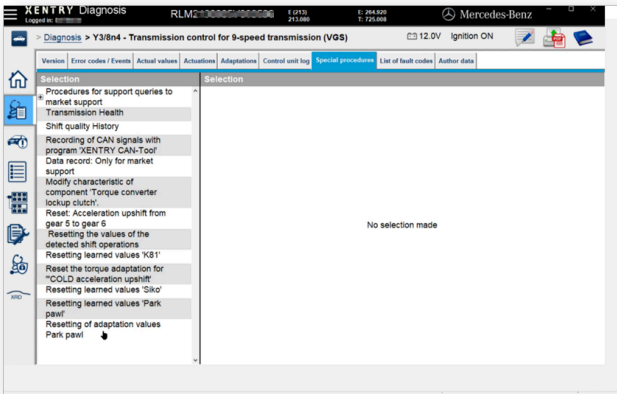
Attachments	
File	Description
<a href="#">Xentry_EN (1).png</a>

Reset procedure in Xentry (ONLY perform if no software is available)

1. Perform special procedure "Resetting of adaptation values 'Park Pawl'"

Only perform this special procedure if there is NO available software for the VGS control unit.
