RAPID UPDATE

Rapid Update 812 Grecale – Multi SW Upgrade Pack

DATE: February 9, 2026

VEHICLES INVOLVED: (M182) Grecale MY23, MY24 and MY25

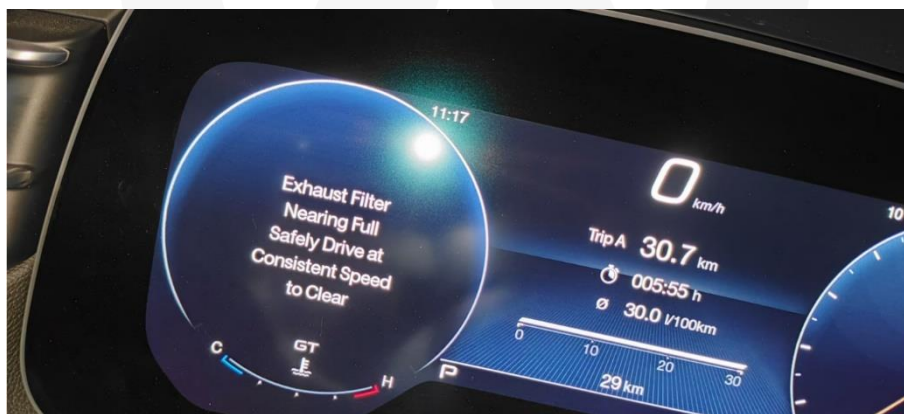
- Using MD-EVO, clear DTCs.
NOTE : Following the update, in very rare cases, the following message may appear on the screen.

This message does not indicate any technical problems with the car and simply suggests that an extra urban cycle should be performed at cruising speed to facilitate spontaneous GPF regeneration.

Technically, this message is activated when the GPF is about 50% full, in a non-critical condition. In some cases, the message may appear on pre-delivery vehicles if frequent cold engine start/stop cycles have been performed. Again, this message is to be regarded as a technical suggestion and should in no way be seen as a vehicle malfunction.

The reason why this warning has been implemented in this new software version is to inform the customer in good time so that the vehicle can be kept in perfect working order. Therefore, no further action is required by the workshop should this message appear following the update. **TCM SW Update (some MY23 only)** We also ask you to inform the customer of both the new warning function and the possible need to drive an extra-urban cycle. For this reason, any request for supplementary work under warranty concerning this issue will be rejected.
