Service Bulletin

Bulletin No.: PIP6095B

Subject: 6T40 Harsh Garage Shift into Drive

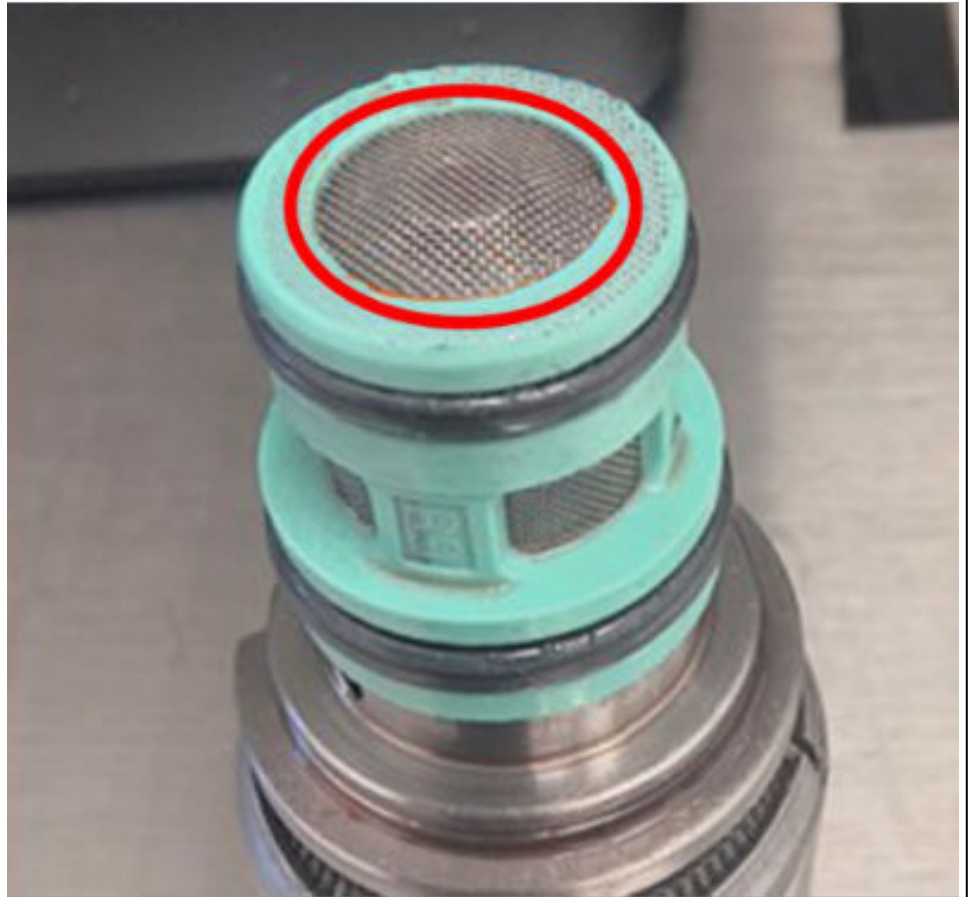
Involved Region or Country	GMNA, South Korea, China, Japan
Condition	Some customers may complain of harsh garage shifts into drive.
Cause	<p>There may be an issue with the normally high solenoids in the control solenoid valve and transmission control module assembly (TEHCM) having a valve over travel and contact or rupture the solenoid screen as shown below.</p>

6. If the solenoid valve is found to be touching or pushing through the screen, replace the control solenoid valve and transmission control module assembly (TEHCM) and the control valve body per SI instructions.
