<b>REFERENCE:</b>	<b>TSB:</b> 08-058-26 <b>GROUP:</b> 08 - Electrical	<b>Date:</b>	February 11, 2026	<b>REVISION:</b>	08-407-25
<b>VEHICLES AFFECTED:</b>	2023 (WL) Jeep Grand Cherokee / Grand Cherokee L			<b>MARKET APPLICABILITY:</b> <input type="checkbox"/> NA <input type="checkbox"/> MEA <input type="checkbox"/> SA <input type="checkbox"/> IAP <input type="checkbox"/> EE <input checked="" type="checkbox"/> CH <b>NOTE:</b> This bulletin applies to China markets.	
<b>CUSTOMER SYMPTOM:</b>	<b>Customers may experience the following:</b> <ul style="list-style-type: none"> <li>Vehicle no start due to a depleted 12V battery.</li> </ul>				
<b>CAUSE:</b>	Loose PDC connector pin

This bulletin involves inspecting the PDC C3 connector for improperly installed pins and correcting the connector pins if found to be installed backwards.

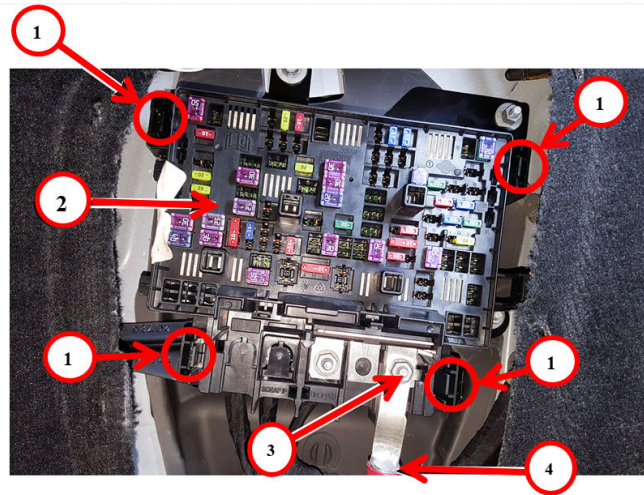
**Fig. 2**  
PDC

- 1 - PDC retaining Tabs
- 2 - PDC
- 3 - Electrical Terminal Nut
- 4 - Positive Cable

3. Remove the electrical terminal nut and positive cable from the PDC [Fig. 2](#).

4. Release the retaining tabs securing the PDC to the PDC bracket [Fig. 2](#).
5. Pull the PDC out from the PDC bracket and disconnect the C3 wire harness connector [Fig. 3](#).

16. Engage the retaining tabs securing the PDC to the PDC bracket [Fig. 2](#).
17. Connect the positive terminal to the PDC and secure using an electrical terminal nut [Fig. 2](#).

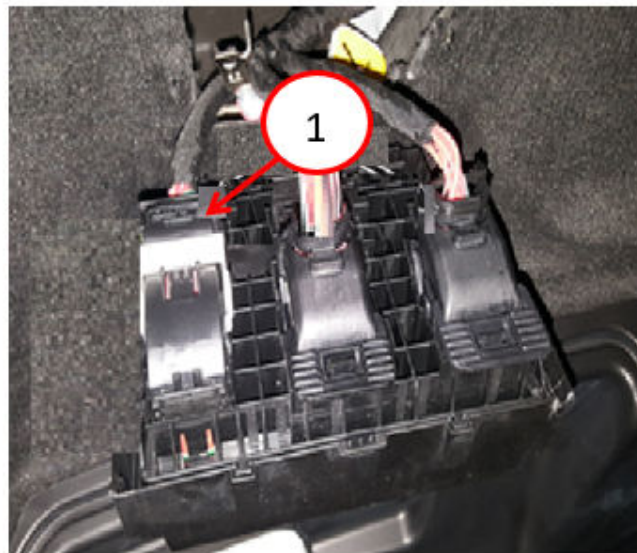
**Fig. 3**  
PDC C3 Connector

- 1 - Disconnect C3 Connector

13. Install the red connector terminal cap to the C3 connector [Fig. 4](#).
14. Connect the C3 wire harness connector to the PDC [Fig. 3](#).
15. Position the PDC back into the PDC bracket.

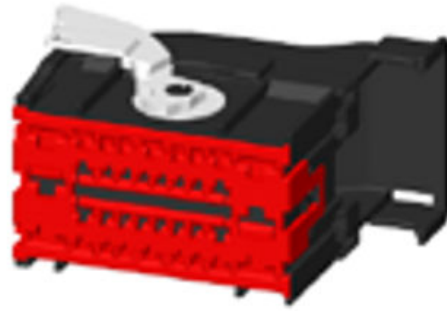
**Fig. 4**

C3 Red Connector Terminal Cap

6. Remove the red connector terminal cap from the surface of the C3 connector [Fig. 4](#).

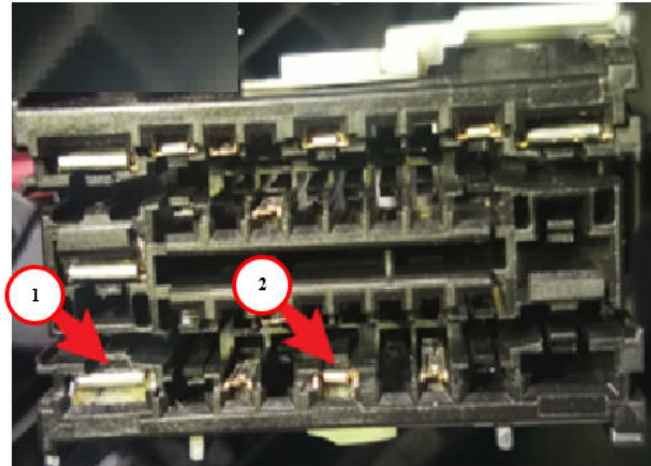
**Fig. 5**

Remove Pins

- 1 - Large Pin  
2 - Medium Pin

7. Remove the medium and large pins from the connector [Fig. 5](#).

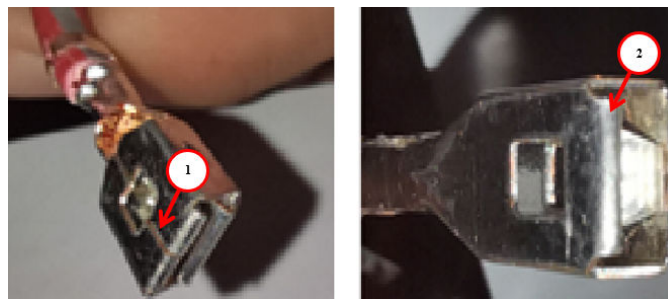
**Fig. 6**

Pin Inspection

- 1 - Seam Visible - Indicates Incorrect Alignment  
2 - Rolled Edge - Indicates Correct Alignment

9. Was a seam noticed when inspect the large and medium pins [Fig. 6](#)?
  - YES>>> Proceed to [Step 10](#).
  - NO>>> Proceed to [Step 11](#).
10. If you can see a seam between the large and medium pins on this connector, it means that the pin installation is incorrect. The pins need to be rotated 180 degrees prior to installing them back to the connector.

11. For the smallest pin, gently pull the wire from the backside of the connector to check if it's loose. Secure as needed.
12. Correctly align and install the large and medium pins back to the connector.
