## STAR ONLINE PUBLICATION

**Case Number:** S2108000121 - Rev. B

**Symptom/Vehicle Issue:** Check Engine Light On And Service Hybrid System Displayed. P0A0A-00 High Voltage System Interlock Circuit "A" Is Active

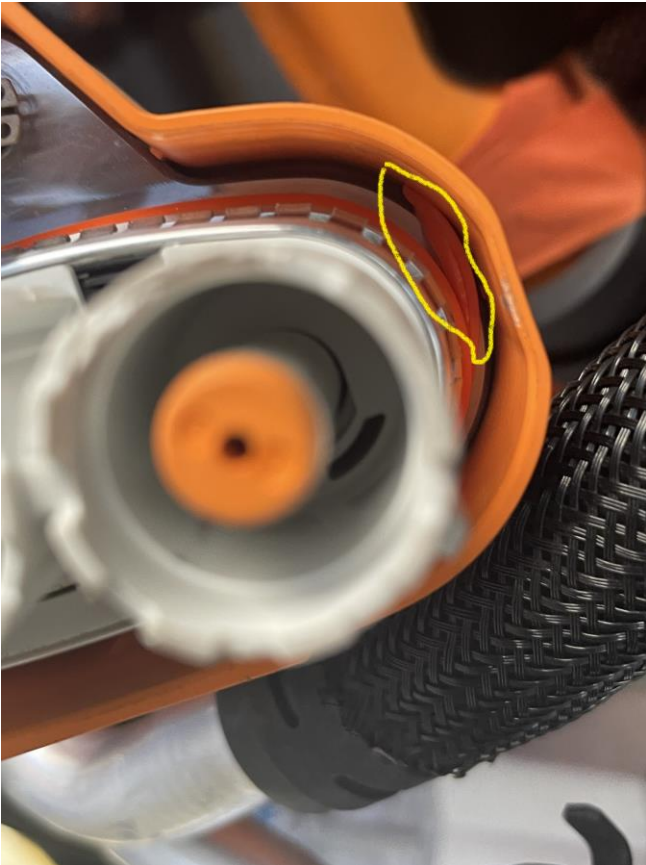
Inspect the HVIL connector seals for damage or tears and the terminals for spread contacts. If any of the High Voltage connectors seals are damaged, the wiring harness will need to be replaced. If HVIL terminals appear to be spread or damaged, HV component replacement will be necessary. Contact STAR for assistance.

**Damaged HV Connector Seal**

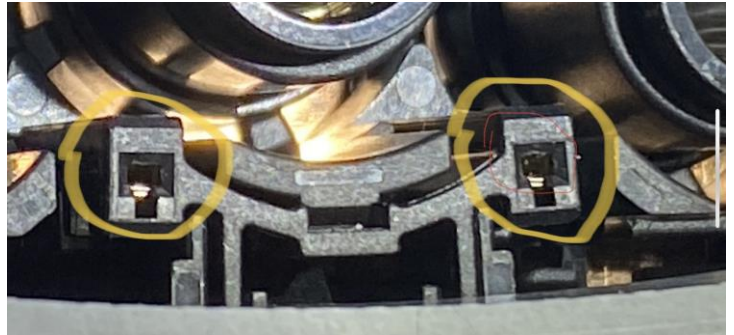
**Spread HVIL Terminals**

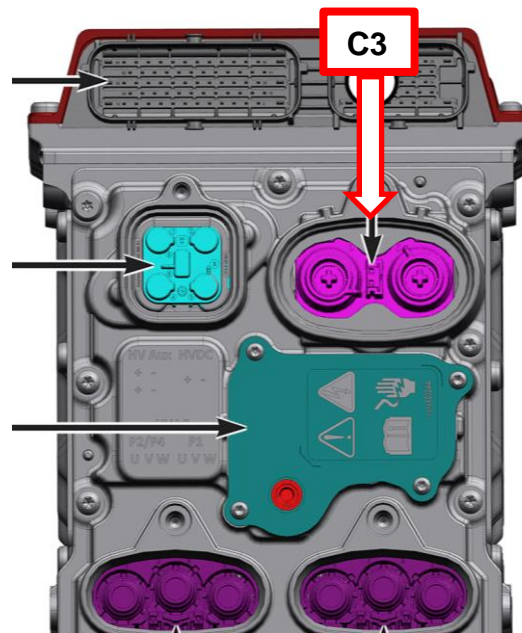
**PIM C3 Connector Location**

The Power Inverter Module (PIM) C3 connector is especially prone to being installed at an angle. Before torquing down the bolt, confirm that the C3 is fully and squarely seated by utilizing the 3 windows provided around the orange plastic colored shield of the connector. There should be no empty space when looking through the window. When fully seated, only the aluminum PIM housing should be seen. Review the images below.

**Installation of HVIL Connector:** Turn the HVIL connector bolt one revolution while applying forward pressure and wiggling the connector, push it firmly so that it is completely seated. Ensure the connector is seating square to the connector housing.

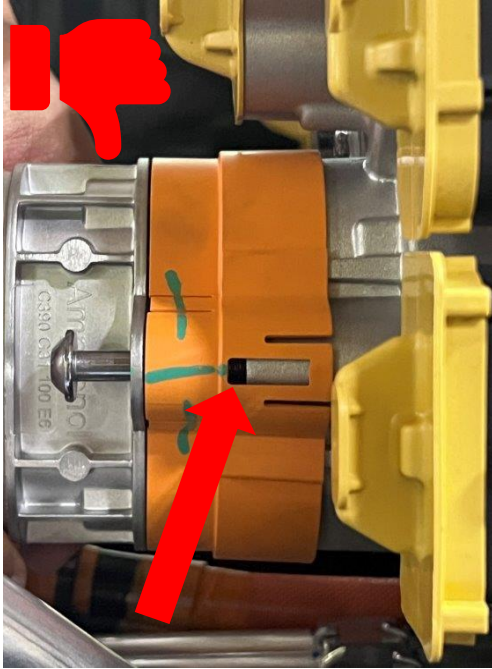
**Not Good: Air Gap in Window**

**Failure to squarely and fully seat the connector before torquing down the bolt can result in HVIL terminal damage**

Once the connector is in fully seated position, hand start the fastener and drive it until the specified torque of 80 In-Lbs. or 9 Nm is achieved.

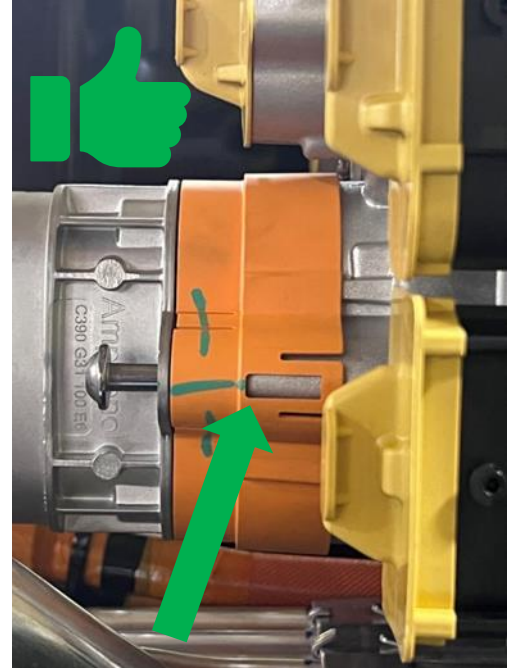
**Good: No Air Gap in Window**
