STAR ONLINE PUBLICATION

Case Number: S2508000059

Symptom/Vehicle Issue: wiTECH Does Not Connect To The Vehicle. No Power At OBD II Port

Models Affected: 2025 Ram 2500 (DJ), Ram 3500 (D2), Ram 3500 Cab Chassis (DD), Ram 4500/5500 Cab Chassis (DP)

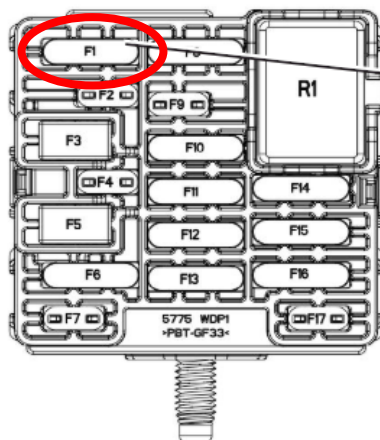
FUSE F1 10A

Diagnosis: Inspect for a blown F1 fuse located in the Interior PDC.

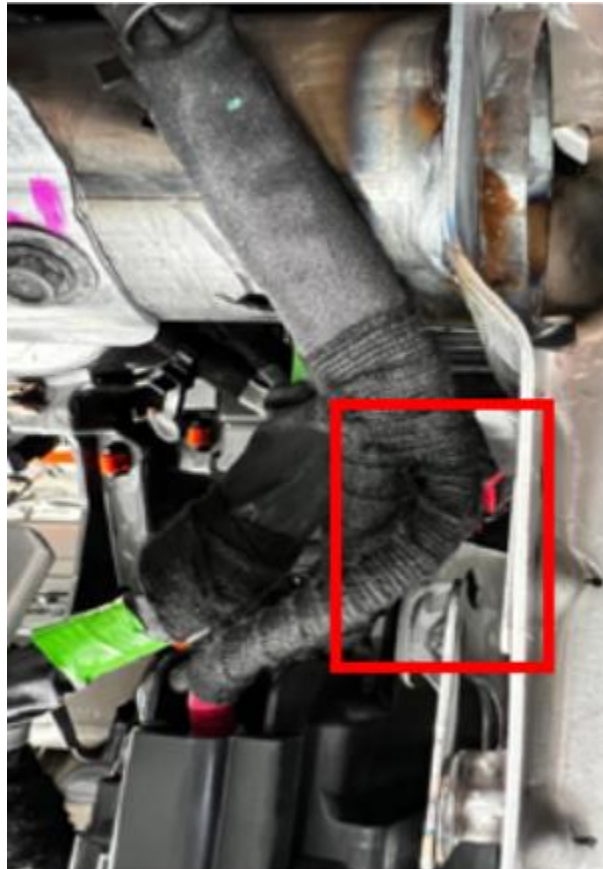
Discussion: When connecting the Micro Pod to the OBD II port, the light on the pod may not illuminate and wiTECH may not be able to establish communicate with the vehicle. This may be caused by a blown F1 (10A) fuse in the Interior PDC, which provides B+ power to the DLC via the A900 circuit. The fuse may have blown due to a short to ground on the A900 circuit that has come in contact Interior PDC support bracket.

If the F1 fuse is blown. Thoroughly inspect the dash harness containing the A900 (GY/RD) circuit to see if it is abrading against the Interior PDC support bracket.

Repair: If the harness and A900 (GY/RD) circuit are contacting the bracket and damaged, causing a short to ground. You will need to repair the circuit and then add high abrasion tape to protect the harness from future any abrasion or rub through. It is also recommended to attempt slightly relocating the harness away from the bracket.

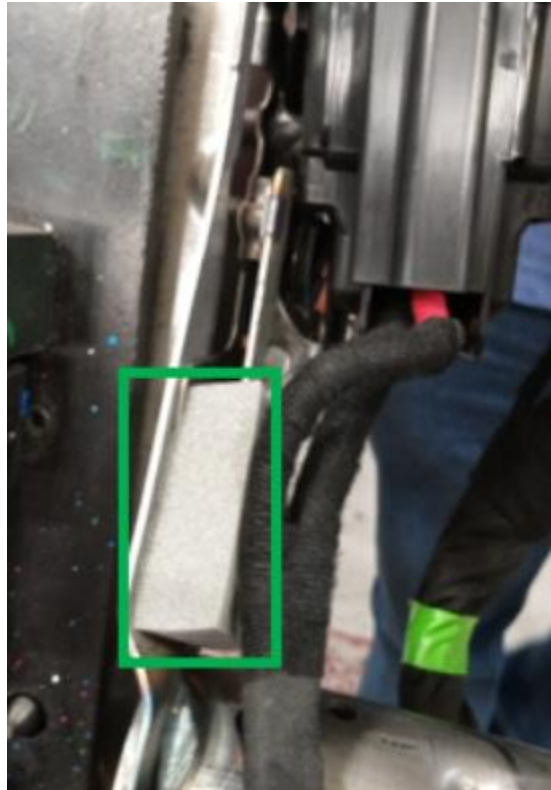
Foam block on Interior PDC Bracket

At the plant, engineering has added a foam block to the Interior PDC support bracket to remove the possibility of the harness making contact. (see image below)
