STAR ONLINE PUBLICATION

Case Number: S268A000005

Models: 2025-2026 Ram 1500 (DT)
2025-2026 Ram 2500 (DJ)
2025-2026 Ram 3500 Pickup (D2)
2024-2026 Jeep Wagoneer S (KM)
2022-2026 Grand Cherokee (WL)
2022-2026 Grand Wagoneer (WS)

Symptom/Vehicle Issue: Front HDMI Port or Front Passenger Display Module (FPDM) Not Projecting Video

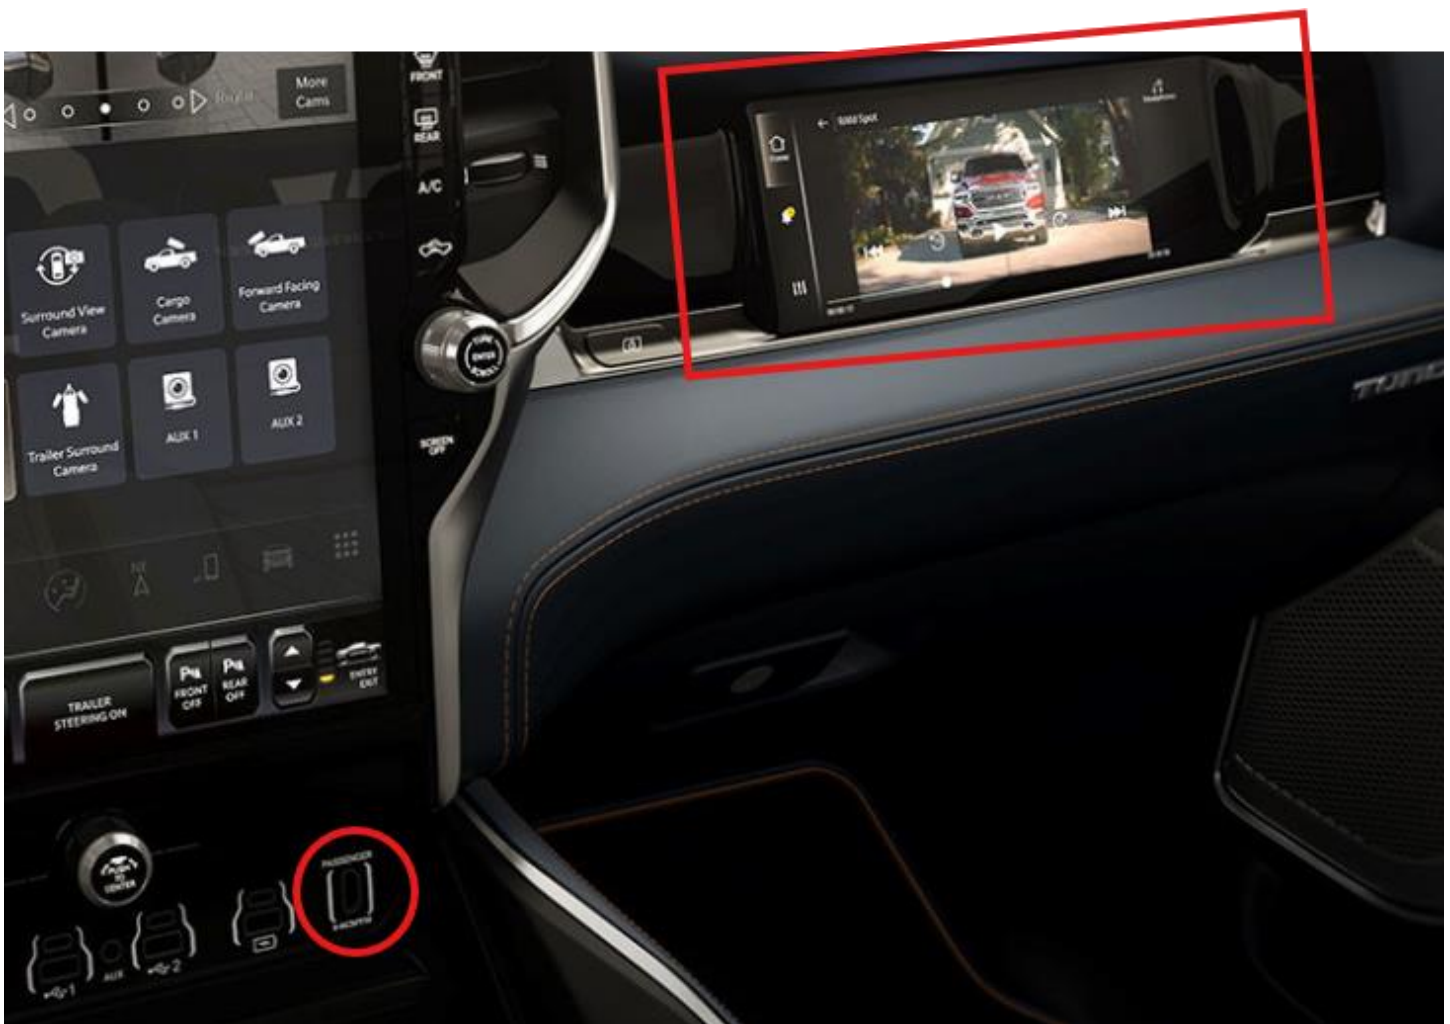
Figure 1. Front HDMI Port for Front Passenger Display Module

6. Check the radio is up to date on software. Check for any TSB or Service bulletins for system updates.
7. Reboot radio and retest. Press and hold volume/power knob for about 20 seconds till radio reboots. Allow radio to full reboot and then retest system operation.
8. Unplug HDMI port, then re-connect HDMI port connector. Retest system.
9. Try known good HDMI port in vehicle or try suspect port in known good vehicle.
