SIB 31 01 26

THUMPING AND/OR GROANING NOISE FROM FRONT AXLE

2026-02-04

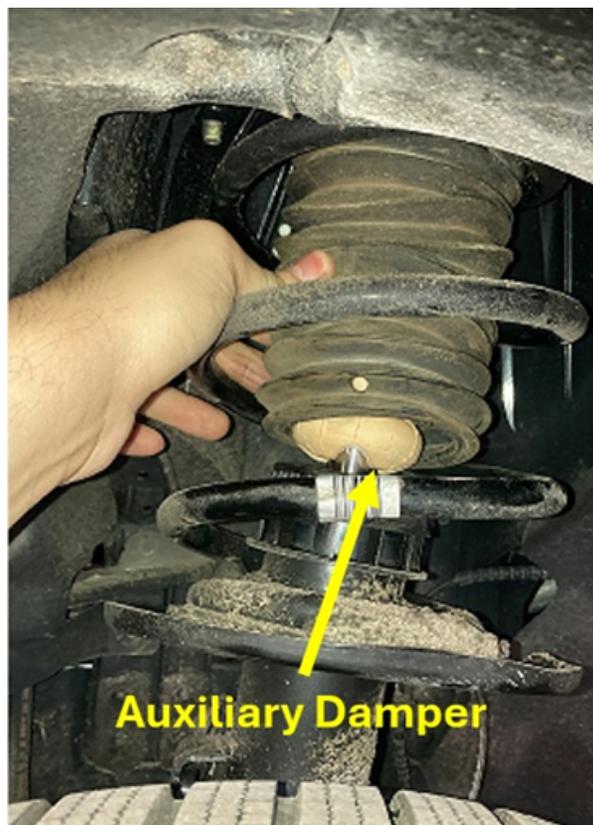
The auxiliary damper (aka additional shock absorber) detaches from the support bearing (aka guide support)

Replace the left and right support bearing and auxiliary damper.
