SIB 51 03 26

CREAKING NOISE FROM THE LOWER B-PILLAR TRIM PANEL

2026-02-17

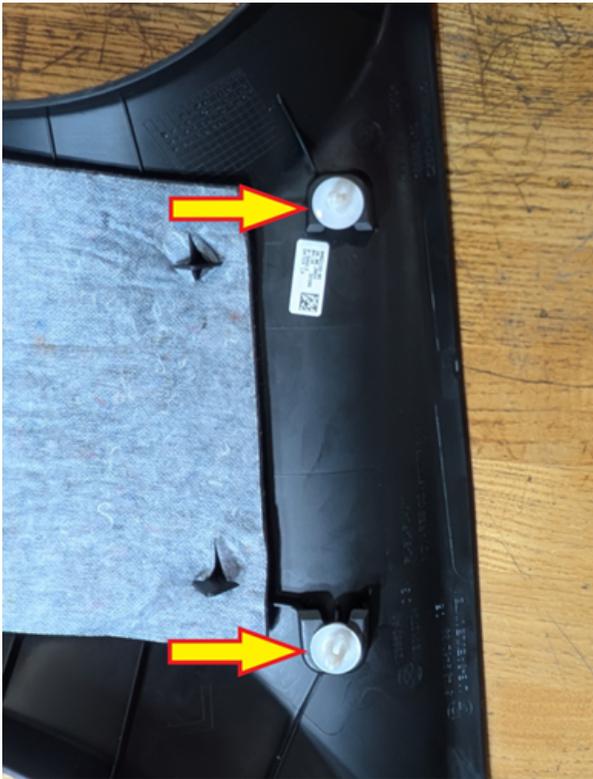
1. Remove the pertinent B-pillar per REP 51 43 150 “Removing and installing/replacing the trim panel for the left and right B-pillar.”
2. Once the B-pillar trim is removed, the lower white panel clips (yellow arrows) need to be removed.
