SIB 65 03 26

DIRECTIONAL ARROWS INCORRECT IN AR VIEW – HU-H6  
2026-02-17

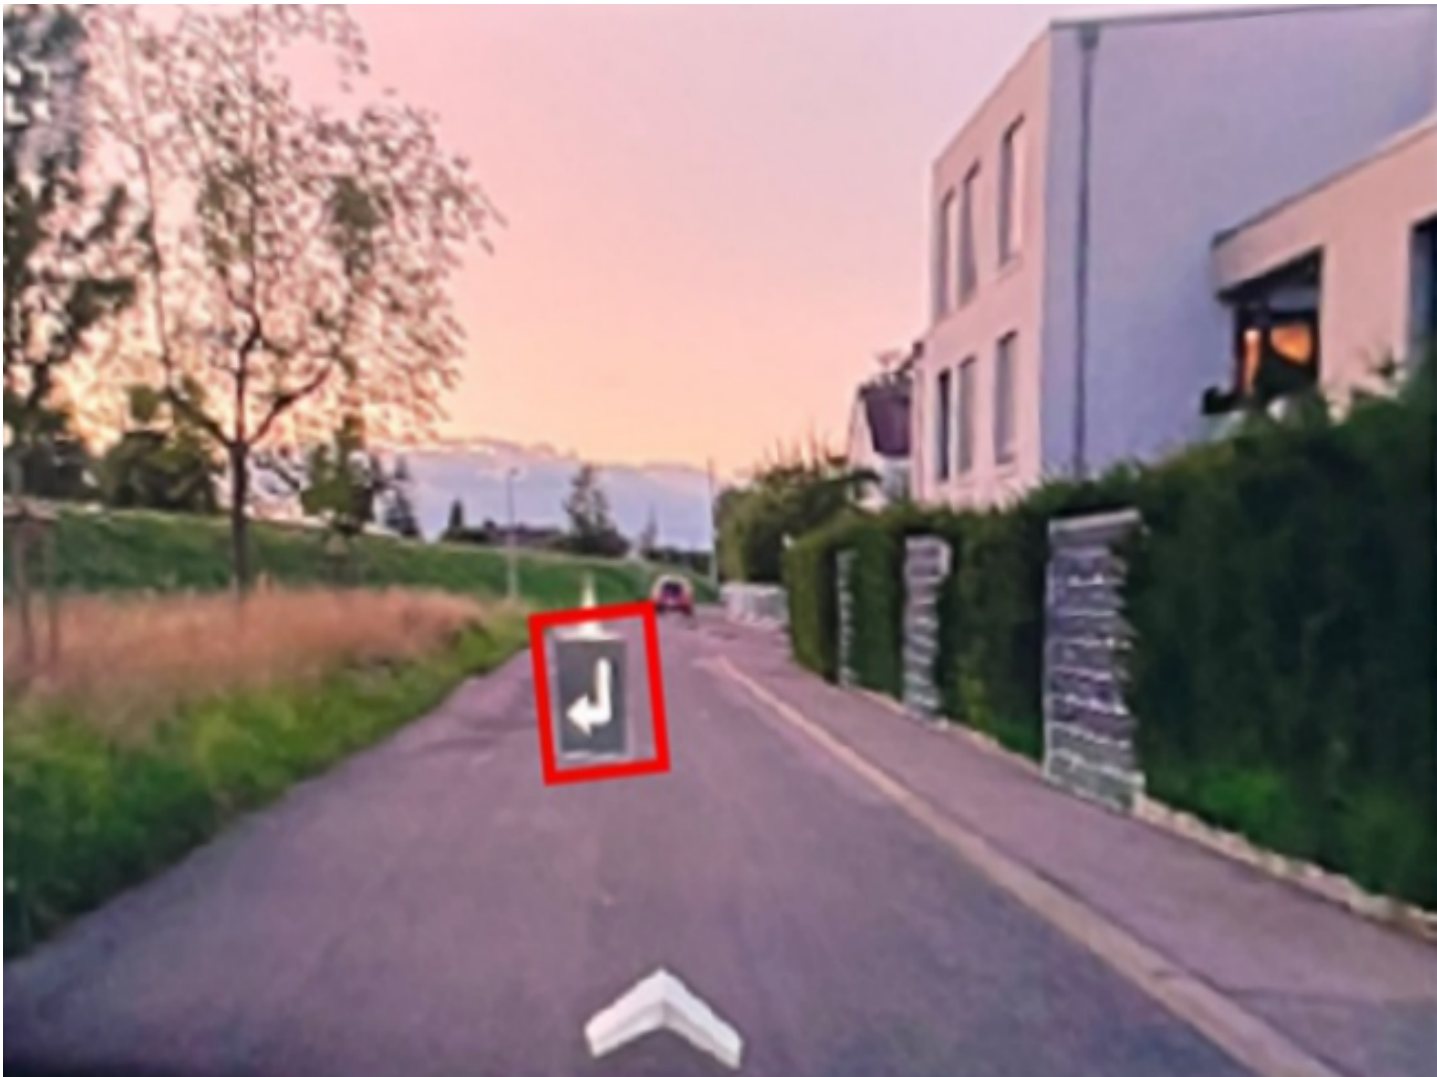
In Augmented View, the arrows are rotated by 180° (shown inverted below) when displayed on the Central Information Display (CID).

Unfavorable software in the Headunit 6 (HU-H6).

Program the HU-H6.

If the I-level is lower than ...25-11-540, program the vehicle to I-level ...25-11-540 or higher using ISTA 4.57.25 (released on December 15, 2025) or higher.
