## SIB 72 01 25

### G1X/G3X FALSE ALERT RF SEAT OCCUPIED W BELT UNBUCKLED-EXTENDED LIMITED WARRANTY 2026-02-11

This Service Information bulletin (Revision 05) supersedes SI B72 01 25 **Dated October 2025**

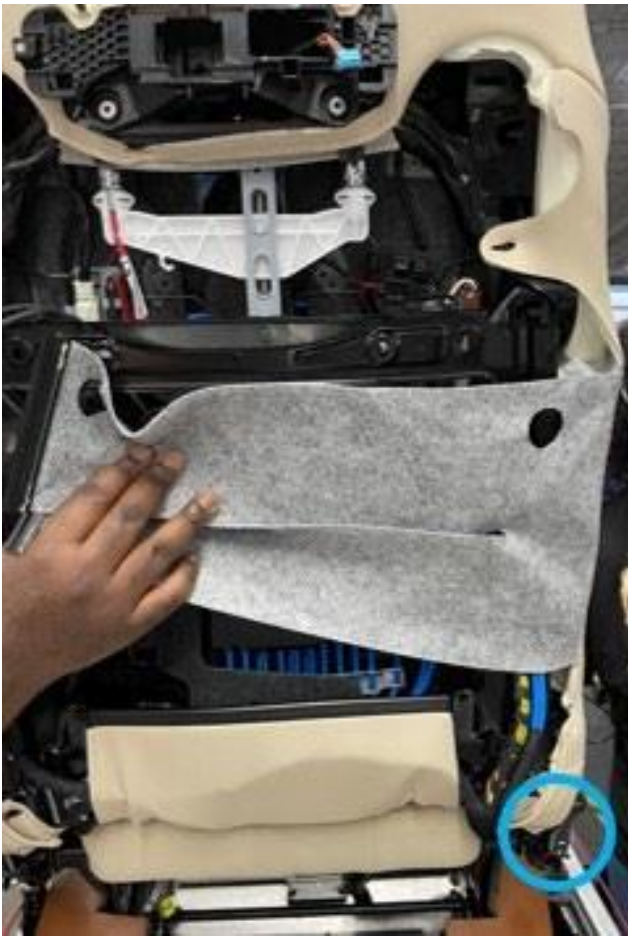
3. Prior to replacing components, inspect the connection of the CIS mat ground wire to the structure at the lower right side of the backrest (circled).

The eyelet on the ground wire should make solid connection to the structure with no free play.

If free play is identified, repair as needed.

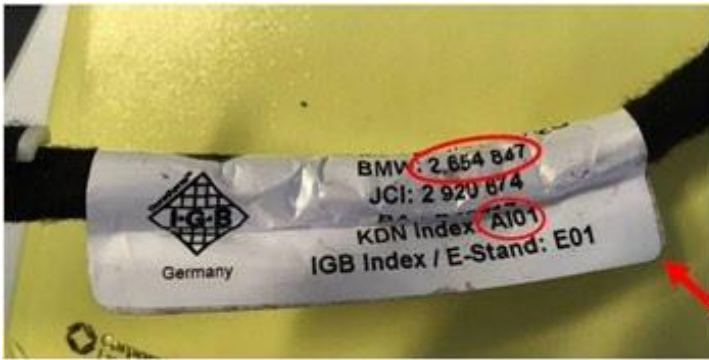
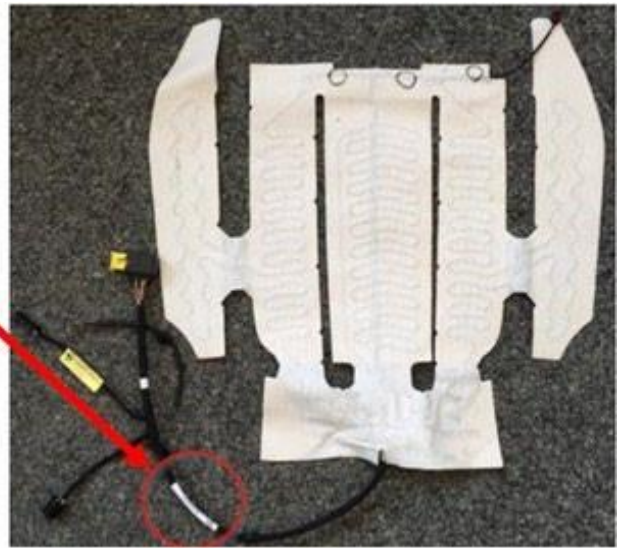
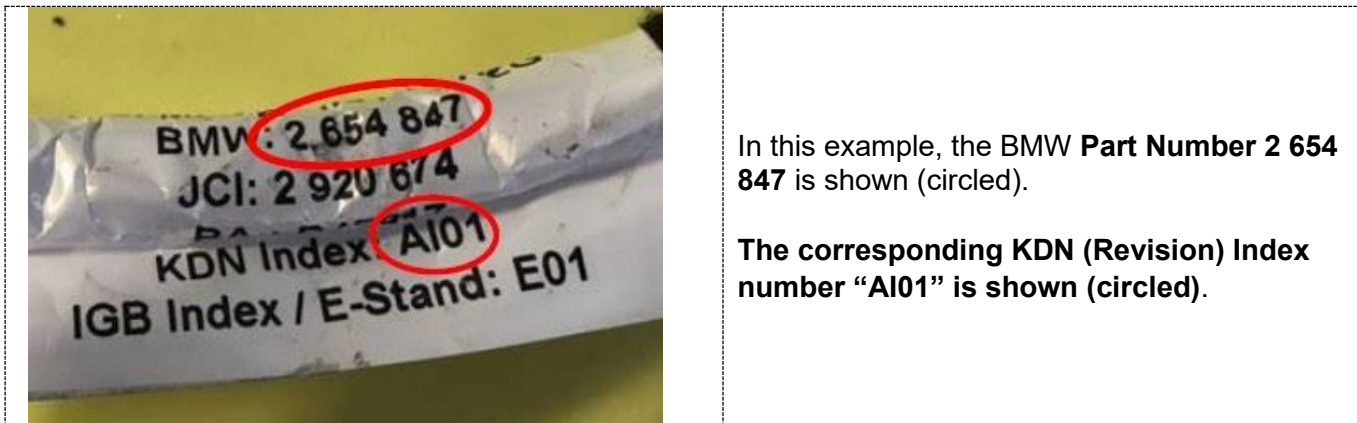
4. If steps 1 to 3 did not identify those items as the cause of the false right front seat occupied notice, access the bottom seat cushion per Repair Instructions so that the installed:

- Front passenger's seat heating / CIS mat part number, and its
- Change Index number can be determined.

To access the label's information, loosen seat mounting, open the central connector, fold seat to the back, completely.

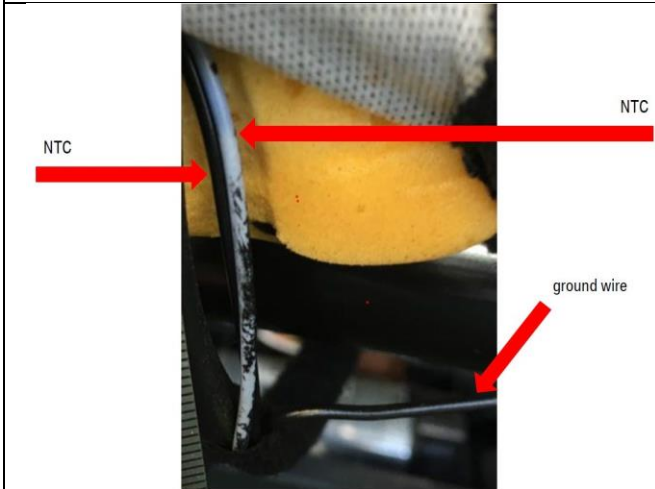
The following cables/cable assemblies are now exposed:

- two NTC cables (negative temperature coefficient lines) for temperature
- Outgoing grounding wire.

**THESE WIRES MUST NOT BE CUT!**

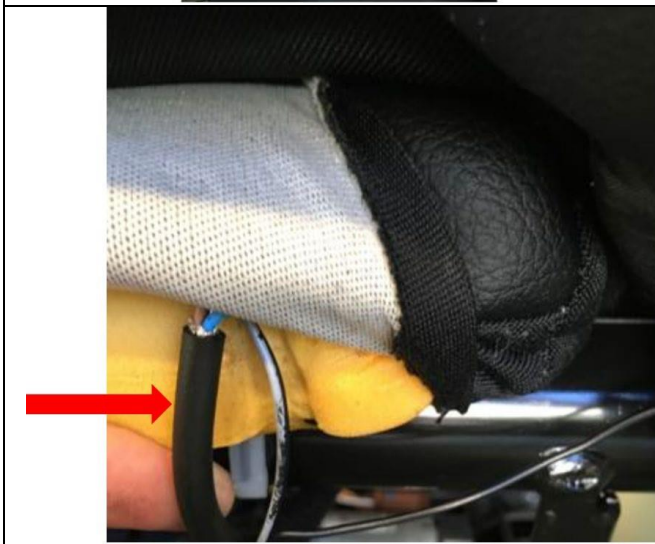
The following cables/cable assemblies are now exposed:

- Cable assembly (4 cables in a rubber jacket) including shielding.

This is the wiring that will be modified

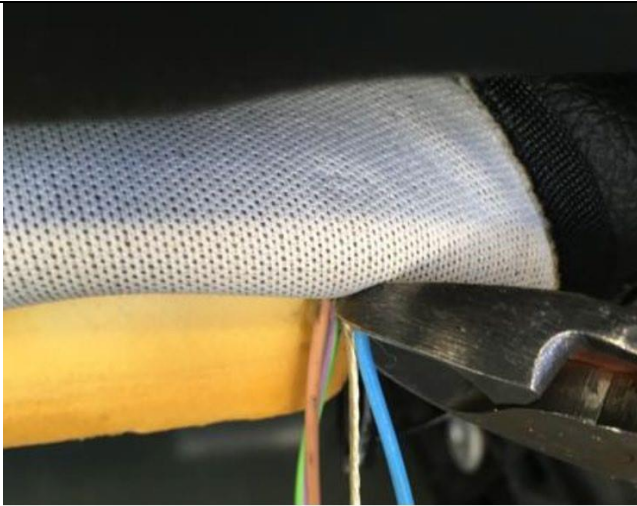
There are 4 wires in the cut cable assembly, but only 2 of which are needed (brown and green/purple).

The other two cables (blue and a cable Without a colored jacket) are no longer needed and can be cut off.

Cut open the cable assembly 2 centimeters before the seat heating element and remove the rubber jacket.

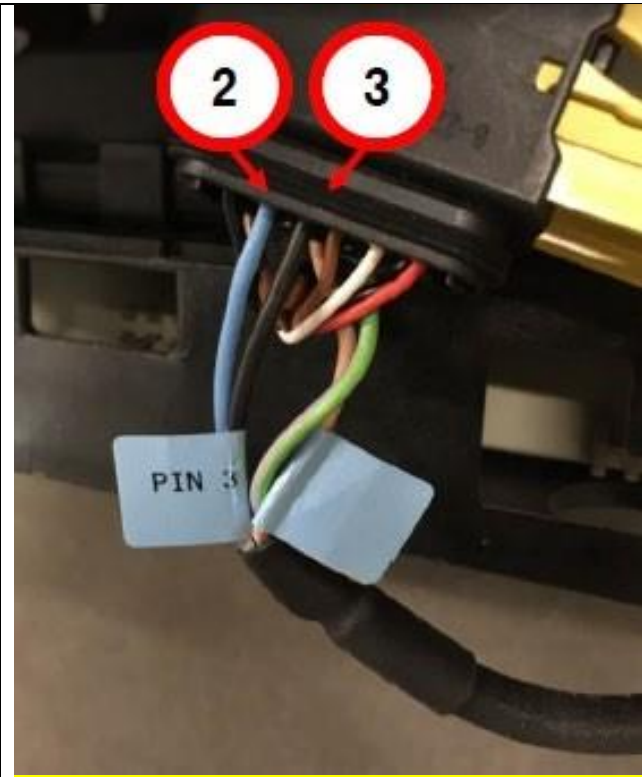
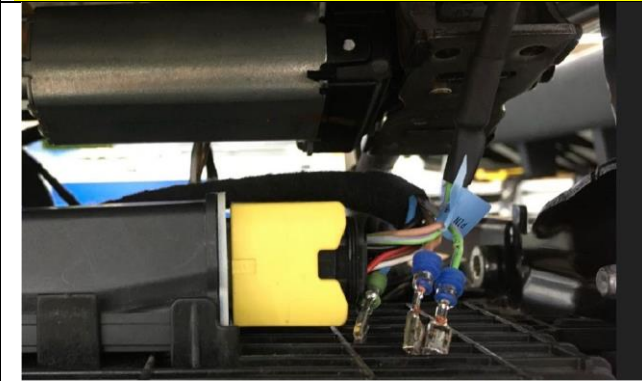
The 4 old cables remain in the wiring harness
