SIM 31 01 26

THUMPING AND/OR GROANING NOISE FROM FRONT AXLE

2026-02-04

E-Series	Model Description	Production Date
F55	MINI Hardtop 4 Door	Start of Production

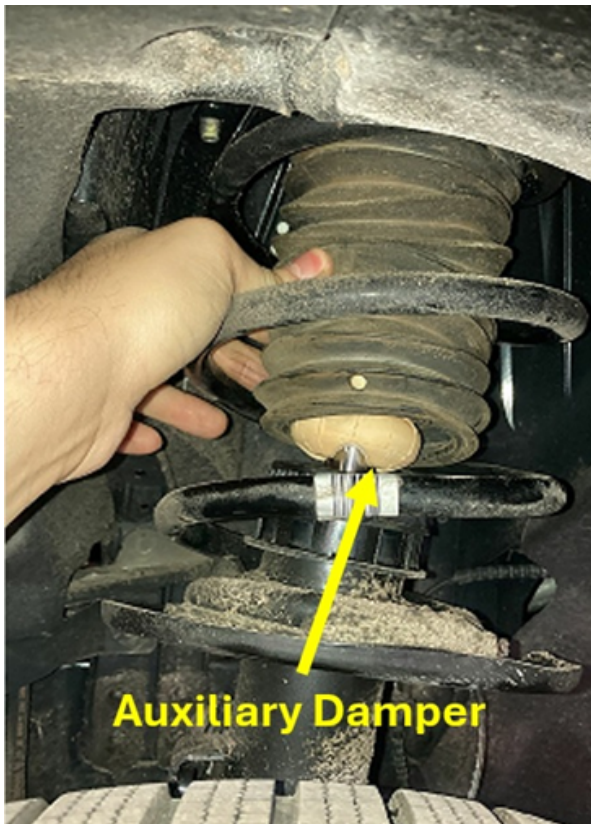
The auxiliary damper (aka additional shock absorber) detaches from the support bearing (aka guide support).

Replace the left and right support bearing and auxiliary damper.
