Service Bulletin

Bulletin No.: PIT6477B

Subject: Unable to Perform GDS2 Automated Bleed After Master Cylinder Replacement

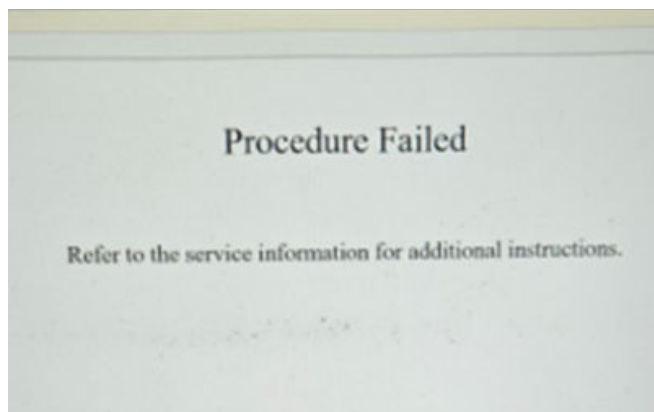
7058016

Involved Region or Country	North America
Condition	Some Technicians may notice that they get an error screen when trying to perform the automated bleed after master cylinder replacement, (See Error Screen Below).
Cause	Software Anomaly with GDS2 Software.

An updated version of GDS2 has been released to address this issue. Please launch Techline Connect (TLC) and verify that GDS2 is updated to version v2026.02.12 or later.

When performing the GDS2 Auto Brake Bleed procedure, you will now see two options: "Automated Brake Bleed" and "Modified Automated Brake Bleed."

Begin by selecting "Automated Brake Bleed." If the procedure completes successfully, no further action is required.

If the "Automated Brake Bleed" procedure does not complete successfully, proceed with "Modified Automated Brake Bleed," which incorporates the updated fix.
