# Service Bulletin

Bulletin No.: PIT6485

**Subject:** Missing Tailgate Assist/Pull Handle

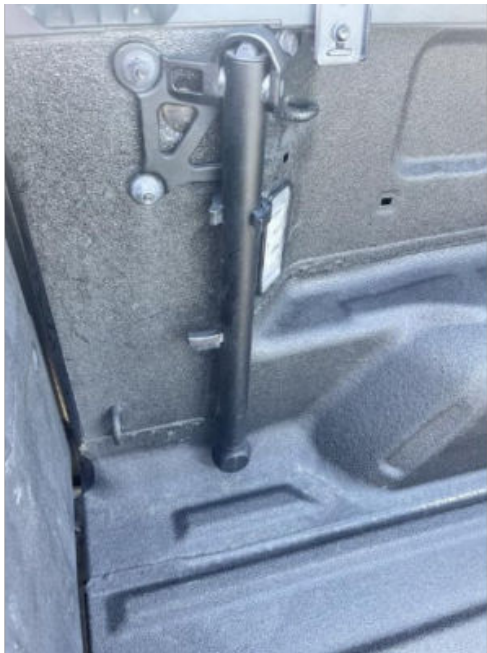
6714845

| Condition | A technician (during PDI) or a customer may comment that the tailgate assist handle was not included at the time the vehicle was delivered, see picture below. |
| Cause | The assist handle has changed from an included part of RPO QK2 (Mult Flex or MultiPro tailgate) to a stand-alone option, RPO TGH. To get the handle, RPO TGH must be ordered for the handle to be included. |

Do not install an assist handle on a vehicle that is missing the handle unless the vehicle is equipped with RPO TGH.

If a customer desires to have the handle, they can purchase the assembly through the parts department. This is a customer pay (non-warranty) item. Any warranty claims submitted for the tailgate handle that doesn't have the RPO: TGH will be charged back.
