# HYUNDAI

## Technical Service Bulletin

| GROUP<br><b>ENGINE<br/>MECHANICAL</b> | NUMBER<br><b>26-EM-002H</b> |

**SUBJECT:** ENGINE NOISE INSPECTION & REPLACEMENT  
(WARRANTY EXTENSION TXX8)

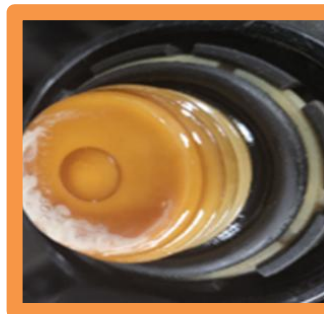
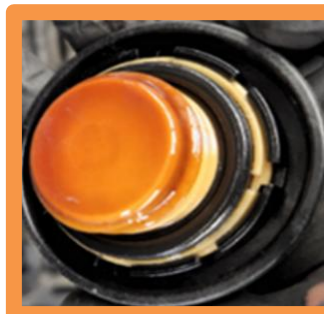
**PASS**

The oil cap condition will be used to determine if the rear bank rocker cover removal is needed.

Using the STUI camera function, take a photo of the engine oil cap.

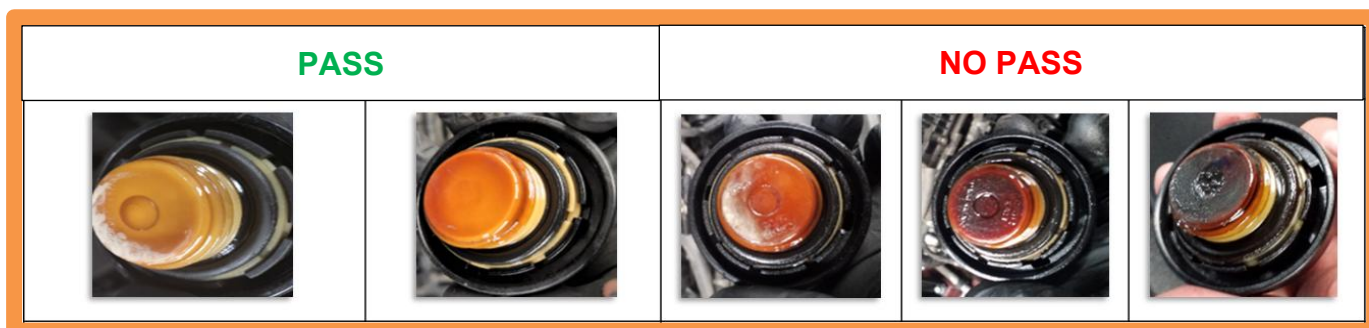
- A. If the BCT result is **PASS**
- Save a screenshot of the result.
  - Reinstall all parts in the reverse order of the removal process and replace non-reusable parts.
  - Follow a normal diagnostic procedure if both front and back banks show a **PASS**.
  - Do **NOT** remove the front rocker cover.
- B. If the BCT result is **NO PASS**
- Save a screenshot of the result.
  - Inspect the oil cap condition to determine **PASS** or **NO PASS**.
- **PASS** – proceed to the next step.
  - **NO PASS** – remove the rear bank rocker cover and provide images of the valvetrain and inside of the cover. Include a sticky note of the repair date.

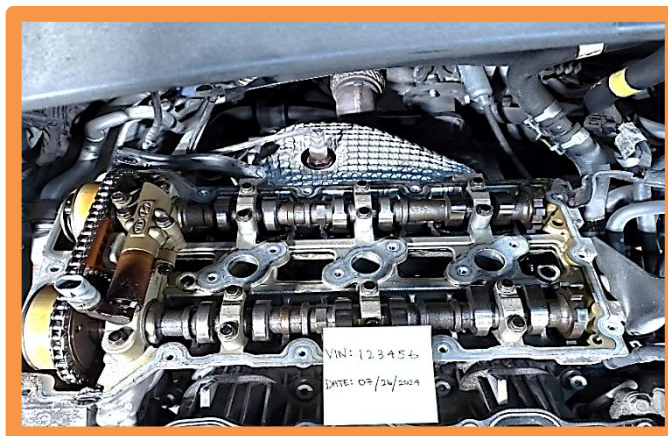
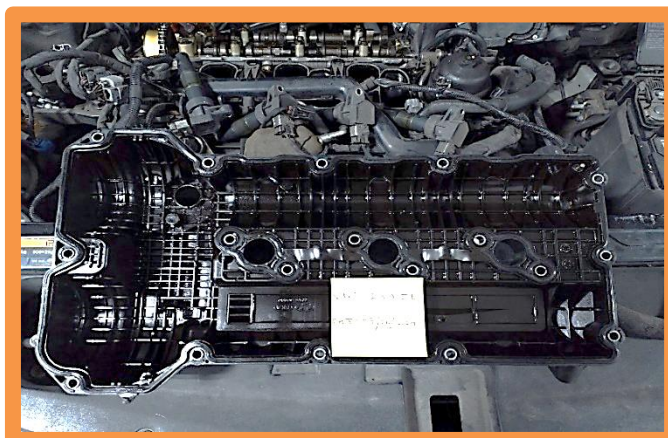
Ensure the photo is clear and focused, and matches the examples shown to the right when submitting valvetrain images via STUI.

Do **NOT** remove the front bank LH rocker cover for valvetrain images. This can disturb the high-pressure fuel system and line. Claims may be subject to chargeback if the front bank rocker cover is removed.

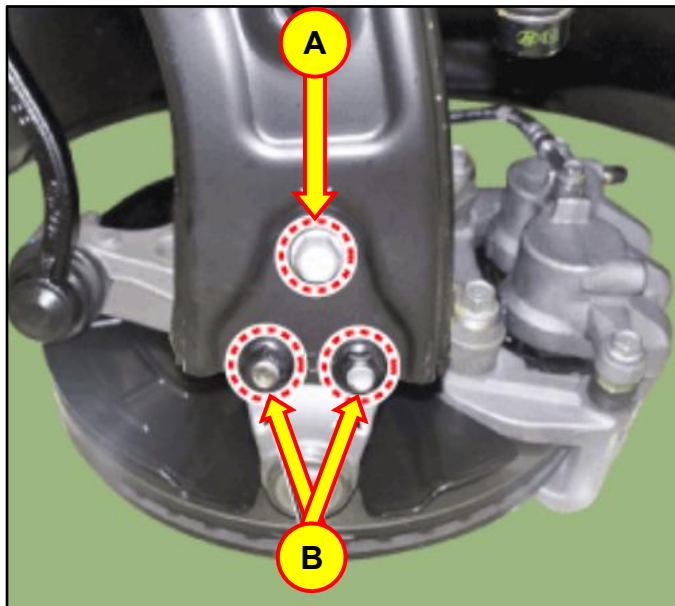
3. During the removal of the front subframe from the vehicle, loosen and unbolt the LH and RH lower control arm ball joint assemblies (A & B).

The lower control arm ball joints do **NOT** need to be removed from the steering knuckle as shown in the shop manual.

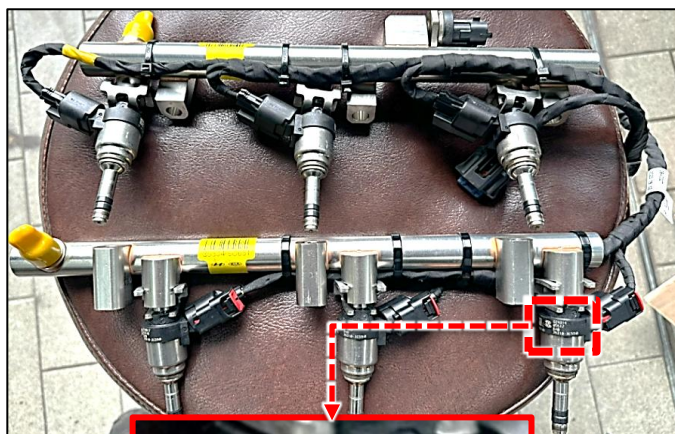
4. During the replacement, install the applicable injector tip seals based on the marking on each injector. Since both seals are included in the kit, use the table below to match the applicable part.

Select the appropriate tip seal according to the existing fuel injector part number.

**Use of the incorrect tip seal may result in a critical fuel leak.**

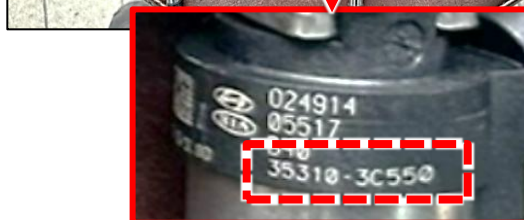
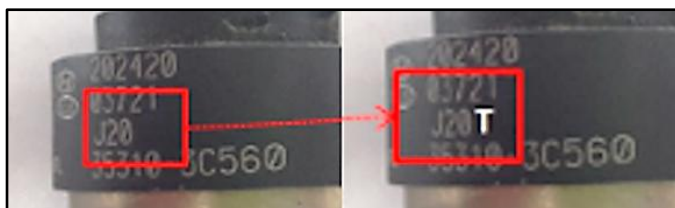
Tip-Seal Part Identification as shown on the right.

P/N: 353132T000 is labeled.  
P/N: 353123C720 is **NOT** labeled.

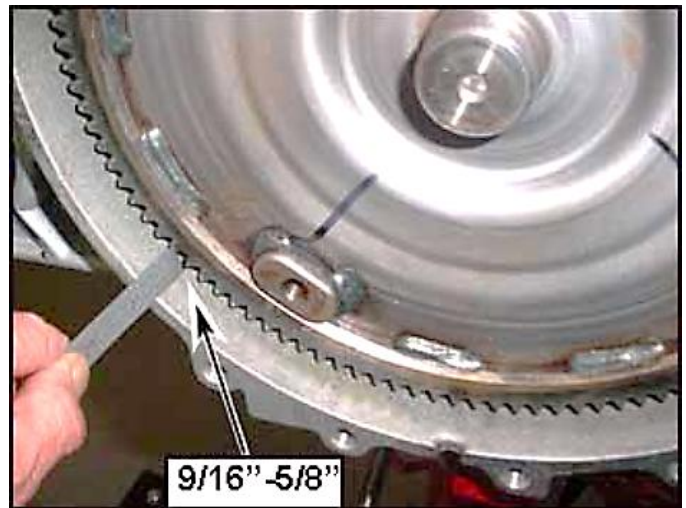
If the torque converter is **NOT** fully seated, the oil pump may be damaged during reinstallation.
