HYUNDAI Technical Service Bulletin

NUMBER
26-BE-002H

SUBJECT: INOPERATIVE HORN ASSEMBLY REPLACEMENT

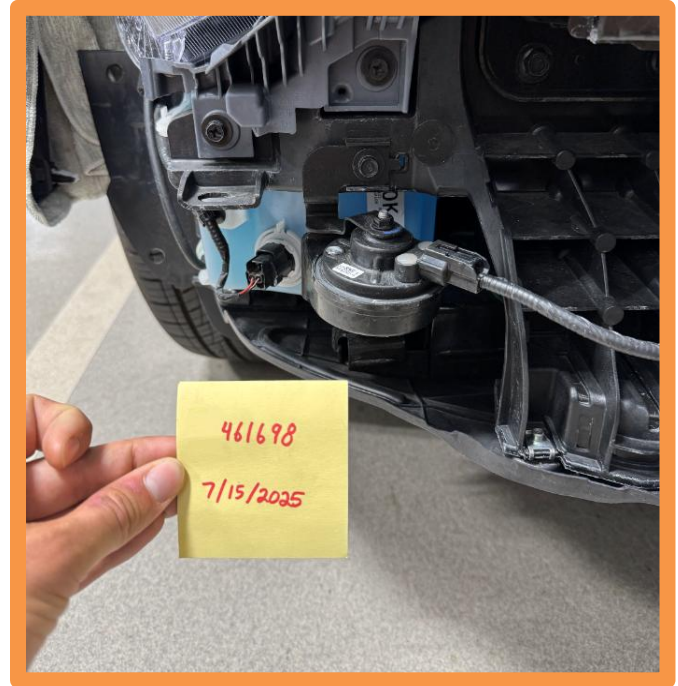
Using the STUI camera function, take a photo of the original horn.
