# Technical Service Bulletin

GROUP <b>BODY ELECTRICAL</b>	NUMBER <b>26-BE-003H</b>
DATE <b>FEBRUARY 2026</b>	MODEL(S) <b>TUCSON (NX4A)</b>

**SUBJECT:** INOPERATIVE HORN ASSEMBLY REPLACEMENT

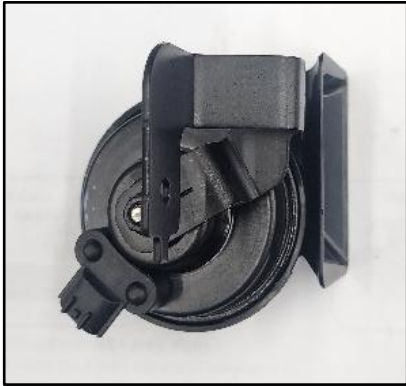
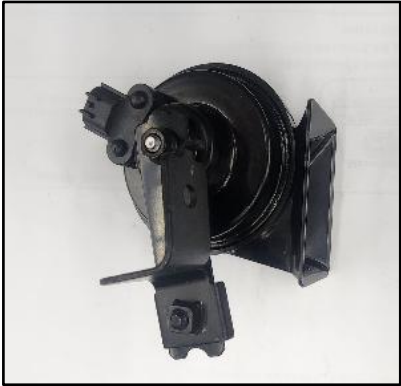
**Description:** Some Tucson (NX4A) vehicles may have an inoperable horn that may be caused by foreign substances causing internal parts to oxidize. This bulletin provides instructions on how to replace both inoperative horns.

Model	Part Name	Part Number	Figure	Remarks
Tucson (NX4A)	Horn Assy - Low Pitch	96641-CW500QQH

Qty: 1
	Horn Assy - High Pitch	96651-CW500QQH

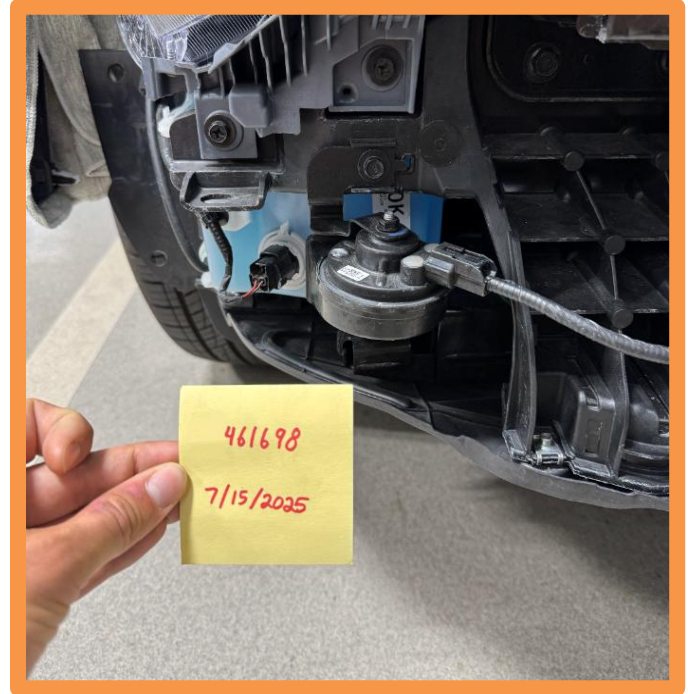
Using the STUI camera function, take a photo of the original horn.

Upload the photo to STUI.
