**HYUNDAI**
Technical Service Bulletin

GROUP BODY ELECTRICAL	NUMBER 26-BE-004H
DATE FEBRUARY 2026	MODEL(S) TUCSON (NX4A)

SUBJECT: INOPERATIVE HORN ASSEMBLY REPLACEMENT
(WARRANTY EXTENSION Z11)

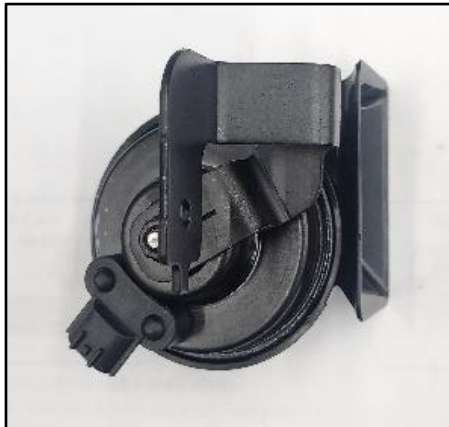
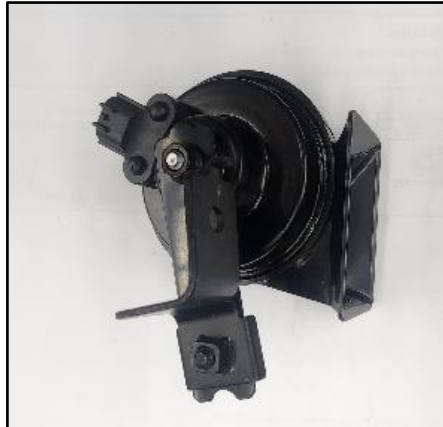
Description: Certain Tucson (NX4A) vehicles may have an inoperable horn that may be caused by foreign substances causing internal parts to oxidize.

This bulletin provides instructions on how to replace both inoperative horns.
