Technical Service Bulletin

GROUP BODY ELECTRICAL	NUMBER 26-BE-001H-1
DATE FEBRUARY 2026	MODEL(S) SEE BELOW

SUBJECT: INOPERATIVE HORN ASSEMBLY REPLACEMENT
(WARRANTY EXTENSION Z09)

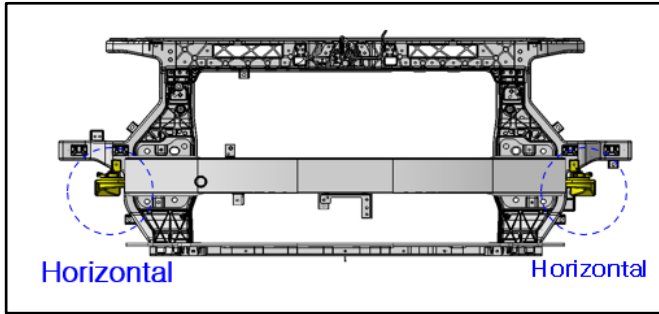
Before

Description: Some vehicles may have an inoperable horn that may be caused by foreign substances causing internal parts to oxidize.

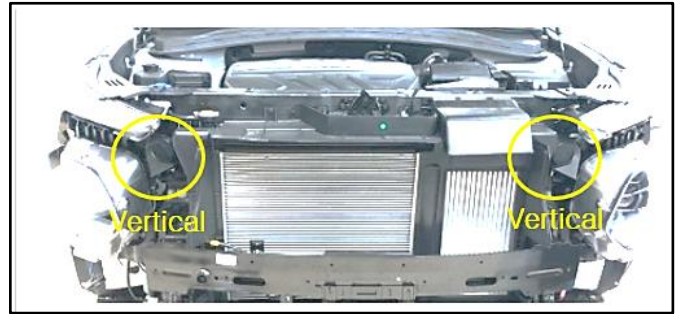
After

The new horns are intentionally mounted in a vertical position as opposed to the previous horizontal position.

If a horn needs to be replaced, follow the instructions within this TSB to install the latest design.
